บทความทบทวนผู้ป่วย
(Case review)

Cases Report: Clavicular Fractures after Hook-Plate Fixation Surgery

Keywords: clavicular fractures, hook plate, complications

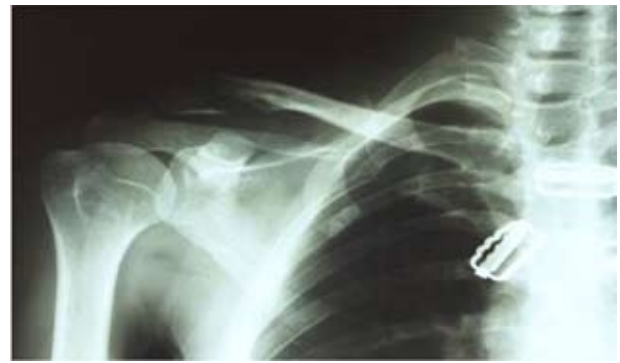
In July 2012, a 40-year-old man had traffic accident and presented with pain at right shoulder due to a displaced fracture of distal end of right clavicle (Neer type II) with no associated neurovascular deficit (Figure 1).

Figure 1. A radiograph showing a distal clavicular fracture (Neer type II).

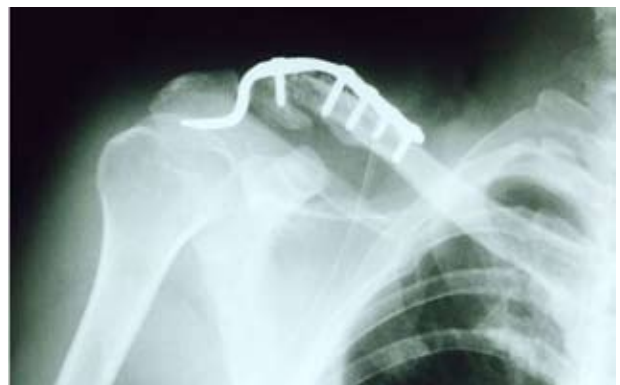
He was operated by open reduction and internal fixation using 6-hole hook plate with 4 screws into the medial fragment and a single screw into the lateral fragment (Figure 2).

Figure 2. A postoperative radiograph presenting the distal clavicle which was fixed by using a 6-hole hook plate with 4 screws in the medial part and a single screw in the lateral part.

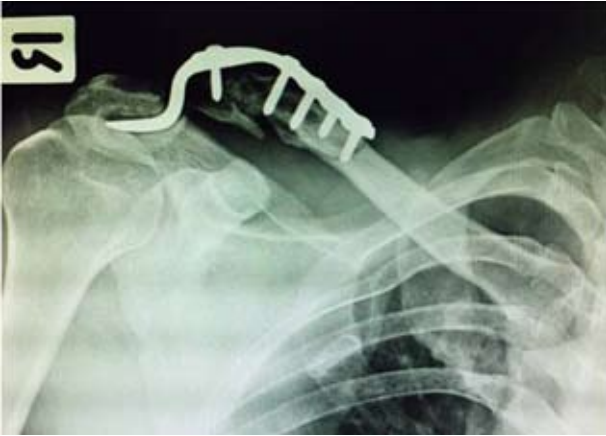
At 18 months after surgery, he had painful at right clavicle after traffic accident. He fell from motorcycle and landed on to his right shoulder directly. The radiograph showed a minimally displaced fracture at the medial end of plate and osteolysis over the acromial undersurface (Figure 3).

Figure 3. A radiograph showing the clavicle fracture at medial end of the hook plate after the motorcycle accident. Note osteolysis under the acromial surface.

The fracture reduction at distal clavicle was maintained. However, the fracture at medial end of plate was treated conservatively by immobilization in arm sling until no pain during shoulder motions. He, then, lost to follow up again.

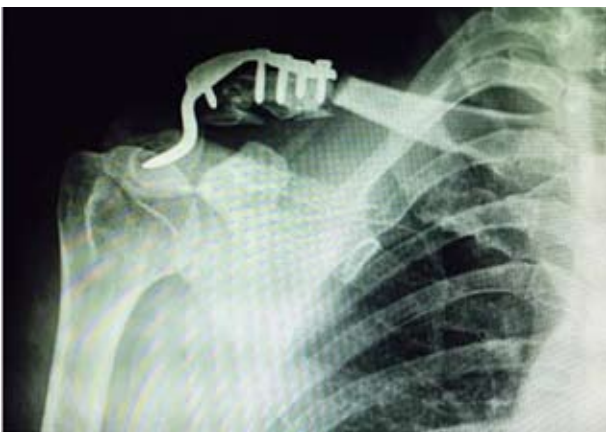
A year after his second injury, he came to the orthopedic department due to medium velocity traffic accident. He presented with painful at right clavicle. The radiograph showed a fracture at the medial end of plate (Figure 4).

Figure 4. A radiograph demonstrating the clavicle fracture at medial end of the hook plate after the second injury.

This fracture was managed conservatively and healed eventually. The implant was removed and a broken of hook plate was observed in pre-operative radiograph (Figure 5).

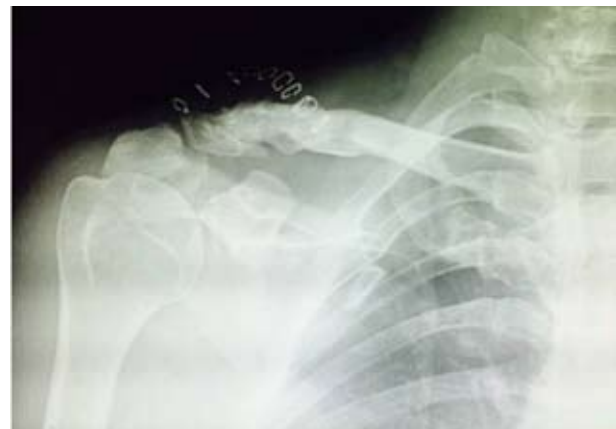
After the hook plate was removed (Figure 6), he had a full range of painless shoulder movements.

Figure 6. A radiograph after hook plate removal showing the union of both fracture sites (distal clavicle fracture and clavicle fracture at medial end of the hook plate).

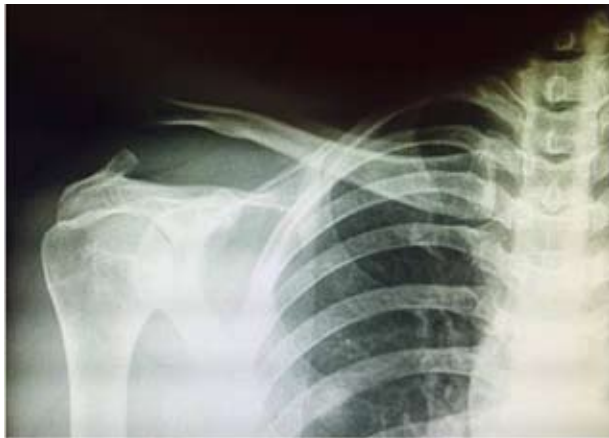
In February 2015, a 47-year-old woman fell motorcycle and landed heavily on her right shoulder and arm. She had painful and could not move her right shoulder due to displaced right acromioclavicular joint (Rockwood type IV) (Figure 7) with no associated neurovascular deficit.

Figure 7. A radiograph showing acromioclavicular joint dislocation (Rockwood type IV).

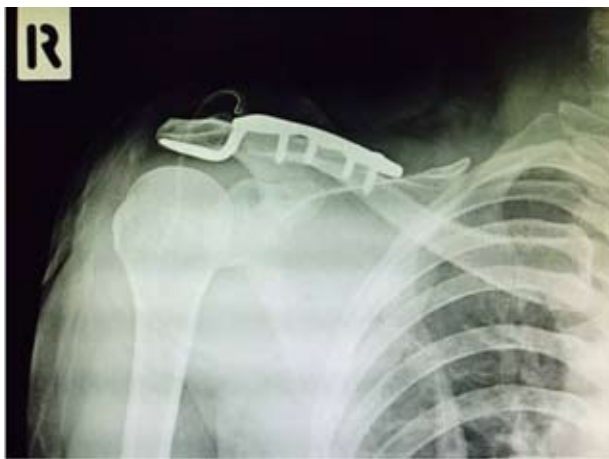
She was operated by open reduction together with internal fixation using 5-hole hook plate with 4 screws into the clavicle (Figure 8).

Figure 8. A postoperative radiograph demonstrating a reduction at acromioclavicular joint using a 5-hole hook plate.

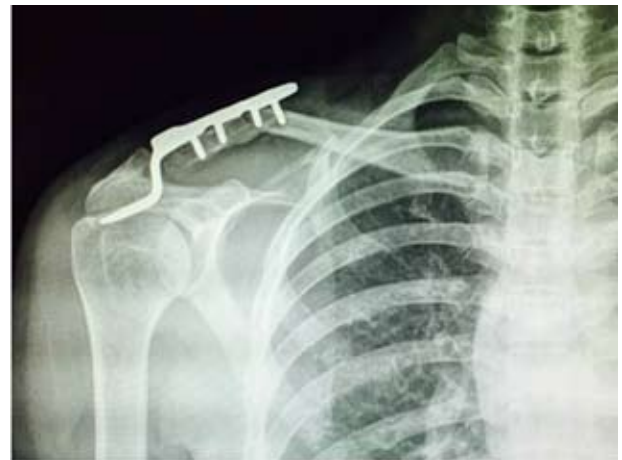
Two weeks after operation, she experienced pain at right clavicle after lying down on right shoulder. The radiograph showed a fracture at the medial end of plate (Figure 9).

Figure 9. A radiograph revealing the clavicle fracture at medial end of the hook plate after injury.

Although the prominence of medial end of hook plate was observed, the acromioclavicular joint reduction was maintained. The right shoulder was immobilized by arm sling for 4 months. After that radiographs were performed and evidenced as union of the clavicle fracture. The hook plate was then removed. The patient had finally no complaint on pain during shoulder movements.
