FACTA UNIVERSITATIS

Series: **Architecture and Civil Engineering** Vol. 12, N° 2, 2014, pp. 133 - 148

COLLISION OF BUILT HERITAGE REVITALISATION PRINCIPLES AND “DESIGN FOR ALL”

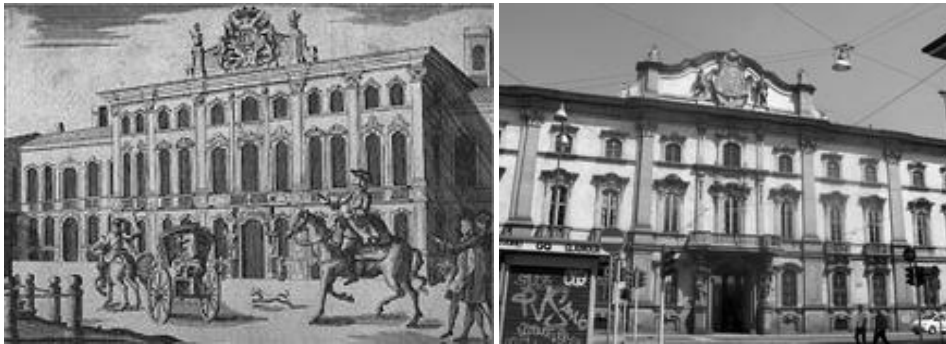
Fig. 2 The main entrance to the palace Arese Litta in the XVII and XXI century, respectively [16]

The spacious complex within the former medieval town is situated close to the major roads. Nowadays, there is no parking space in front of the main entrance on Via Magenta, basically due to changes in street regulation which were created to meet needs of traffic which increased in speed and frequency. Originally, the street was integrated with the square (Fig. 2). On the eastern side of the complex, there are about 25 parking places. The main entrance to the theater remains the one from the garden, with access from Foro Bonaparte (Fig. 3).

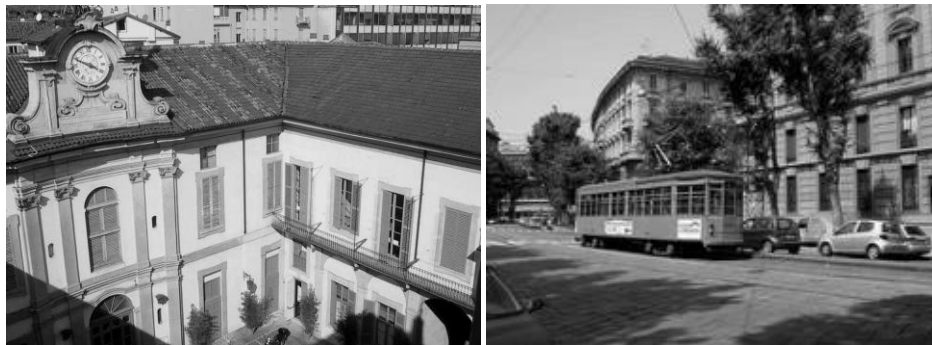
Fig. 3 The entrance to the palace Arese Litta from the garden and driveway from Foro Bonaparte, respectively [16]
