## Static and dynamic experimental study of strengthened reinforced short concrete corbel by using carbon fabrics, crack path in shear zone

**ABSTRACT.** The paper presents an experimental analysis of tracking the path of the cracks and crack growth in strengthened or repair reinforced concrete short corbels bonded by carbon fiber fabrics under static and dynamic loads.

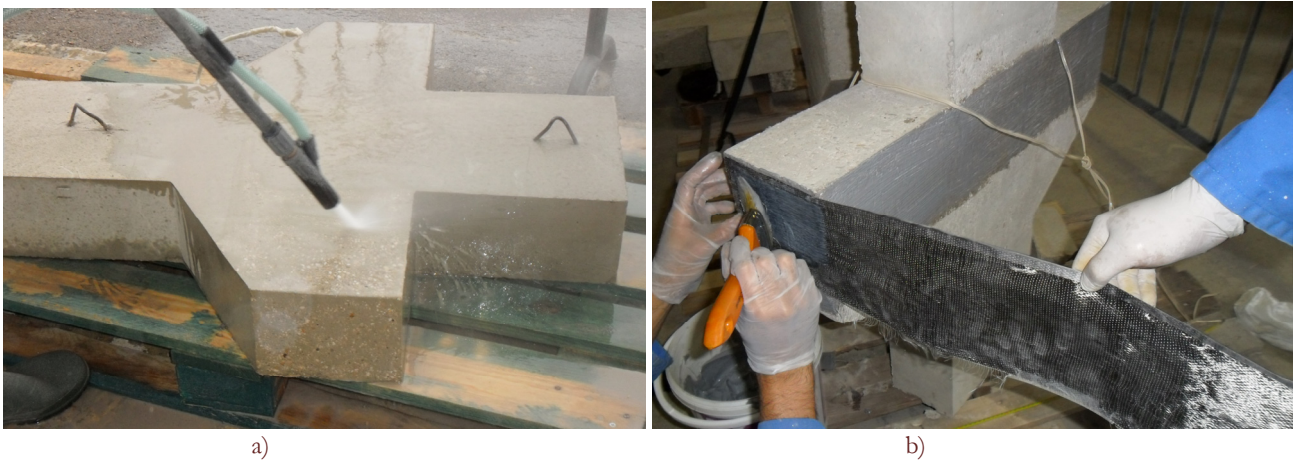
Figure 2: Details of bonding system of: a) Sandblasting of corbels and b) Application of carbon fiber on concrete surface by wrapping.

The surface preparation was of primary importance and calls for care. However, preparation of the concrete surfaces must be carried out to remove any loose or weak material, oil, grease etc... In this case grit blasting was a good method, Fig. 2a. The four corners of the corbel are rounded to reduce the decrease in strength and to prevent tearing of composite material. Preparation of surface should be carried out just prior to the bonding operation to prevent any contamination. After, the contamination can be avoided by applying glue on concrete and carbon fiber fabrics is applied.

So, epoxy is applied on concrete with a brush and then, fabric is placed on epoxy. Second coat of epoxy is rolled into the fabric like Fig. 2b. The fabric is wrapped completely around the corbel and the fabric is overlapped on the face of the corbel. Pressure must be applied to squeeze out excess glue.

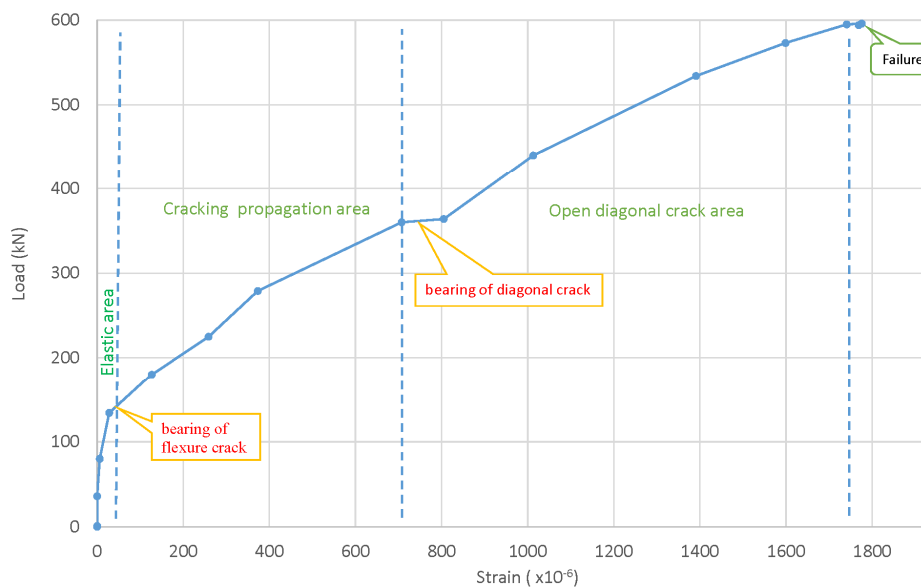
Figure 3: Mechanical behavior of reinforced concrete corbel C0, strain of tensile steel bar.

Firstly, the reference specimen without strengthening is submitted to a vertical load under static loading to collapse. This test enabled to determine the three specific areas: elastic area, crack propagation area and open diagonal crack area showed in Fig. 3. Knowing the load-strain curve, an average value of load is defined. This value is corresponded to average load in between 20 % to 40 % of maximum tensile strength. The magnitude and number of fatigue of the repeated loads are fixed to one million cycles.

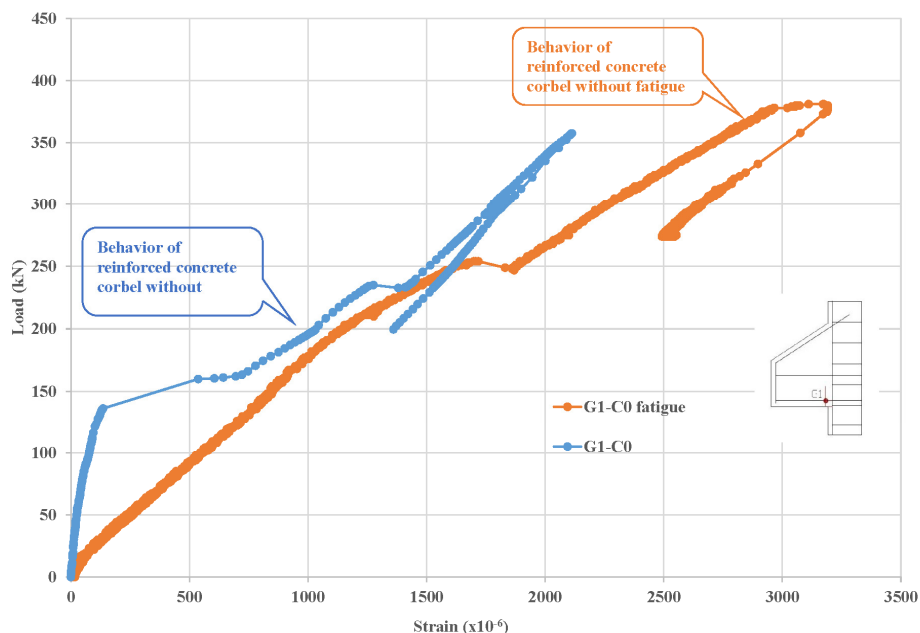
Figure 4: Effect of fatigue on reinforced concrete corbels under static tests.

Fig. 4 described the comparison of behavior between reinforced concrete corbels "C0" loaded in static and dynamic tests. There is a change in slope at 60 kN for unstrengthened corbel in static loading. In fact, after one million cycles of fatigue,

the reinforced concrete corbel is loaded in simple tensile test to failure. After dynamic loading the curves showed that the range elastic area was lost. The diagonal crack appears at 254 kN more lately than without fatigue at 235 kN as shown in Fig. 4. The fatigue changed the stress distribution in the concrete corbel therefore cracking so, the structure is consolidated further. After one million cycles, the tensile ultimate load of reinforced concrete corbel was 381 kN. However, the test results showed an increase load of 6 % compared with reinforced concrete corbel static loading. Of course, it would be a little impact on the ultimate failure load after one million cycles.

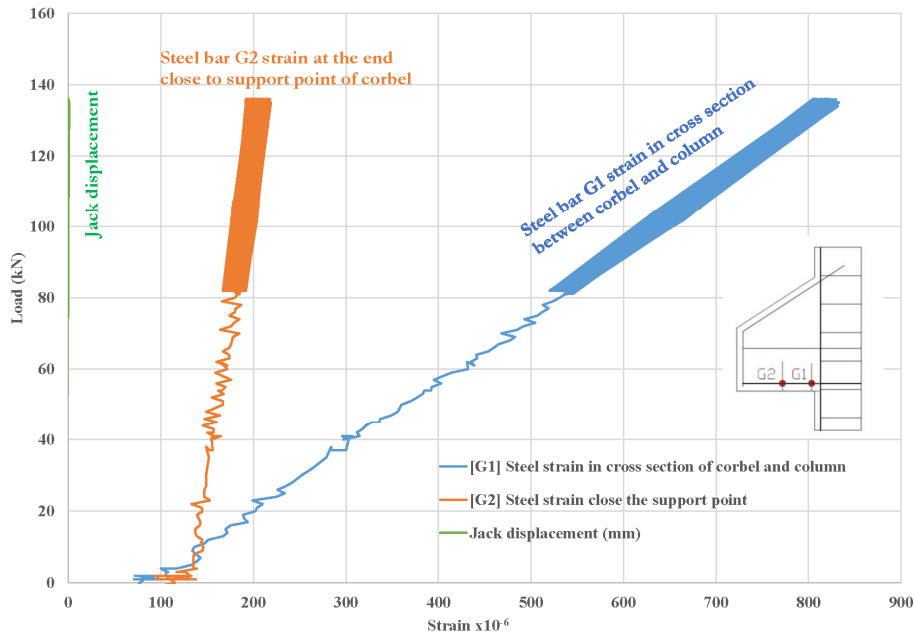
Figure 5: Strains of steel bar in cross section and support load point of corbel ("C0" fatigue).

The fatigue results of reinforced concrete corbels on Fig. 5, showed that strains of steel tie are very small (less than  $200 \cdot 10^{-6}$ ) after one million cycles. The jack displacement was also smallest. One million cycles did not enough increasing to failure. In fact, the experimental tests will continue up to one million cycles. There would be little influence on the ultimate tensile strength of strengthened reinforced concrete corbel after one million cycles.

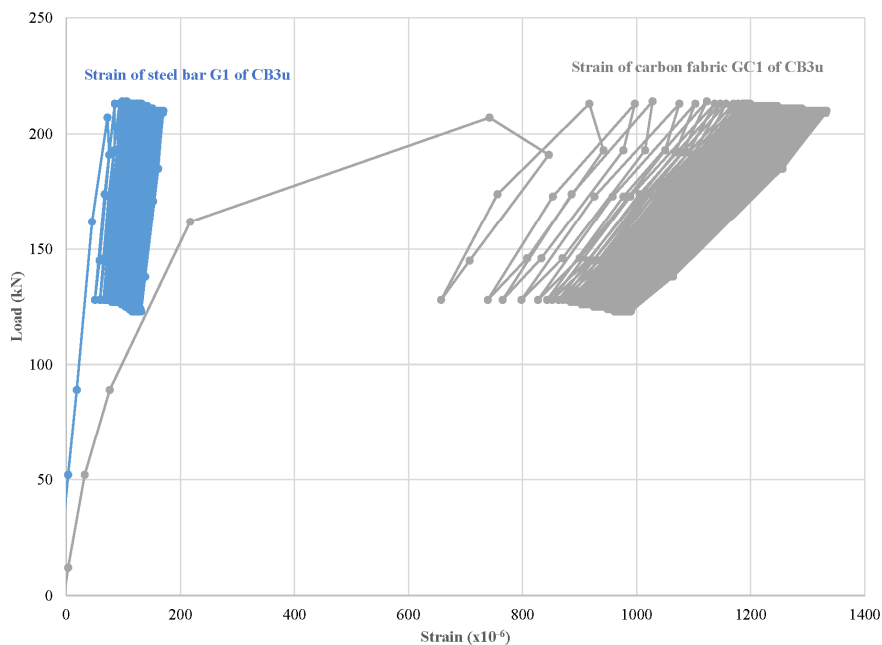
Figure 6: Strains of steel and carbon fiber fabrics of strengthened corbels under fatigue test.

The carbon fiber fabrics included the strain of structures about  $400 \cdot 10^{-6}$  while the steel bar is deformed less than  $200 \cdot 10^{-6}$  as shown in Fig. 6.

The appearance of bearing at 365 kN physically characterized by diagonal and deformations reached at  $600 \cdot 10^{-6}$ . The carbon fibre fabrics have resumed strain of structure. The strain of steel tie at mounting section is relatively small in the range of  $100 \cdot 10^{-6}$  as shown in Fig. 6. The strain at point G1 pulling close cross section where strains are highest. Deformations are sufficient to cause the disorder in the structure. The investigating did not show failure of carbon fabrics. The strain of carbon fibres fabrics at point GC1, the same position like G1, at least  $400 \cdot 10^{-6}$  between in Fig. 6 of  $900 \cdot 10^{-6}$  to  $1300 \cdot 10^{-6}$ , is insufficient to generate cracks in strengthened reinforced concrete corbel.

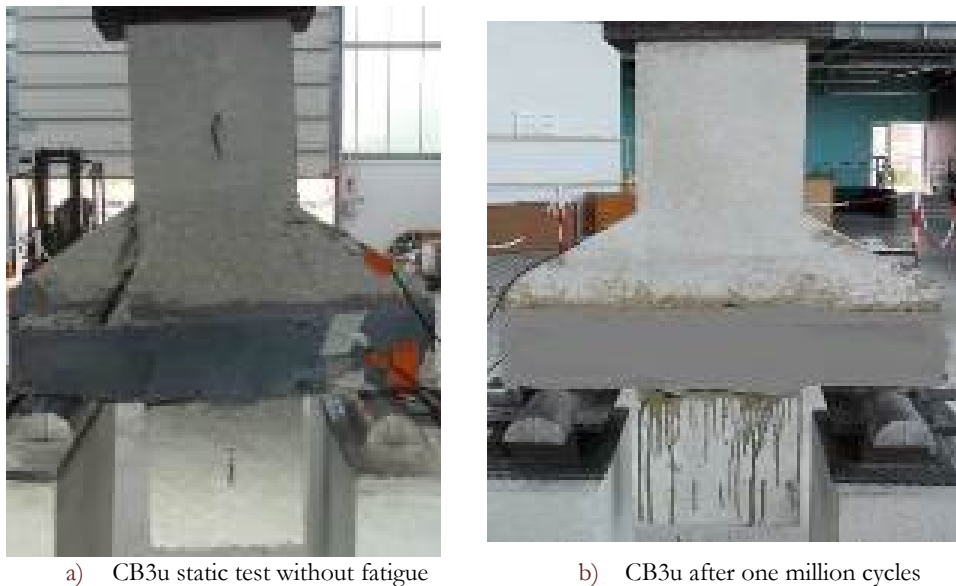
Figure 8: Cracking and failure in strengthened concrete corbel. a) CB3u-static loading to failure, b) CB3u -after one million cycles.

The results show in Fig. 8, the cracking and failure modes of strengthened reinforced concrete corbels. After static test, the specimen ruptured in shearing and splitting failures Fig. 8a. Strengthened corbel after one million cycles has no visible cracks, when the corbel is strengthened by wrapping, Fig. 8b. In fact, the results show the same failure cracks as CB3u static test.
