Management of multi-source information to identify the typology of the horizontal structures in historical masonry buildings: the case study of the Museum of Capodimonte in Naples (Italy)

A. Maione, L.U. Argiento, C. Casapulla, A. Prota

University of Napoli Federico II, Department of Structures for Engineering and Architecture
arch.maione@gmail.com, lucaumberto.argiento@unina.it, casacla@unina.it, aprota@unina.it

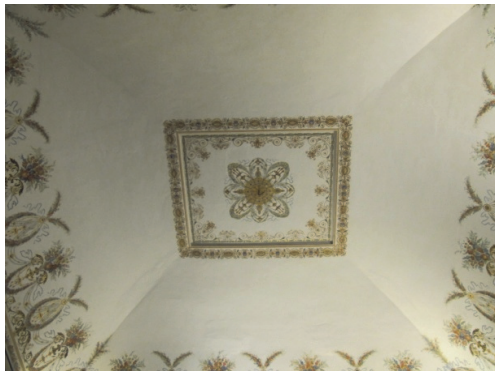
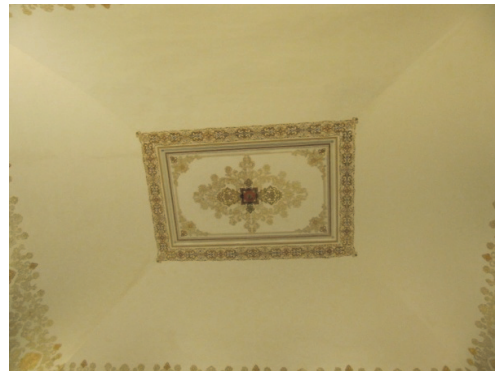
Figure 2: (a) Planimetric identification of the three couples of adjacent rooms (9 and 49, 10 and 48, 11 and 47); views of the intrados of the painted vaults related to (b) room 9 and (c) room 10.

Hence, in order to understand whether the vaults of adjacent rooms have decorative or structural function, the following hypotheses were formulated on the basis of the critical analysis of the historical documentation and of the geometrical survey [4].

According to a first hypothesis, the two adjacent rooms derive from the partition of a unique space covered by a structural masonry vault, maybe required by the exhibition needs of the Museum. With this transformation, three sides of the original vault were preserved, while a wooden structure was built on the fourth one, resembling the profile of the vault. This hypothesis is supported by the inclination of the fourth side of the vault that appears considerably more pronounced. Another possible hypothesis is that the present visible vaults are not load-bearing, but they have a timber structure that repeats the shape of the original masonry vault. This kind of solution, on the other hand, was found out in the rooms 51 and 52 (see Fig. 3) which also result from the division of a unique space; in fact, by approaching the narrow space behind

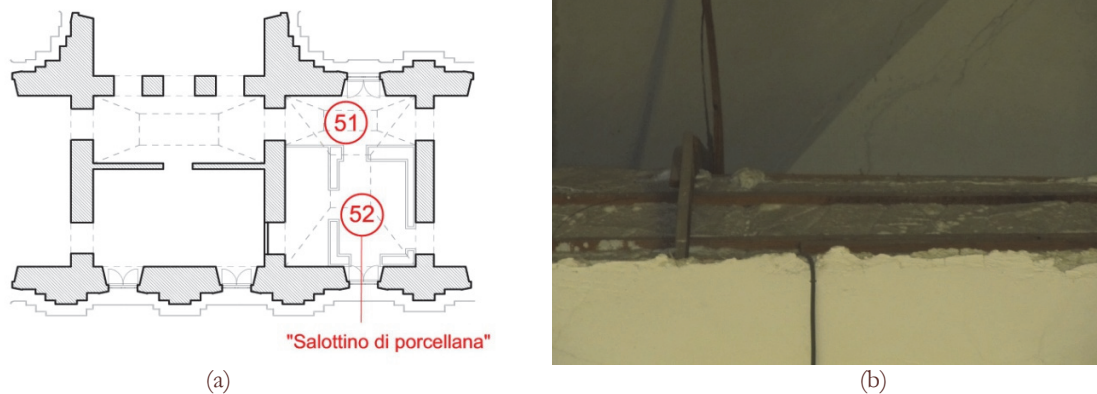
Figure 3: "Salottino di Porcellana" (room 52): (a) planimetric position and (b) timber vault realized under the earlier masonry vault, visible from the empty space behind the room.

the room 52 (hosting the precious "Salottino di porcellana") it was possible to discover that under the original masonry vault, still in place, there was a timber structure consisting in a series of ribs completed with a mat of plaited canes and bricks on a sheet. The height at the keystone of this latter vault is lower than that of the original one.

No-load-bearing vaults composed of timber structure with overlying load-bearing masonry vaults. Examples of this typology are the "Salottino di porcellana" (Fig. 3), the Library near the hexagonal staircase (Fig. 11) and the rooms on the east side of the south court. This typology dates back to the years between 1952 and 1957 [7] and is related to the need of dividing existing large rooms into two smaller ones, or in other cases it was adopted to host decorative furniture coming from other historic buildings.

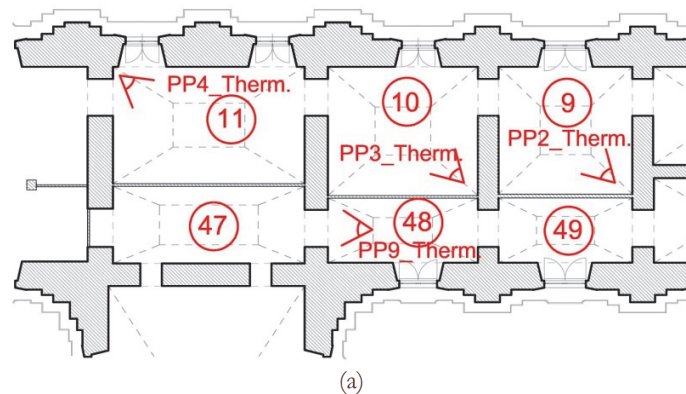
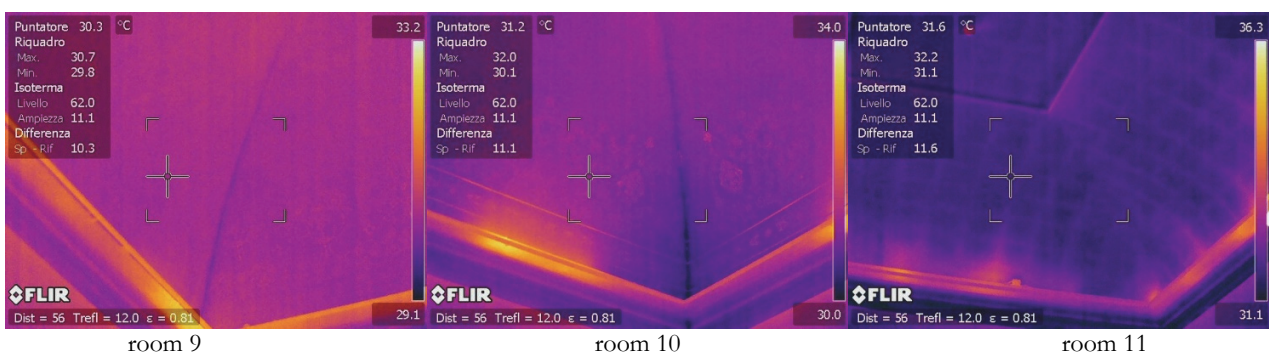
Figure 5: Planimetric localization of the points of view of the camera (a) and thermographic images of the intrados of the vaults for rooms 9, 10 and 11.

Fig. 5 reports the results of the thermographic survey related to the vaults covering the rooms 9, 10 (both painted) and 11. In particular, the thermographic image related to room 11 confirmed that it is not structural, as already suggested by the presence of a thin wall in common with the adjacent room 47.

Instead, as far as the painted vaults of the rooms 9 and 10 are concerned, their thermographic images do not reveal the signs of the timber skeleton and this may lead to suppose the presence of masonry vaults. This result, however, seems to be not consistent with the presence of a non-structural wall on one side, as previously highlighted.

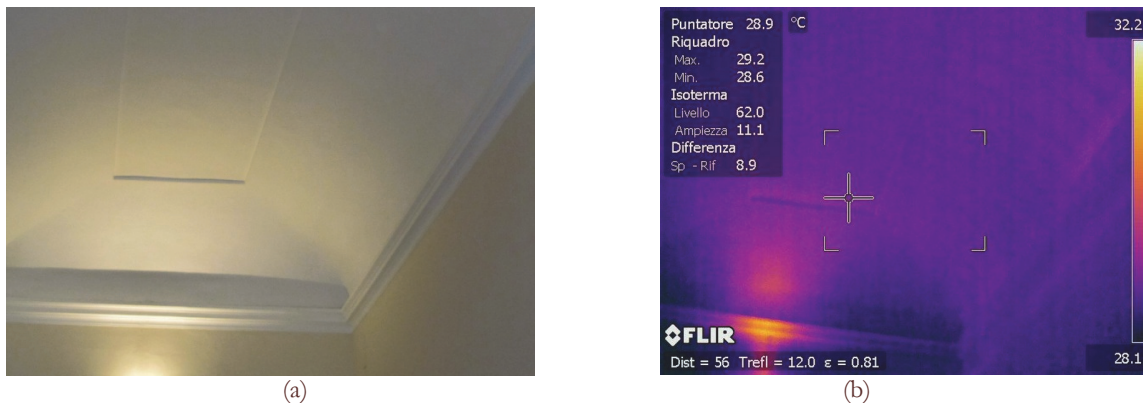
Figure 6: Room 48: (a) view and (b) thermographic image of the intrados of the vault.

On the other hand, also the vault covering the room 47 has probably a timber structure, as suggested by the thermographic image of the similar room 48 in Fig. 6b. It is very likely, therefore, that the timber structures were created after the partition of the unique space covered by the original vault.

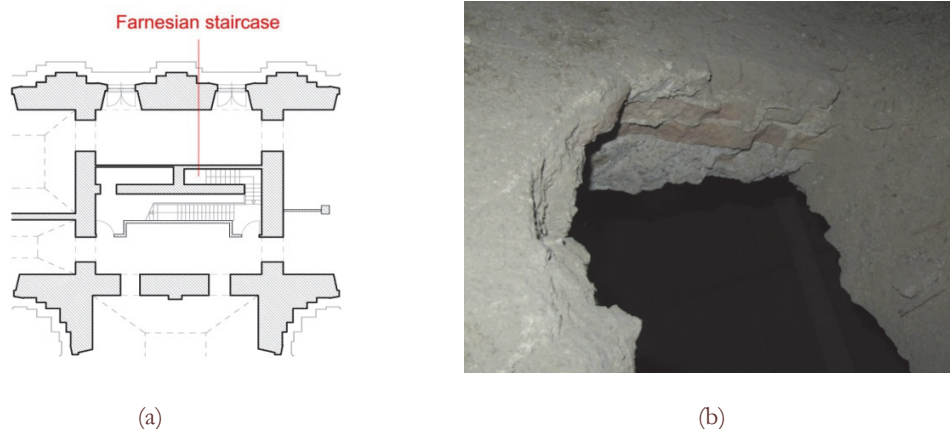
Figure 7: (a) Planimetric identification of the Farnesian staircase and (b) no-load-bearing masonry vault visible from the staircase.

Thus, a plausible explanation of this configuration was derived from a further typology of vault (Fig. 7) that was possible to see from a crawl space of the Farnesian staircase. It is a no-load-bearing masonry vault, characterized by a thin thickness of bricks disposed on a sheet (20 cm average thickness). This typology could be compatible with the underneath thin wall and maybe it was related to the need of preserving the paintings on their intrados surface.

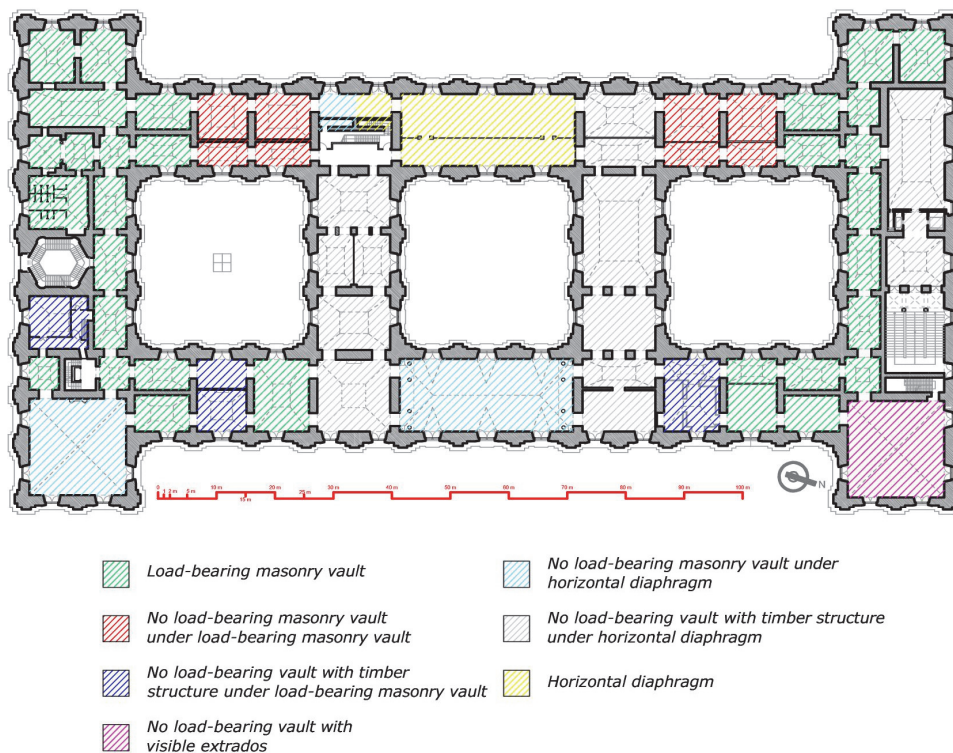
Figure 8: Typological characterization of the horizontal structures upon the first floor.

Therefore, by critically integrating different sources of information, a proper classification of the no-load-bearing vaults was proposed on the basis of their constructive typology and of the overlying horizontal structures. This approach allowed defining a complete typological characterization of the horizontal structures present upon the first floor of the building. In fact, the following typologies can be identified (Fig. 8):

- Load-bearing masonry vault;
- No-load-bearing masonry vault with overlying load-bearing masonry vault;
- No-load-bearing masonry vault with overlying horizontal diaphragm;
- No-load-bearing vault composed of timber structure with overlying load-bearing masonry vault;
- No-load-bearing vault composed of timber structure with overlying horizontal diaphragm;
- No-load-bearing masonry vault with visible extrados;
- Horizontal diaphragm.

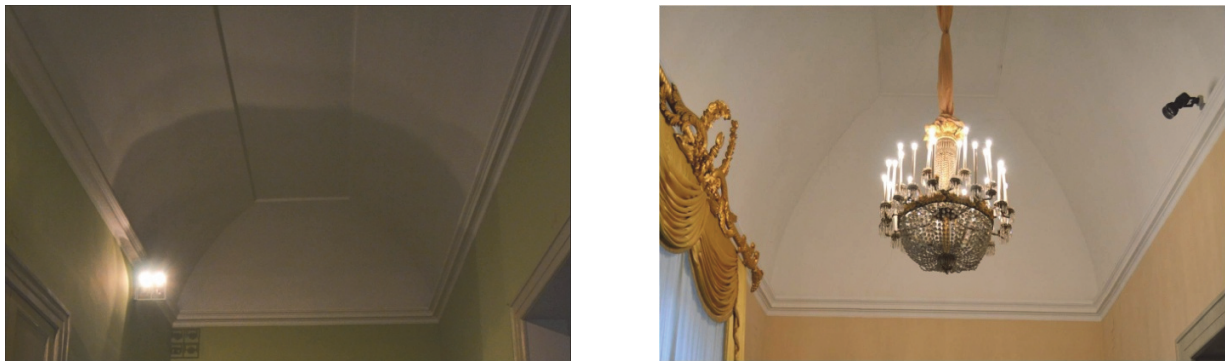
Figure 9: Load-bearing masonry vaults.

Load-bearing masonry vaults (Fig. 9) have a prevailing configuration as a schifo or mirror vault and maximum height of about 8.8 m; moreover they are dated back to the construction of the building and characterize the rooms of the north and south sides. Their structural behaviour could be easily modelled through validated numerical methods [28-31].

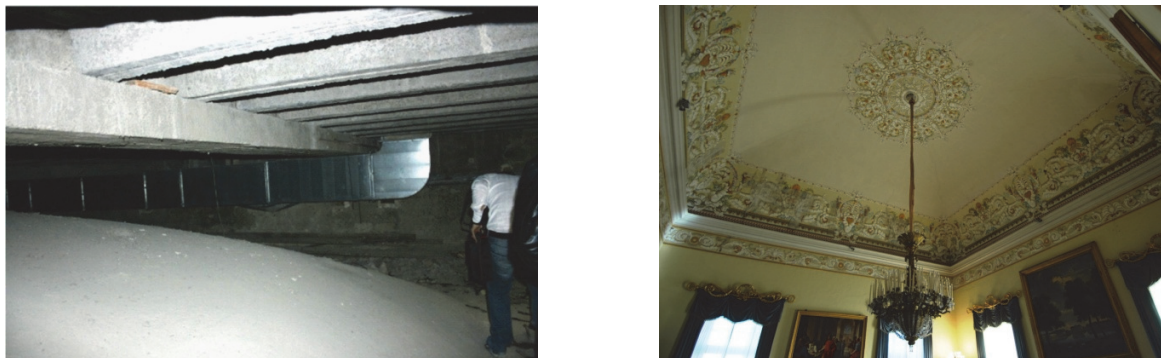
Figure 10: No-load-bearing masonry vaults with overlying horizontal diaphragm: the "Sala della culla".

No-load-bearing masonry vaults with overlaying horizontal diaphragms. The historic analysis allowed to refer this typology to two different circumstances: the first one is the substitution of the earlier load-bearing masonry vault with a c.a. diaphragm likely due to structural problems; the other one is related to the project of the architect De Felice of the years between 1952-1957, when new rooms devoted to the exposition were created on the last level of the building and horizontal structures were realized above the vaults of the rooms with double height upon the first level as the "Sala della Culla" (Figs. 2a and 10) and the "Salone delle Feste" (Fig. 2a) [7].

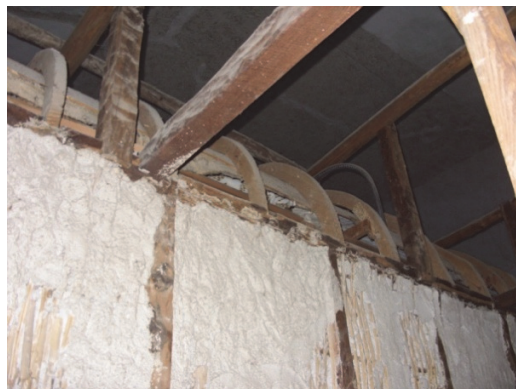
Figure 11: No-load-bearing masonry vault composed of timber skeleton visible from the Library.

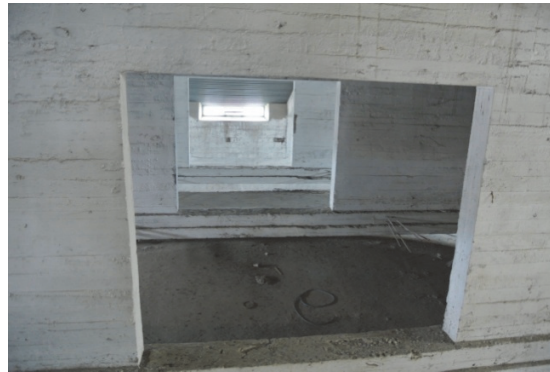
Figure 12: The extrados of the vault of the "Sala Camuccini".

A single example of *no-load-bearing masonry vault with visible extrados* is represented by the vault of the "Sala Camuccini" (Fig. 12), a double height room located at the northeastern corner, opposite to the "Sala della culla". The extrados of this vault is visible from the crawl space where the presence of c.a. beams suggests the intention to realize an overlaying diaphragm as it was for the aforementioned "Sala della culla".
