# Corrosion Behaviour of Al, Cu, and Fe Alloys in Deep Sea Environment

*The aim of this study is to investigate deep sea environment effects on the corrosion of Al, Fe, and Cu alloys, employed in the KM3NeT project, a deep sea infrastructure designed to host a neutrino telescope. Alloys commonly used in seawater, as well as less widely employed materials were studied. Samples were immersed at the NEMO site (located off Capo Passero, Italy; 3365 m depth) for consecutive time periods of 6, 12 and 18 months. A representative set of samples was recovered and laboratory tests performed to evaluate the type and degree of corrosion attack. Stainless steels reported the best performance in terms of weight loss, corrosion rate, and corrosion morphology. However, also Al 5093 and Al 6082 performed satisfactorily, in terms of weight loss and corrosion rate. This prescreening will be partially employed in selecting building materials for the KM3NeT structure.*

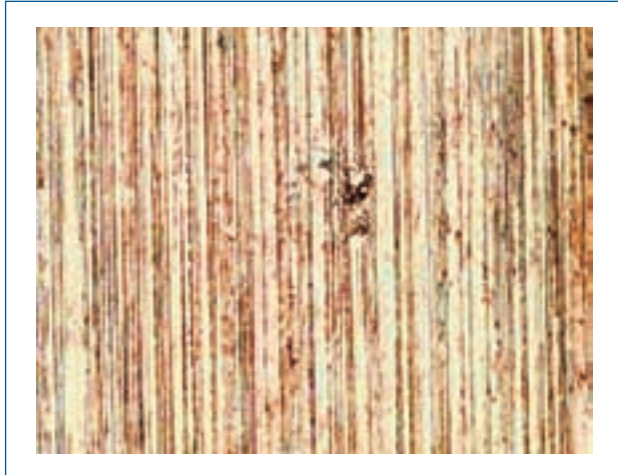
Figure 5: OM (100x) of AA 6082 before (a) and after 18 months of deep sea immersion (b).

Digital imaging of AA 5083 and AA 6082 alloys shows a slight change in texture, due to starting sites of pitting corrosion, only after 18 months of immersion (Figure 3 a) and b)). The AA 5083 and AA 6082 alloys show a quite similar morphology and a comparable degree of corrosion. OM examination clearly shows the presence of cracks in the superficial Al oxide layer (Figure 4 and 5).

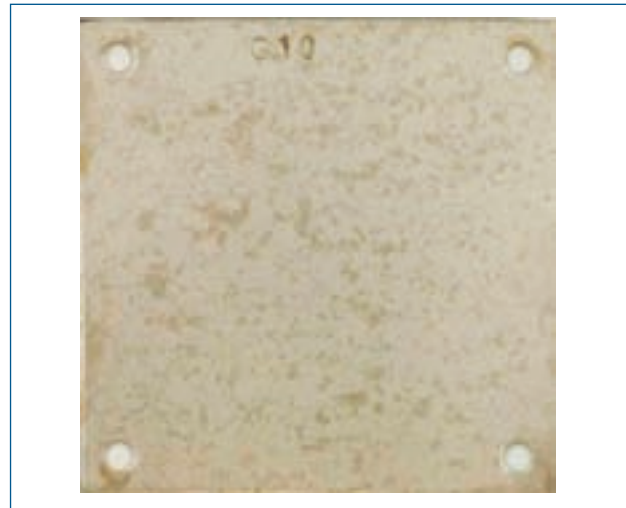
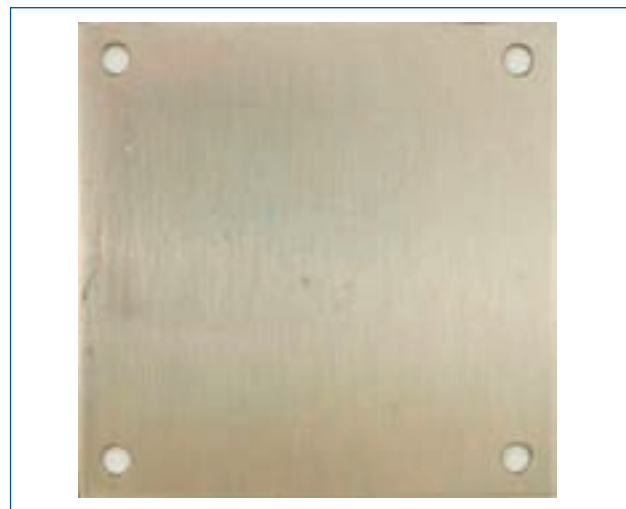
**Figure 11: Stainless steel alloys after 18 months of deep sea immersion Sample size 100x100 mm a) 316 L SS; b) 2205 DSS.**

With regard to the site physical-chemical parameters, we have found that there was enough oxygen content to maintain a passive film on our samples, which, after 18 months of immersion, had shown no change. Stainless steels are known to perform better in aerated seawater, since the lack of aeration at a specific site often leads to crevice attack. Very little oxygen is required to maintain the passive film on a clean stainless surface [15]. Stainless steels recorded almost no detectable weight loss (Figure 4), with negligible corrosion rate (Table 3). No significant degree of corrosion after 18 months of immersion is visible by digital imaging (Figure 12 a) and b)). Figure 13 a) and b) show the OM of the 316 L stainless steel before and after immersion (18

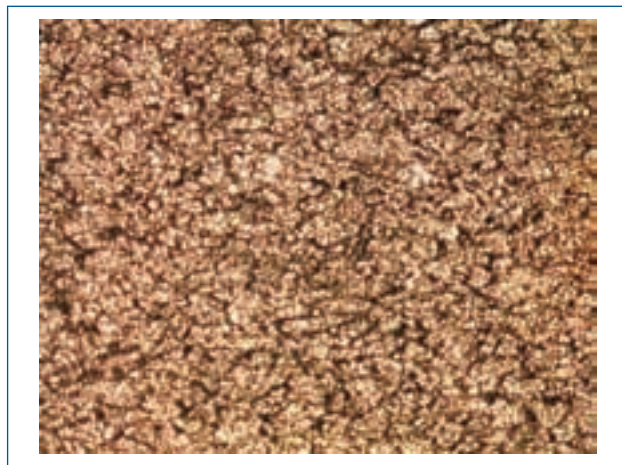
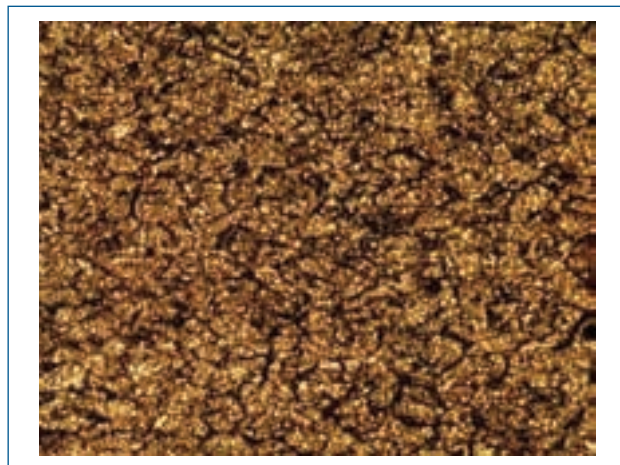
**Figure 12: OM (100x) of the 316 L Stainless Steel before and after immersion 18 months of immersion.**

months); no significant differences are visible.

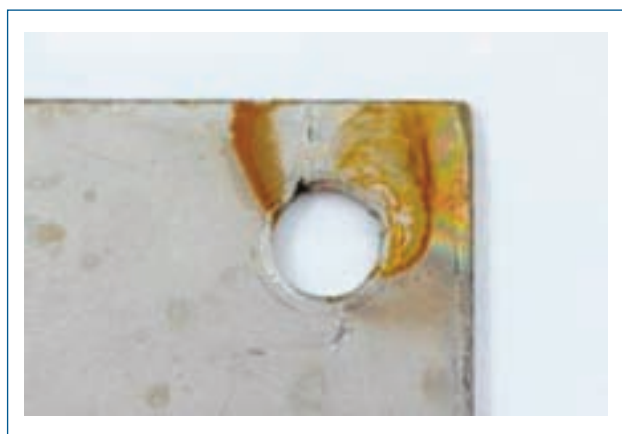
**Figure 13: Crevice corrosion on sample 316 L SS after 12 months of deep sea immersion. Hole diameter: 6 mm.**

An isolated –not statistically significant - case of crevice corrosion was observed on one of the 12 month exposure samples, near the hooks used to fix the samples inside the cages (Figure 14).

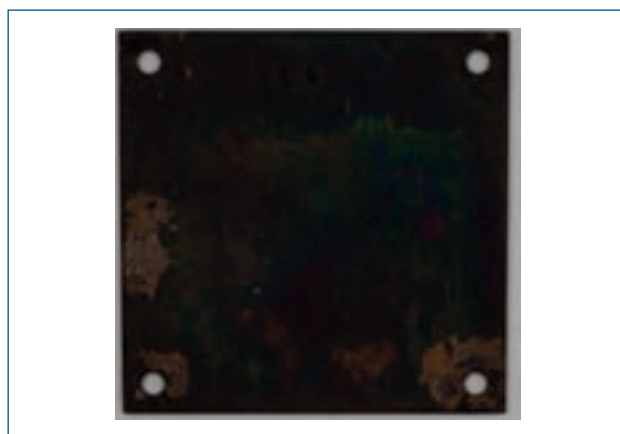
**Figure 14: Cu-Ni 90/10 alloy after 18 months of deep sea immersion. Sample size 100x100 mm.**

The photos in Figure 15 point to a general corrosion attack process.
