Preformed pits as initiation sites for stress corrosion of austenitic stainless steels

ANTONIO ALDERISIO, BRUNO BREVAGLIERI, GIUSEPPE SIGNORELLI, Dipartimento di Ingegneria Chimica, dei Materiali, delle Materie Prime e Metallurgia, Sede Metallurgia, Facoltà di Ingegneria, Università La Sapienza, Roma.

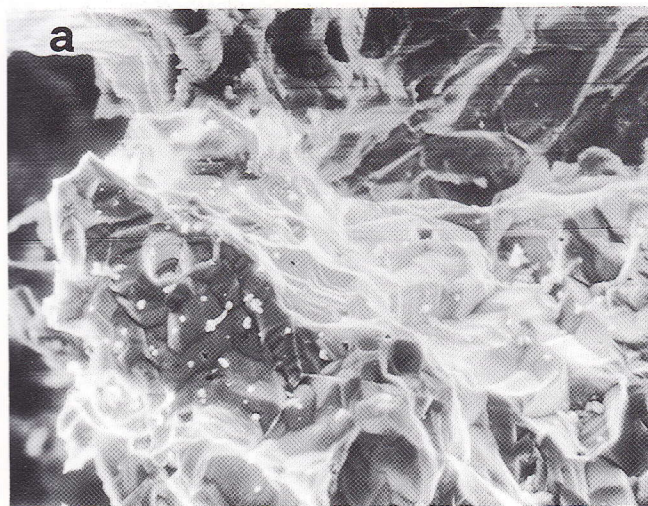
Fig. 7 - (a) as per Fig. 3, 20 h, 70°C; intergranular attack with barely marked fine parallel pleat pattern; $g = 620$; (b) as per Fig. 3, 90°C; intergranular attack with fine parallel pleat pattern; $g = 920$.

Mixed attack (intergranular and transgranular) and transgranular attack have been observed respectively on the crack walls (Fig. 7) and near the mechanically fractured region (Fig. 8) even in the passive range. This situation can be explained by an increase in load to values close to those of fracture, with the result that slip steps appear on the surface.

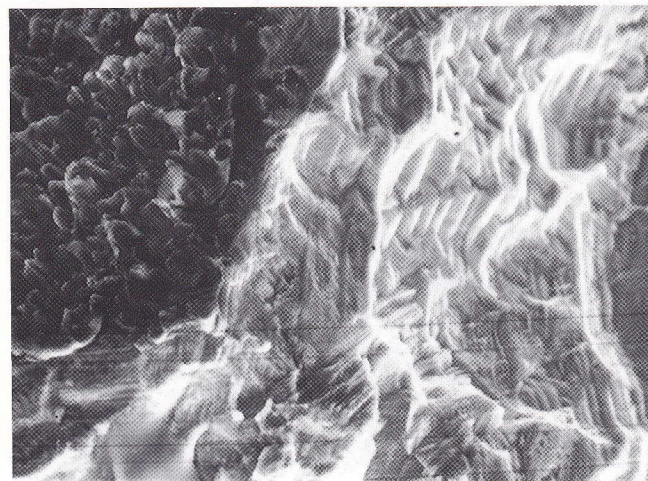
Fig. 8 - As per Fig. 5; transgranular trend of crack close to mechanical fracture region; $g = 900$.

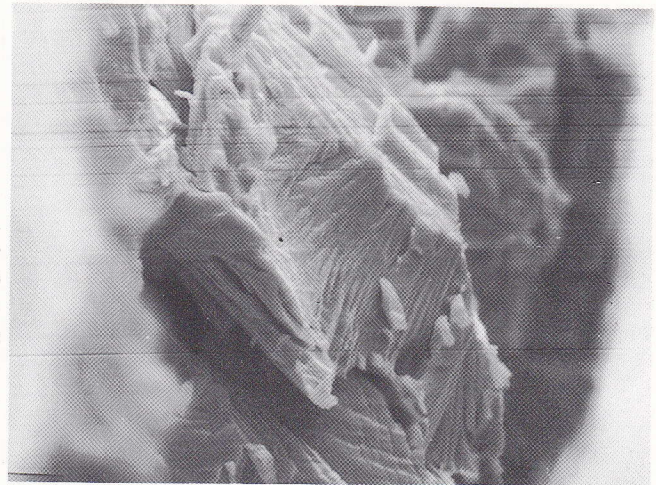
Fig. 11 - As per Fig. 10; crack tip; $g = 1450$.

At higher temperatures — 70 and 90°C — the environment is more favourable for transgranular cracking. Indeed, a fine parallel pleat pattern is to be seen on the walls and at the crack tip (Fig. 11) and sometimes there are both forms of corrosion with barely-marked parallel grooves and micropits (Fig. 12).
