# Studies on metallurgical properties of wire rope for safe operation in mines

*This paper describes the different metallurgical properties which define the state of wire rope in mines like wear and corrosion, lubrication, micro examination, galvanization and chemical analysis. Wear and corrosion affects primarily on outer surface and sometime it may penetrate deeper and change the mechanical property. In abrasive wear, wire and strand movement is restricted, therefore the risk of failure by bending fatigue is increased and reduction of wire area can lead to failure under tensile load. Whereas lubrication retards corrosion and therefore proper lubrication helps in preventing premature failure due to abrasion, fatigue and corrosion. Micro structural study of wire rope reveals both manufacturing defects as well as service degradation. Defects like grain distortion, harmful inclusion, decarburization, damage of zinc coating, corrosion pits etc. is clearly visible in microstructural studies. Galvanization of wire rope protects it from corrosion as well as it has a good fatigue resistance.. Chemical testing of wire rope however ensure quality and safety in mining. The importance of the

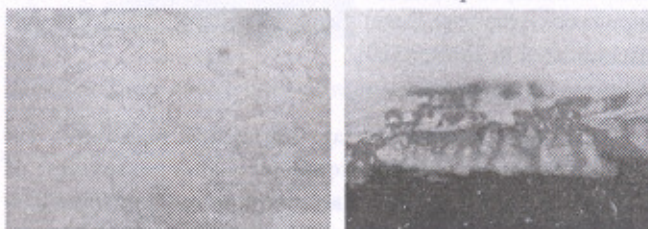
Fig.3d Sample showing impurity inclusion

Fig.3e Wire sample showing crack on zinc coating and corrosion pits

- ♦ Fig 3c revealed decarburization of wire rope which leads to loss of strength of wire rope and resulted in failure.
- ♦ Harmful inclusion (Fig 3d) can only be examined by micro examination. The inclusion leads to brittleness of the wire rope resulting in failure of the rope.
- ♦ Strength of wire rope may severely affecting by damage of zinc coating, corrosion pitting (Fig 3e), stress corrosion pitting (Fig 3f) etc. The micro examination is the only way which can define these defects.

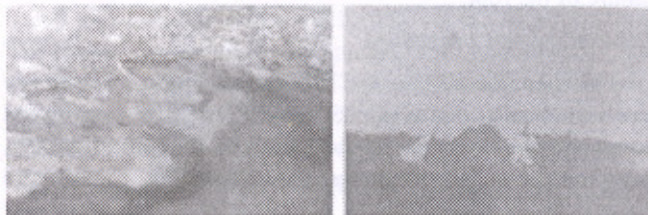
Fig.3f Sample showing stress corrosion pitting in the longitudinal section
