# The Research of Infrared Thermal Image Diagnostic Model for Building External Wall Tiles

Li-Wei Chiang<sup>\*</sup>, Sy-Jye Guo

Department of Civil Engineering, National Taiwan University, Taipei 106, Taiwan, ROC.

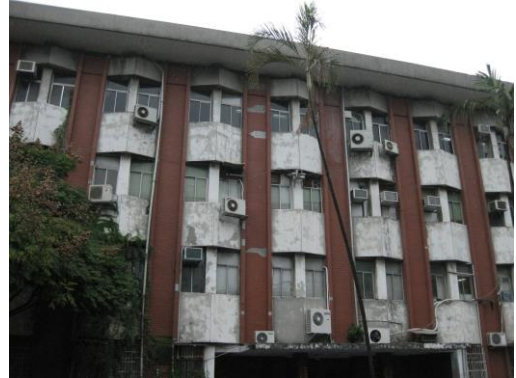
Table 1 Case A of tap tone diagnosis results Case A

The study carried out tap tone diagnosis on 2 buildings. There are 63 areas of deterioration out of 126 tap tone diagnostic tests. The study deems the first peak of the spectrogram as noise, the beginning of the second wave as the start point of deterioration sound, and its end point as the end point of the deterioration sound. The spectrogram is then segmented by lattice points. Further statistical analysis of the 126 deteriorated areas shows that the average start point of deteriorated tiles is 239Hz, while that for the end point is 761Hz. The deterioration extent is indicated by the shaded portion.

This study investigated 2 building cases in the National Taiwan University. This study used lattice segmentation method for analyzing 126 tiles deterioration image spectrums. It is found that the deterioration of the tiles starts at frequency average about 240Hz and ends at about 760Hz. Deterioration hatched range shown in table 1 and table 2.

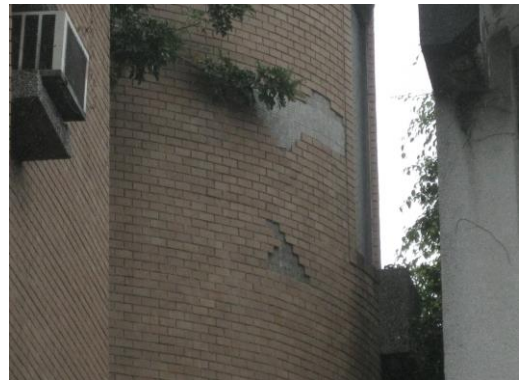
Table 2 Case B of tap tone diagnosis results Case B
