Breakage of stylet inside endotracheal tube following intubation

ABSTRACT

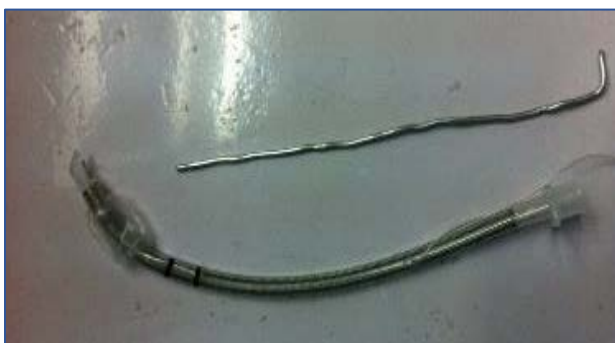
anaesthesia was done with fentanyl 100 mcg, propofol 100mg and vecuronium 6 mg after 5 minutes preoxygenation. Tracheal Intubation was done with flexometallic ETT of 7.0mm ID preloaded with a malleable aluminium stylet. Following easy intubation stylet was pulled out of the ETT with a little difficulty and some extra force was needed. Tracheal placement was confirmed by auscultation and ETCO₂. Patient was mechanically ventilated on volume-controlled mode with a tidal volume of 450 ml and respiratory rate of 12 per min, peak airway pressure was 18 cm H₂O. Anesthesia was maintained with Isoflurane 1-2 vol%, oxygen with end-tidal CO₂ 40 mmHg. During the time of ET tube fixation, consultant anesthesiologist was suddenly alarmed by the length of the previously removed stylet lying on the tray whose tip had ripped off and appeared shorter.

Figure 1. Endotracheal tube with shortened stylet

The shearing or breaking off of stylet tip can occur especially when removal of the stylet from an endotracheal tube is difficult. In our case also, some extra force was needed while removing the stylet. The multiple used stylet could have worn out and might have ripped off. Fortunately, it was noticed in time. The event could have gone unnoticed until it caused partial airway obstruction or was pushed into the trachea by positive pressure ventilation with signs and symptoms of a foreign body in the tracheobronchial tree.

Regular equipment checks are recommended before its use and we should be cautious while using intubating stylets. Stylet must always be checked for intactness after removal from the ET tube—particularly when removal has been difficult.

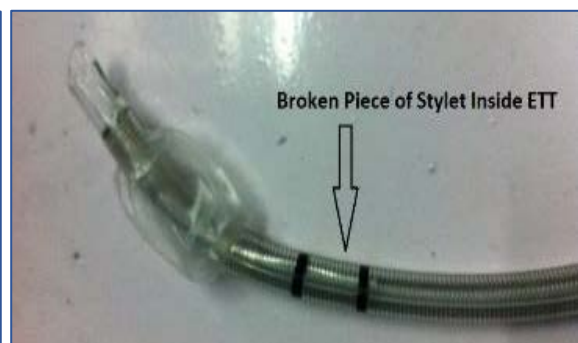
Quickly laryngoscopy was done to see if anything can be visualized above the vocal cord inside the lumen of the endotracheal tube. As nothing was visible, quick decision was made to remove the just fixed ET Tube and replaced with another one. The removed ET tube harboured the tip of the stylet at its tip. After confirmation of the correct placement of new endotracheal tube, surgery was proceeded which lasted for 90 minutes and the intra-operative period remained uneventful. After completion of surgery, the residual neuromuscular blockade was reversed, she was extubated and sent to the post op ward. The postoperative period was uneventful.

Figure 2. Broken piece of stylet inside ETT
