Effects of CR-plating and environment on the cracking of low alloy steels at high temperatures

A DISSERTATION

METALLURGICAL ENGINEERING

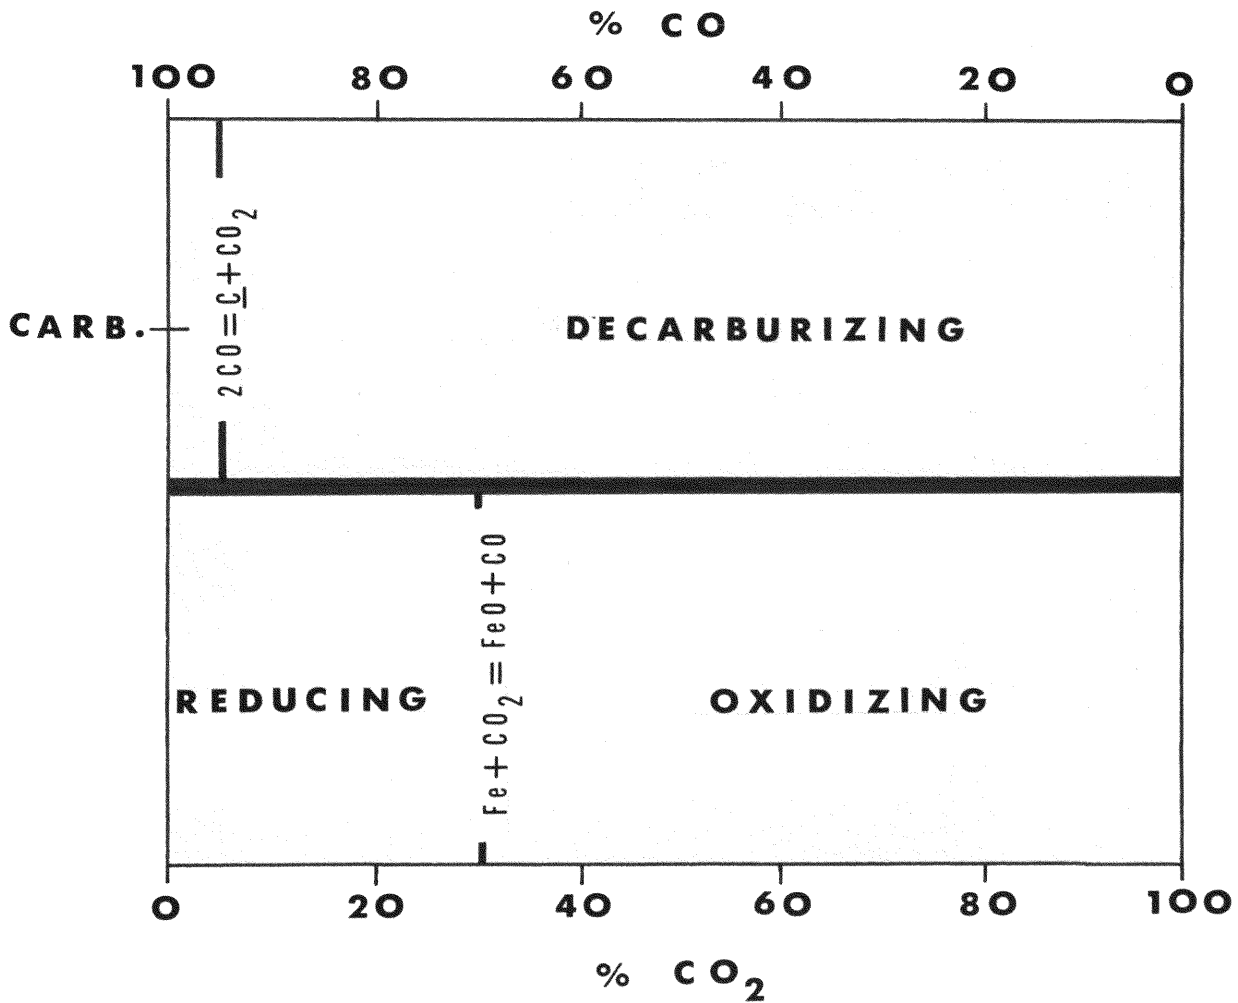
Figure 4. Reactions of iron with CO/CO₂ atmospheres.⁵

Using the values given by Gurry,⁴ for the equilibrium constants K_{I} and K_{II} , and the activity of carbon in austenite, $A_{\underline{\text{C}}}$, the equilibrium gas compositions for the two reactions have been calculated for 1000°C (Figure 4).

presence of the alloying elements of Cr, Mo, V, and Mn which would shift the equilibrium line for reaction II to the right in Figure 4.

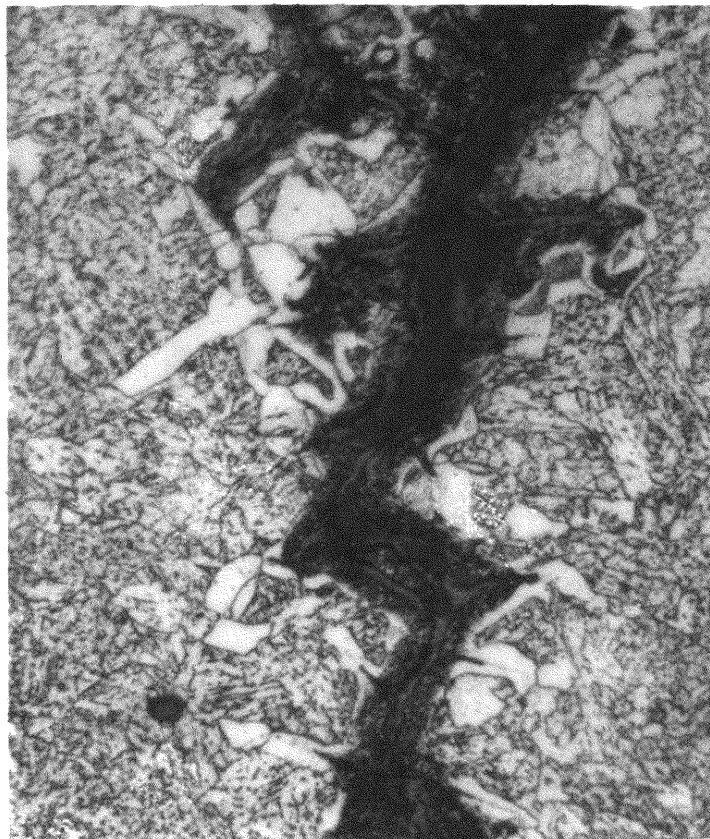
Figure 12.
Photomicrograph of
crack representa-
tive of high CO_2
specimens, nital
etch. 500X

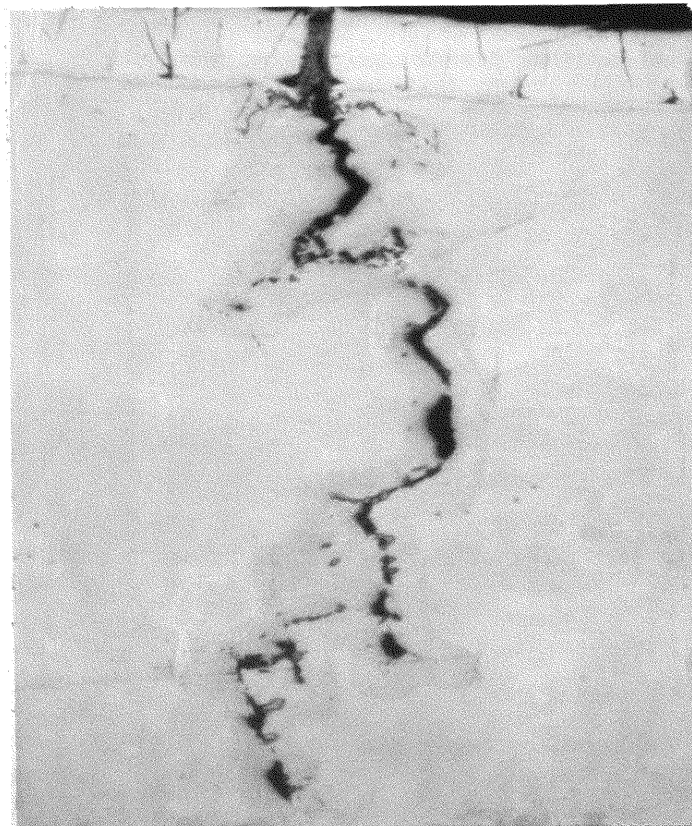
Figure 15.
Crack propagation
in the absence of
pitting in Cr
plated specimen.
50% CO₂, unetched.
200X

Some oxide pits were observed at 50% CO₂, but below this point, cracking in the absence of pitting became increasingly prevalent. Figures 14 and 15 illustrate this condition. Oxide (scale) remained in abundance at 50% CO₂ but completely disappeared in 20% CO₂. In this range, and at 10% CO₂, the mottled zone in the steel became more developed, the particles in this zone grew larger, and a preference for grain boundary formation was noticed. Figure 16 shows this zone at 20% CO₂ near the surface of an unplated specimen. Figure 17 depicts the mottled zone at the root of a crack. This zone is characteristic of all surfaces exposed to the gas, including the fracture surface. Decarburization continued to increase from 50% to 20% CO₂. The unplated specimens exhibited few cracks in CO₂ contents of 50% or more. Some failed

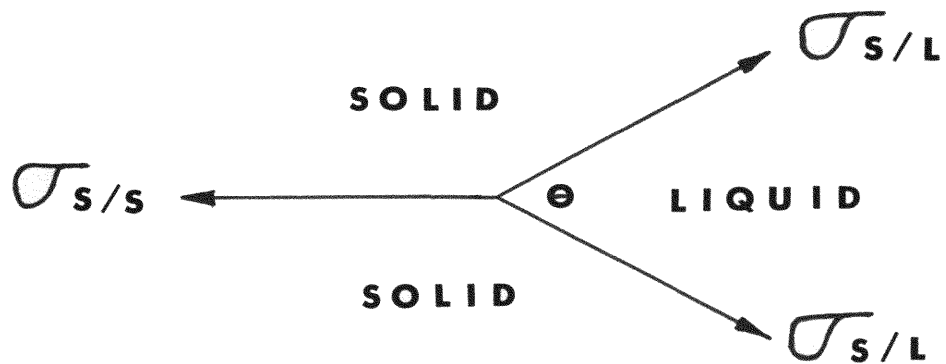
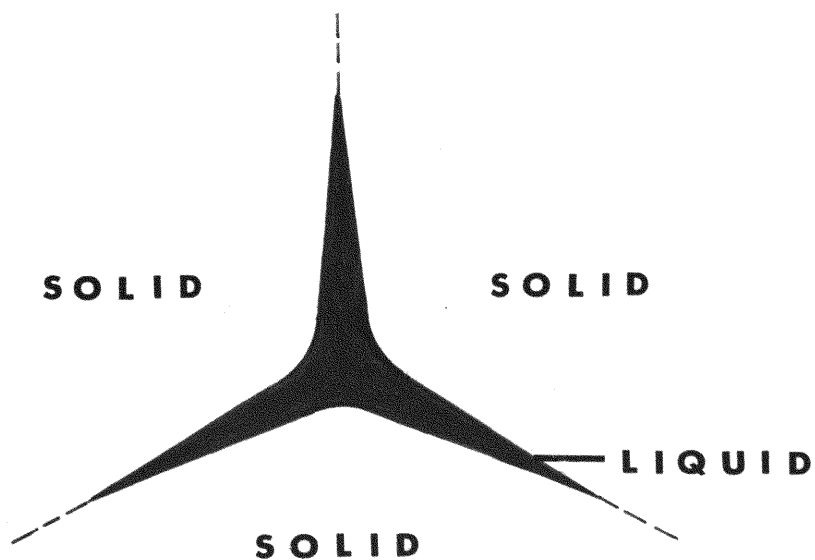
Figure 30. Criteria for liquid metal penetration at grain boundaries. (After C. S. Smith³⁴)

Liquid Cu grossly reduces the life of this steel due to a form of liquid metal embrittlement. According to Smith,³⁴ the formation of liquid films at the grain boundaries can be attributed to interfacial energy relationships which determine the dihedral angle θ , Figure 30. Applying energy values at 1105°C reported by Van Vlack³⁵ for liquid copper/austenite of 430 ergs/cm² and austenite/austenite of 850 ergs/cm² provides a dihedral angle approaching 0°. For this reason, the dramatic reduction of cycles to failure in the presence of a small amount of liquid copper observed in this study is to be expected. The tensile portion of each stress cycle greatly enhances penetration because it opens the properly oriented boundary offering a more favorable condition for penetration.

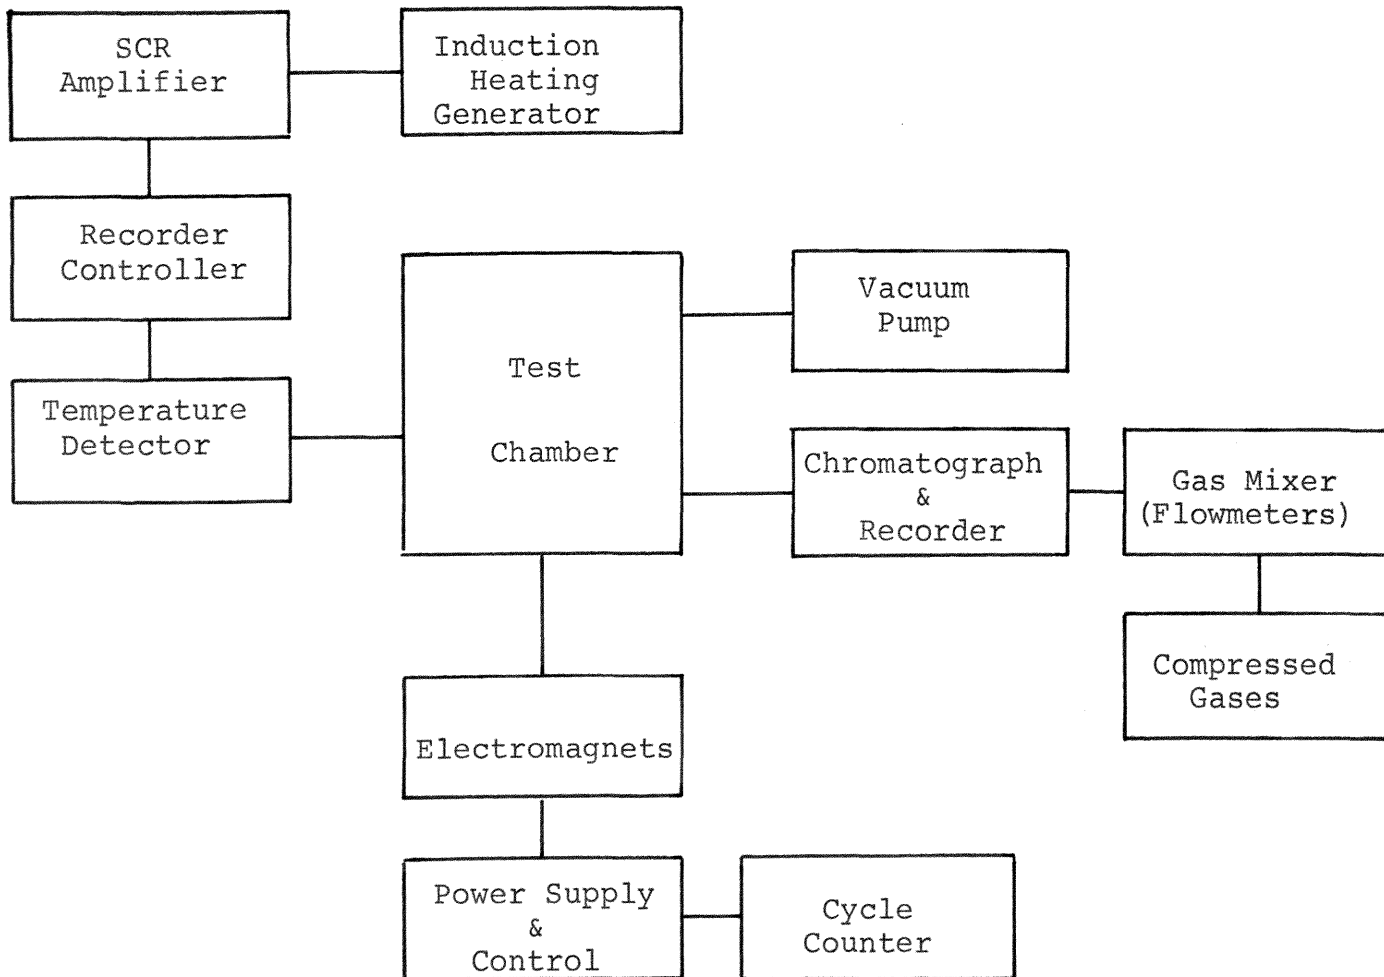
Figure 31. Diagram of apparatus Components.

A laboratory apparatus was designed and constructed which permitted the high temperature testing of Cr-Mo-V gun steel under alternating stress in selected environments. An overall view of this apparatus has been shown in Figure 5. The essential elements of the apparatus are shown in the block diagram of Figure 31. The apparatus can be separated into functional categories consisting of: (1) test chamber; (2) induction heating unit; (3) stress application mechanism; (4) temperature control; (5) environment control. Each of these will now be described in detail.
