## **M-222 SLOPE STABILIZATION CASE HISTORY – GEOTECHNICAL LESSONS LEARNED FROM MICHIGAN DEPARTMENT OF TRANSPORTATION DESIGN BUILD PROJECT**

### **ABSTRACT**

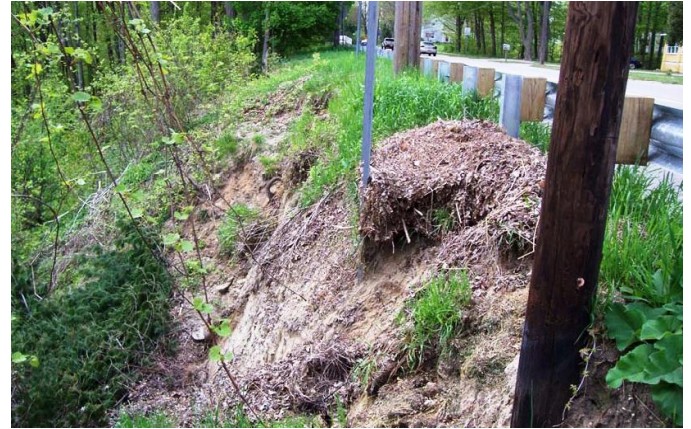
Fig. 3. Scarp Adjacent to M-222 (2009)

In 2009, translational slides resulted in a scarp forming adjacent to M-222 as shown in Figure 3. MDOT periodically observed changes in slope conditions until 2010 when MDOT retained SME to visually observe and photograph existing slope conditions on a weekly basis. MDOT also barricaded off the east-bound M-222 shoulder. Groundwater seepage and soil erosion from piping were observed in areas of the translational slides.

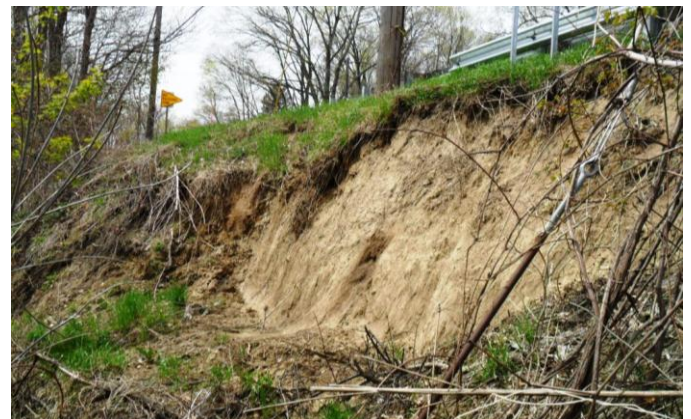
Fig. 4. Scarp Adjacent to M-222 (2011)

In 2011, heavy rain events lead to higher river and ground water levels, which rapidly accelerated the rate and extent of slope instability and worsened the scarp adjacent to M-222. In May 2011, MDOT declared the M-222 Slope Stabilization project an emergency and closed the entire M-222 roadway through the project site. Figures 4 through 7 illustrate the progression and extent of slope instability.

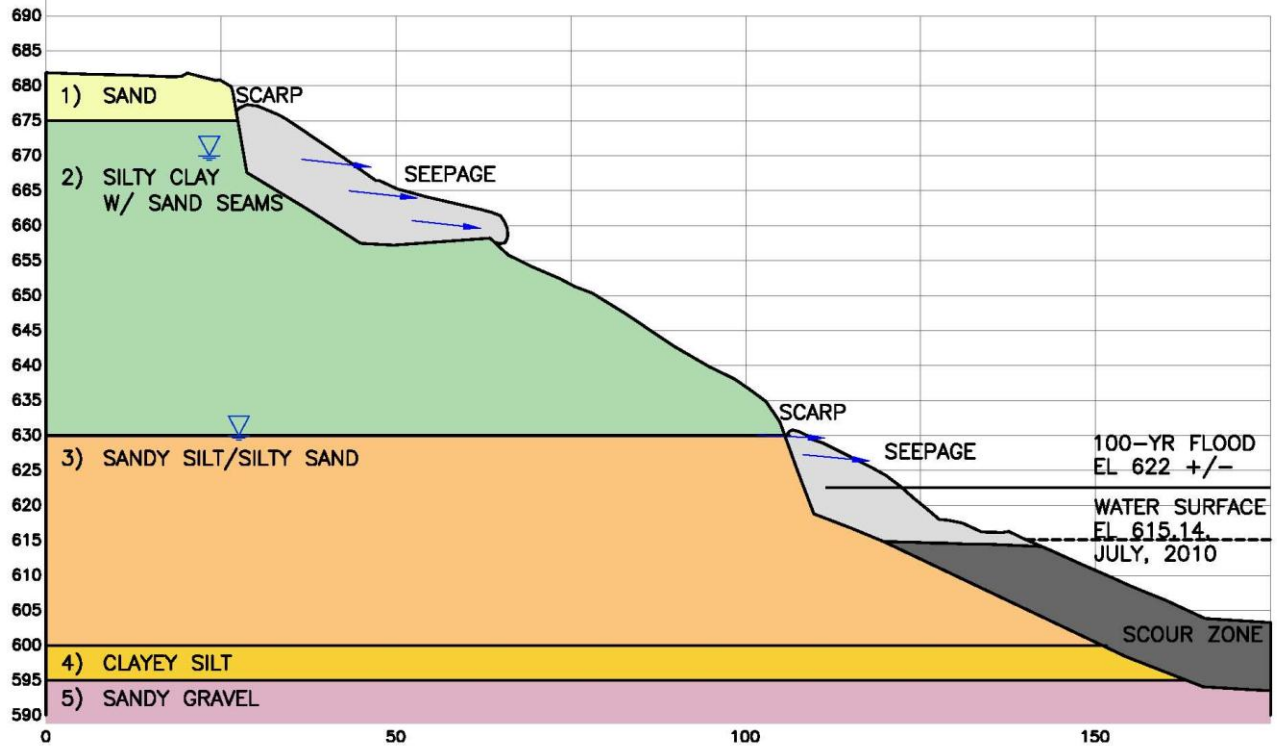
Fig. 9. Generalized Soil Profile

Geotechnical data collected from the test holes was used to develop a generalized soil profile and geotechnical conditions for the project. The generalized soil profile and mean values of select geotechnical index properties are shown in Figure 9 and Table 1.

The generalized geotechnical conditions and soil profile identify one approximately 45-foot thick, silty clay layer. This clay layer represents the average of an upper and lower clay stratum. The upper clay stratum was approximately 25 to 30 feet thick. The lower clay stratum was approximately 15 to 20 feet thick. Mean values of the measured index properties for the upper and lower clay strata are presented in Table 2 for information.

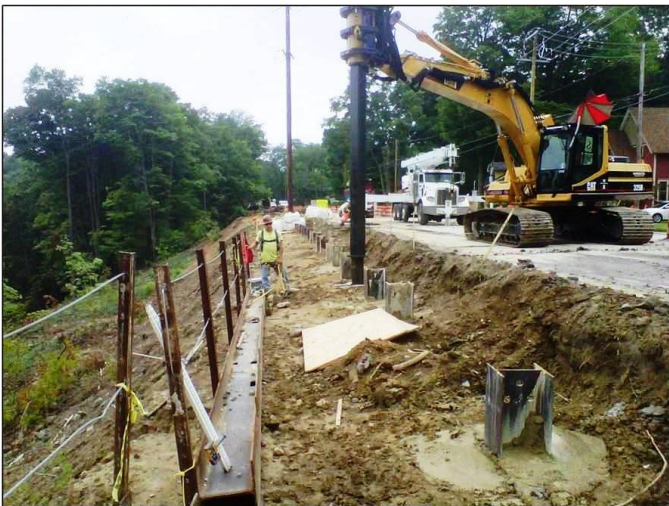
Fig. 18. Soldier Pile Installation

A total of sixty-six (66) permanent soldier piles were installed using traditional drilled shaft installation methods and a 3-foot diameter hole shown in Figure 18. Temporary casing was used in the upper portion of the soldier pile hole due to the sandy soil encountered near the ground surface. Structural ready-mix concrete was placed in each soldier pile hole below the designed CIPC elevation while the remaining height was filled with a controlled low strength material (CLSM).

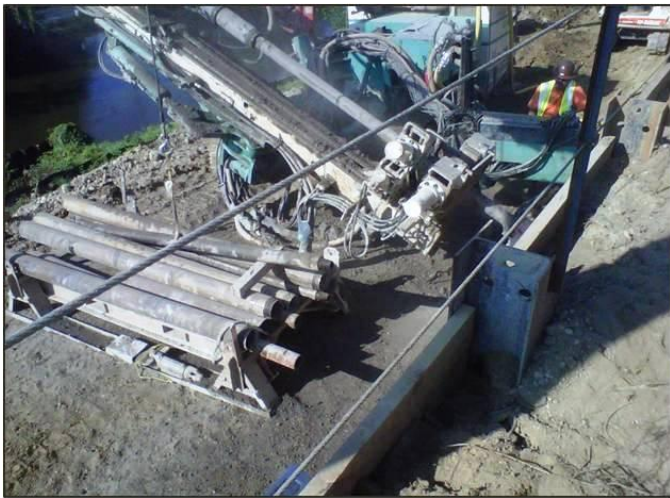
*Fig. 20. Ground Anchor Installation*

Ninety-two (92) ground anchors were installed using temporary drill casing with air and water as the flushing medium as shown in Figure 20. Anchors were tested up to

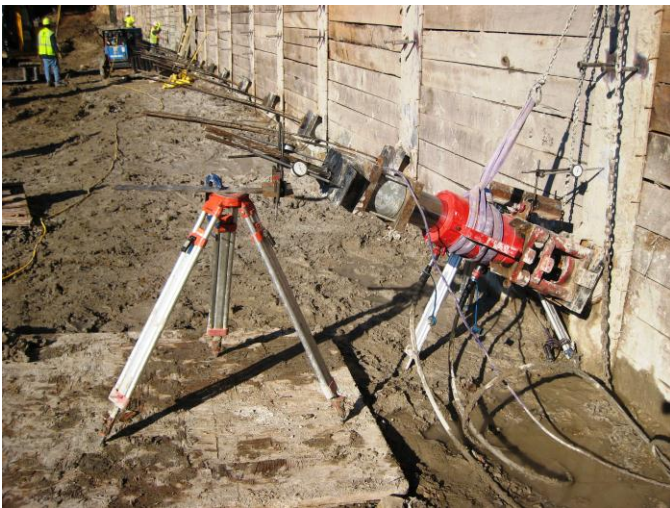
*Fig. 21. Ground Anchor Stressing*

FDL increased in specified increments using a hydraulic jack according to the project specifications as shown in Figure 21. Results from the ground anchor stressing showed that the elastic elongation was within the PTI criteria, but the majority of the anchors did not meet the creep criterion without post-grouting.

One challenge encountered during the ground anchor stressing operation consisted of excessive movement of a few soldier piles near the scarp area while post-tensioning the upper row of ground anchors. Horizontal movement in excess of 1 inch was noted during stressing prior to reaching FDL due to the lack of passive earth pressure provided in the scarp area. The FDL for these select ground anchors was reduced based on case-by-case evaluation when the FDL could not be verified.

The other main challenge from the ground anchor stressing was meeting the creep criterion specified in PTI even with subsequent post-grouting and extended creep tests. Nicholson found through several single strand gun barrel tests that

significant creep was coming from the strand itself and not the ground to grout adhesion. This is also known as metallurgical creep, but PTI's creep criterion does not separate metallurgical creep from their criteria. The confirmed metallurgical creep found in the strand anchors confirmed the elastic elongation performance of the ground anchors, which showed that the full bond length was not being utilized during post-tensioning.
