A Recent Difficult Foundation Problem: The Case of the New Tagus Bridge

Pedro Simão Sêco e Pinto
National Laboratory of Civil Engineering (LNEC), Portugal

Ricardo Oliveira
COBA - Engineering and Environmental Consultants, Portugal

Paper No.SPL- 3

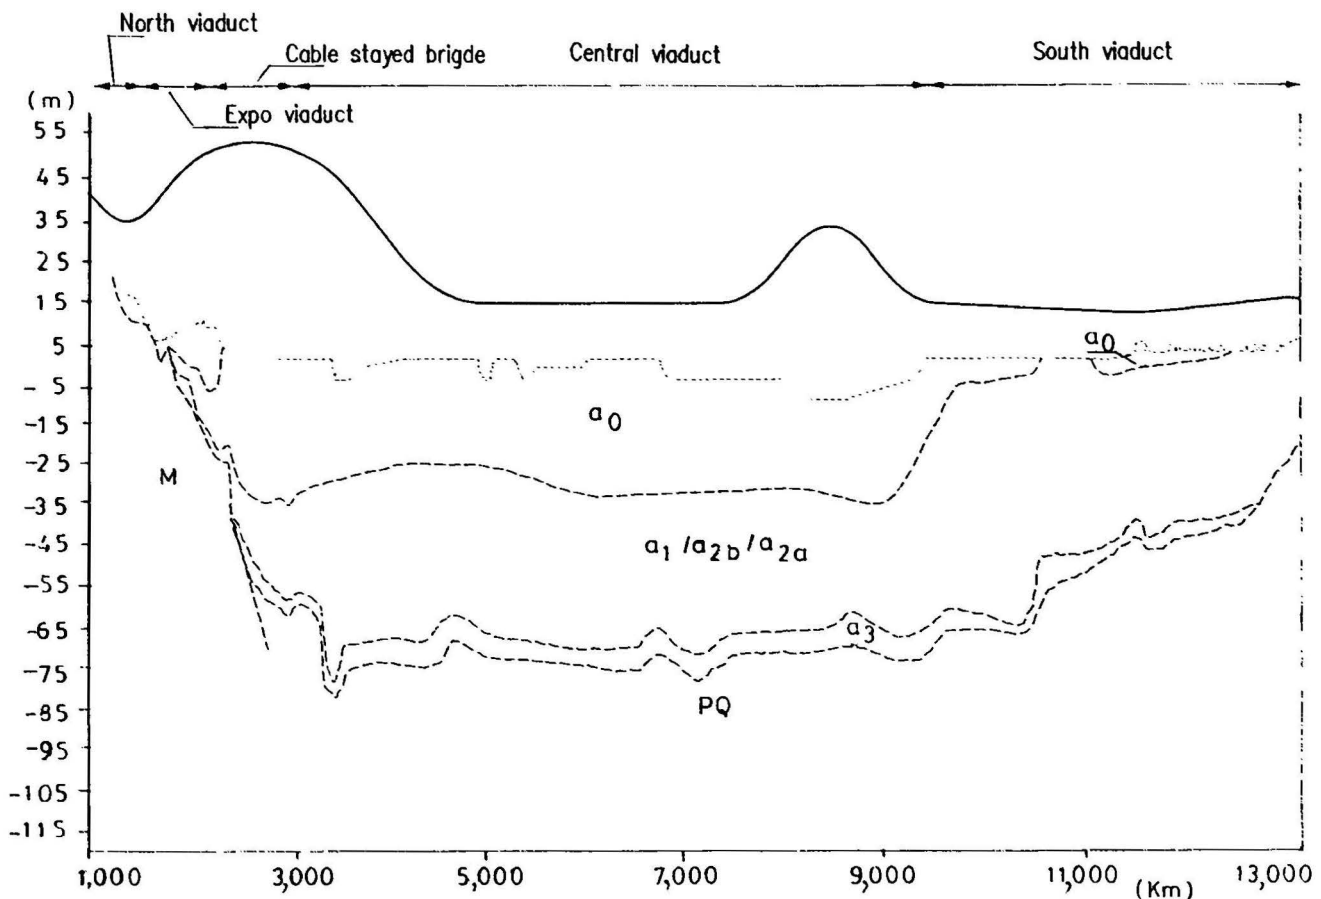
Fig. 2 Simplified geological profile

GATTEL (LNEC, 1993)), the second in 1994 by TEJOPROJECTO (1993a), the ground is composed by the following two main units (Fig. 2):

- a) Alluvial deposits (A1), aged Holocene and Pleistocene;
- b) The bedrock, under alluvial deposits, formed by Plio-Pleistocene and Miocenic materials.

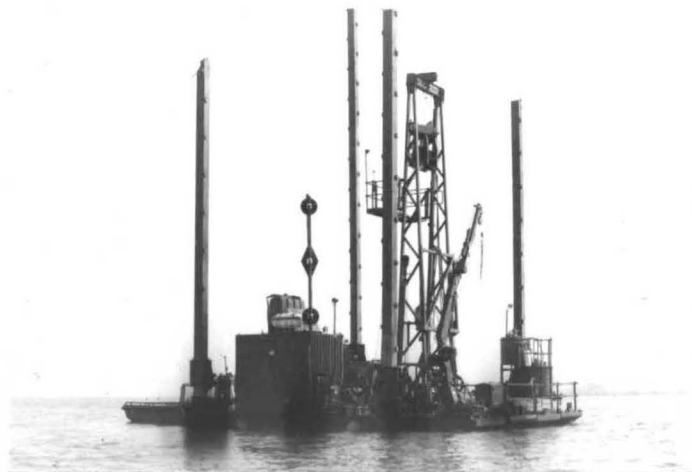
Fig. 3 General view of jack-up drilling system

For the river work three jack-up drilling systems "Skate II" with four legs, equipped with a marine drilling mast, which

allow in - situ testing equipment were used. A general view of jack-up drilling system is shown in Fig.3.

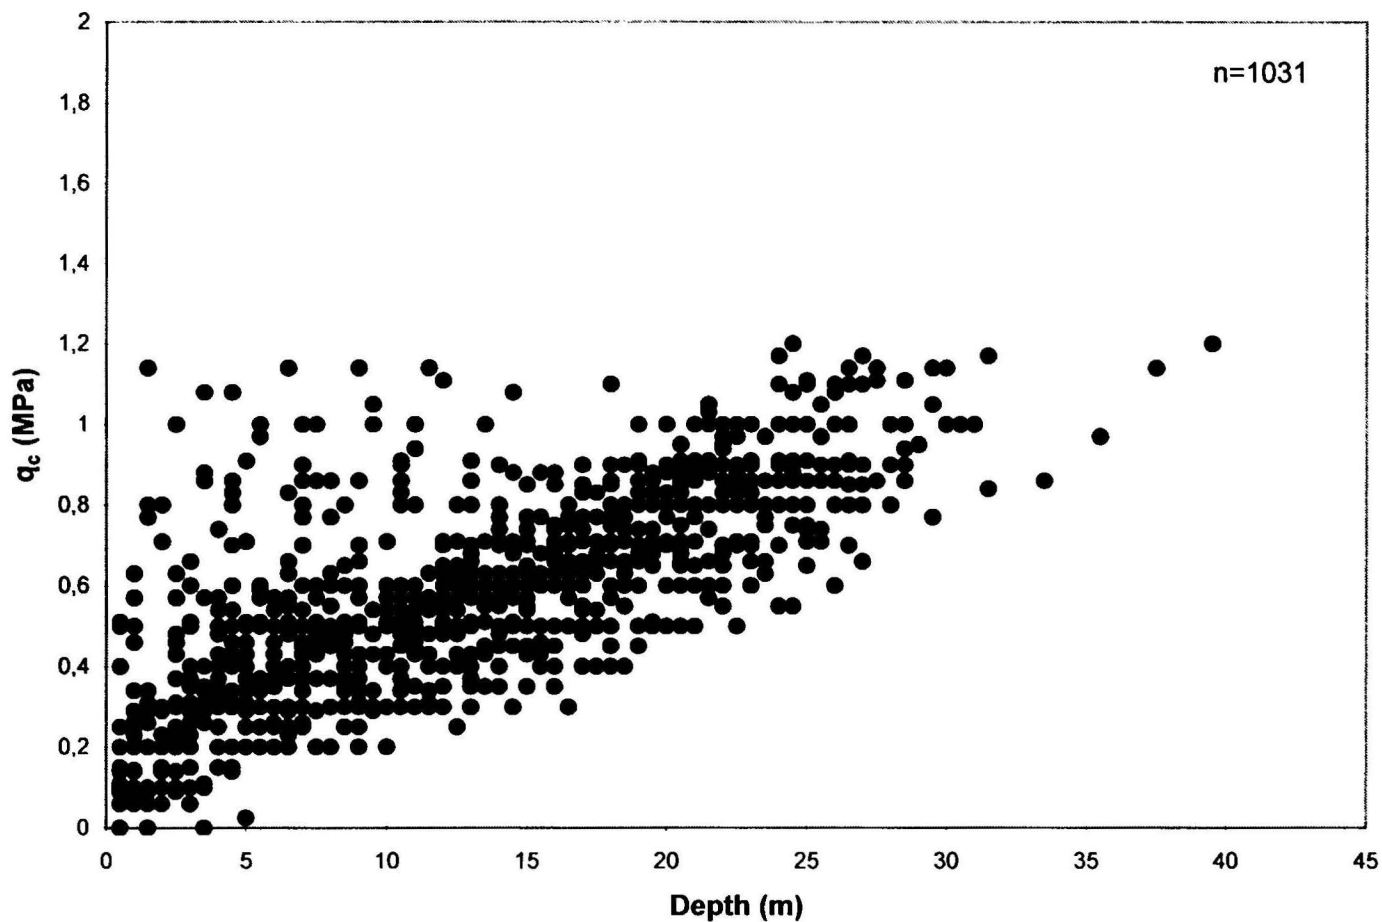
Fig. 6 Variation of q_c values with depth

PCPT tests, with measurement of pore pressures, have given point resistances between 0.15 and 1.0 MPa, with an increase with depth. This trend is illustrated in Fig. 6.

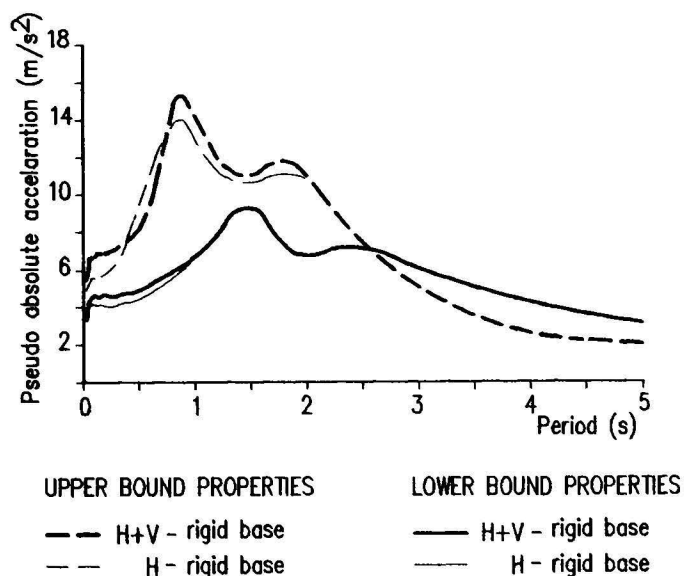
Fig. 12 Computed pseudo absolute acceleration by stochastic analyses for rigid base (adopted from P & V , 1994a)

To evaluate the influence of the direction of incident seismic movement the results of analyses considering only horizontal movements and both horizontal and vertical movements are summarized in Fig. 12.

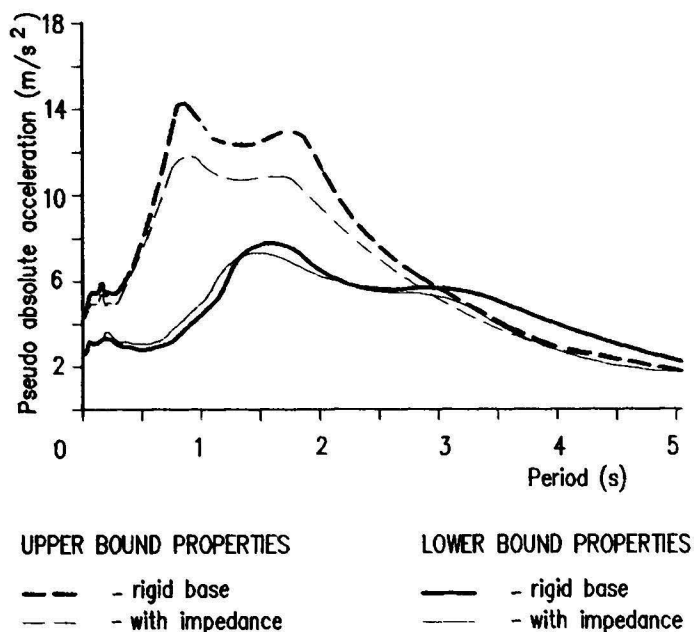
Fig. 13 Computed pseudo absolute acceleration by stochastic analyses for rigid base and with impedance (adopted from P & V , 1994a)

The results of column stochastic analyses considering both rigid base and boundary condition with impedance are shown in Fig. 13.

- (i) A good agreement between stochastic and deterministic results were obtained.
- (ii) The boundary condition has a non negligible effect on the results, particularly for the upper bound parameters.
- (iii) The vertical input has a non negligible influence in the upper bound soil parameters.
- (iv) The surface response spectra calculated for the ultimate limit state by the program SIREN are in reasonable agreement with the values obtained by the program DYNAFLOW.

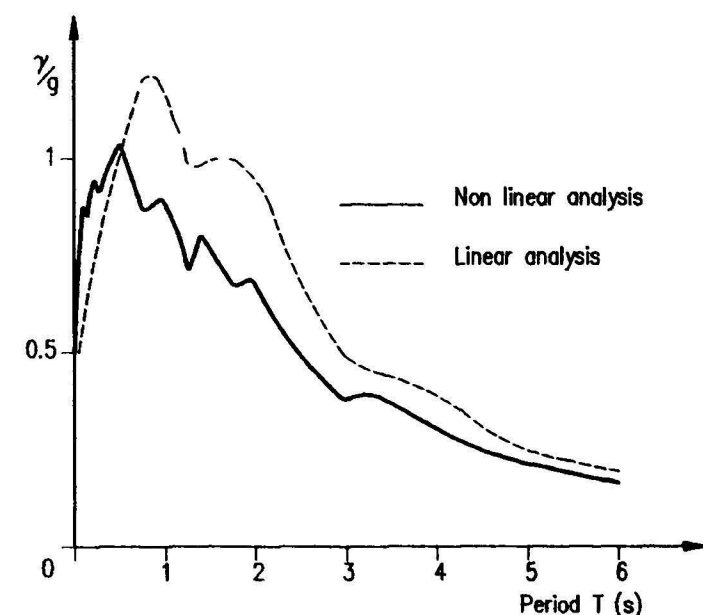
Fig. 14 A comparison between linear and non linear analyses (adopted from EEG, 1994a)

(v) The linear equivalent model has given more conservative results than the non linear model.

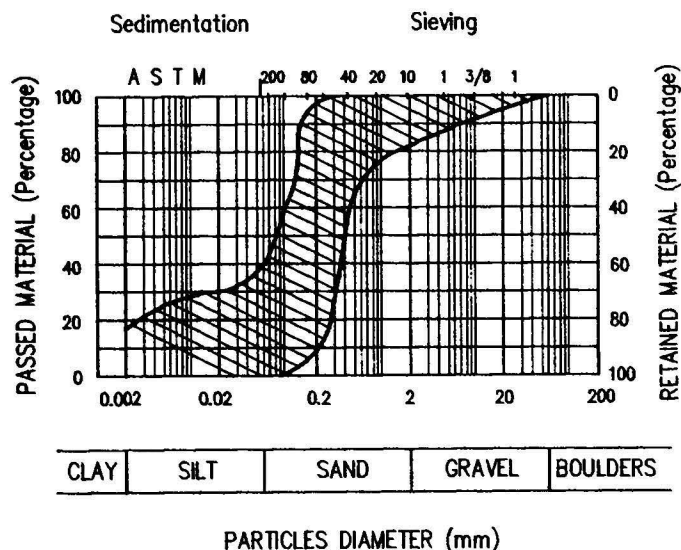
Fig. 18 Sieve curves for material a_1

Taking into account that we are dealing with underwater materials, the sieve curves exhibit percentages of fines lower than in reality, as a consequence of the washing effect during the sampling.

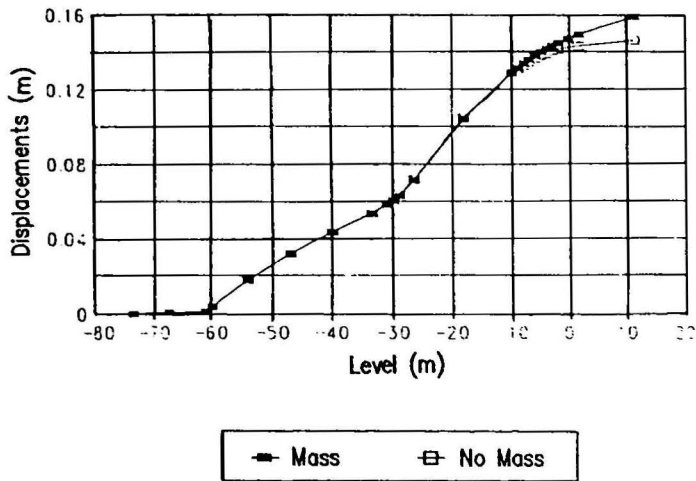
Fig. 22 Piles computed displacement values (adopted from P & V, 1994b)

The displacement values, the axial forces, the shear forces and the bending moments for the piles were computed.

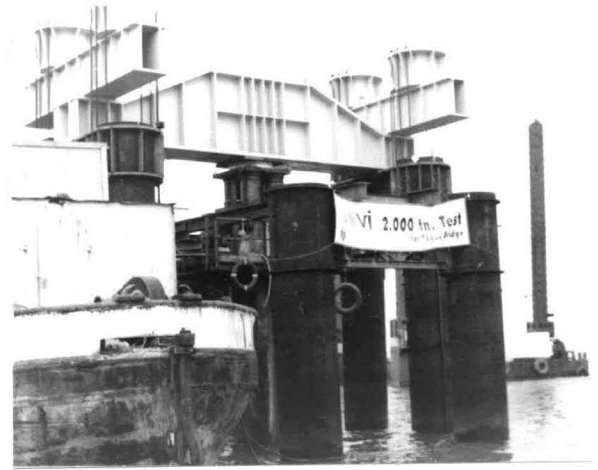
Fig. 25 General view for vertical pile load tests

Load tests were carried out on several test piles and the test locations were representative of the site of the pile foundation and one test pile was located where the most adverse ground conditions are believed to occur.

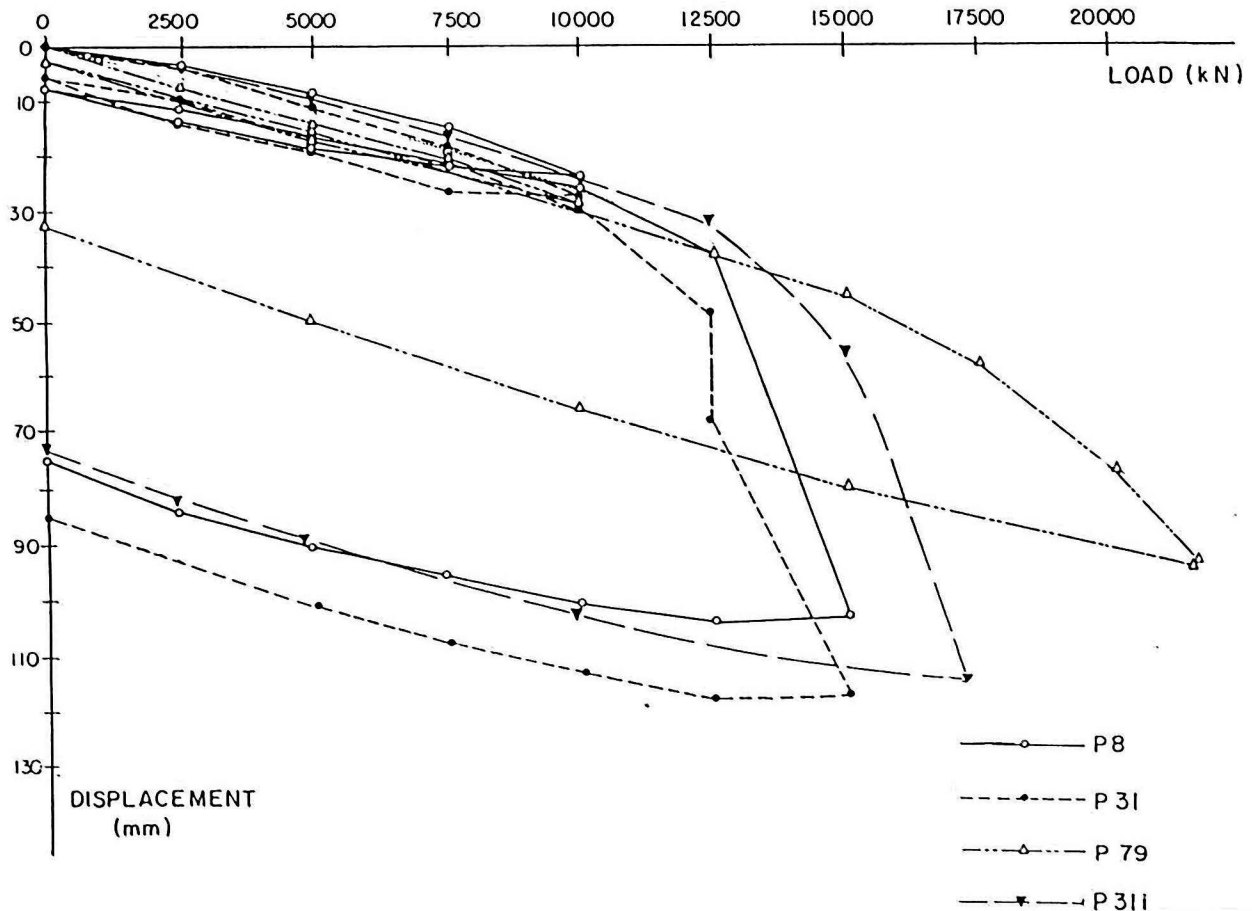
Fig. 26 Load settlement curves for vertical tests (adopted from Agisco, 1995)

The load - settlement curves for piles P8, P31 and P 79 are shown in Fig. 26 (LCPC, 1995).

Failure loads were defined as settlement equal to 10% of the pile diameter, i.e. at 120 mm settlement. Table 10 gives the values of predicted failure loads based from CPT tests and the observed values. The latter are lower than the predicted loads, with the exception of P79 (the length of this pile was increased 10 m) and the difference were attributed to the lower shaft friction values. The effect of grouting on the soil gave insufficient gain in bearing capacity, as can be assessed by P31i.

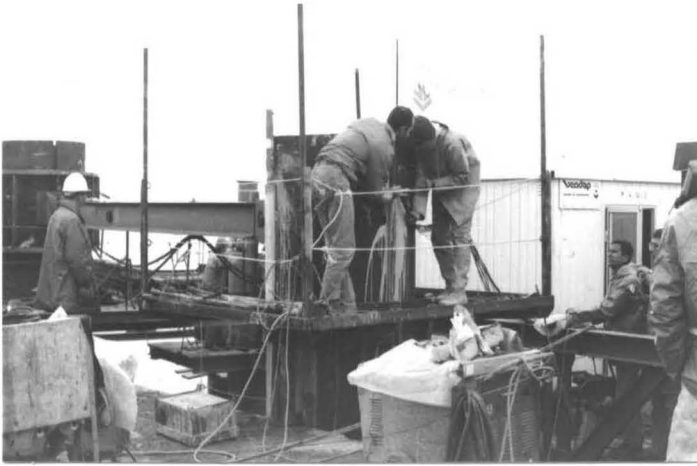
Fig. 27 General view for horizontal pile load tests

For the horizontal load tests the following equipments were installed:

- horizontal displacement
- load cell
- strain gauges to measure strains along the shaft
- inclinometer tubes to measure horizontal displacements
- temperature device.

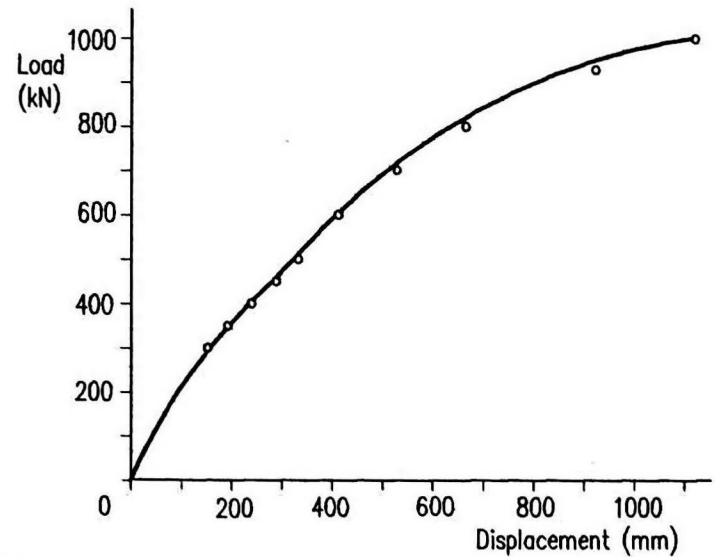
Fig. 28 Measured load displacement curve for horizontal tests (adopted from Terrasol, 1995)

The loading program consisted of: 10 load increments from 50 kN to 500 kN.

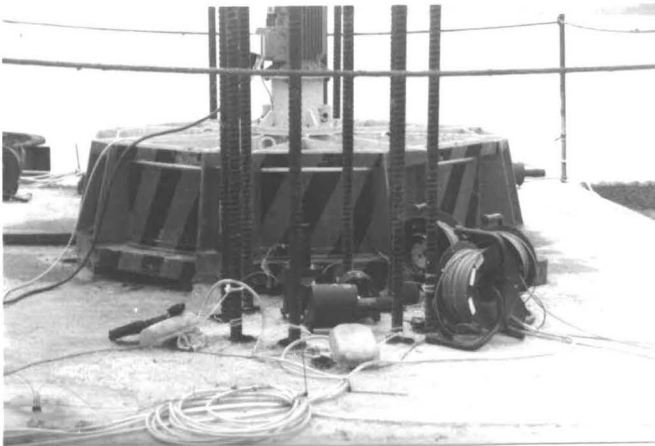
Fig. 30 General view of the shaker

The excitation frequencies were applied in steps of 0.1 Hz in the range from 0.5 to 20 Hz approximately. The dynamic response of the structure, for the various frequencies of excitation, was measured by means of velocity transducers and accelerometers. These equipments were placed in several points in order to monitoring the horizontal and vertical displacements (Fig.31).

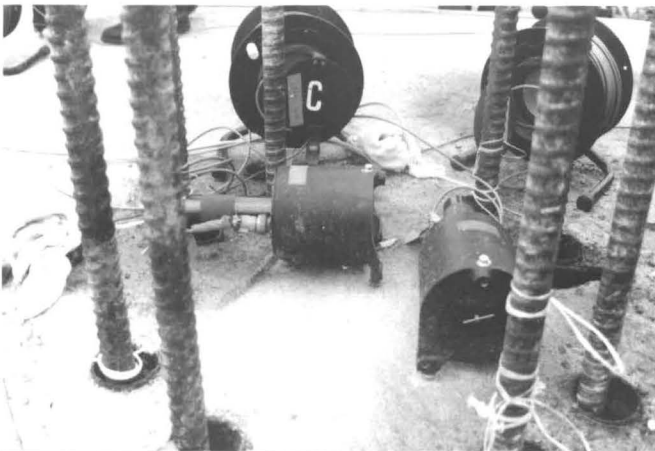
Fig. 31 General view of the velocity transducers

Time series of velocity were recorded on several points, during the test. The digital treatment of this time series was performed by a computer program developed at LNEC (Portugal, 1990).

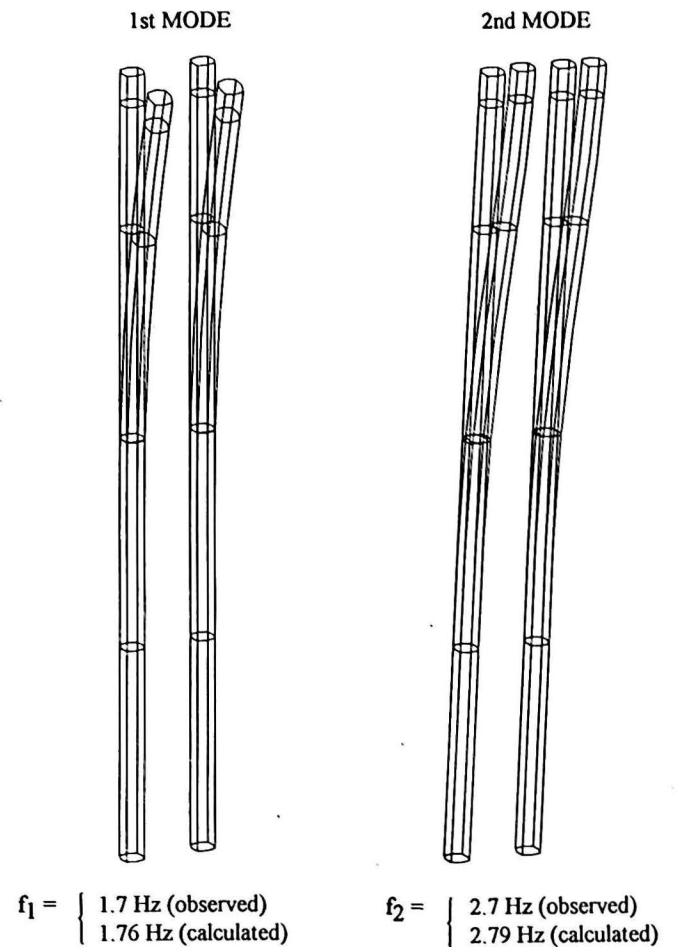
Fig. 32 Configuration of the two first vibration modes. Observed and computed frequencies (adopted from Oliveira et. al., 1996).

The configuration of the two first modes of vibration and respective frequencies (observed and computed) is presented in Fig. 32. The first vibration mode corresponds to the bending of both piles following a direction perpendicular to the vertical plan that encloses both of them. The second mode corresponds to the bending of both piles in the vertical plan that contains them.

The observed and calculated frequencies by the mathematical model are presented in Table 12. There is a good agreement for the two first vibration modes.

Vibration Modes	1	2	3	4
Observed Frequencies	1.7	2.7	-	-
Calculated Frequencies	1.76	2.79	8.78	11.70

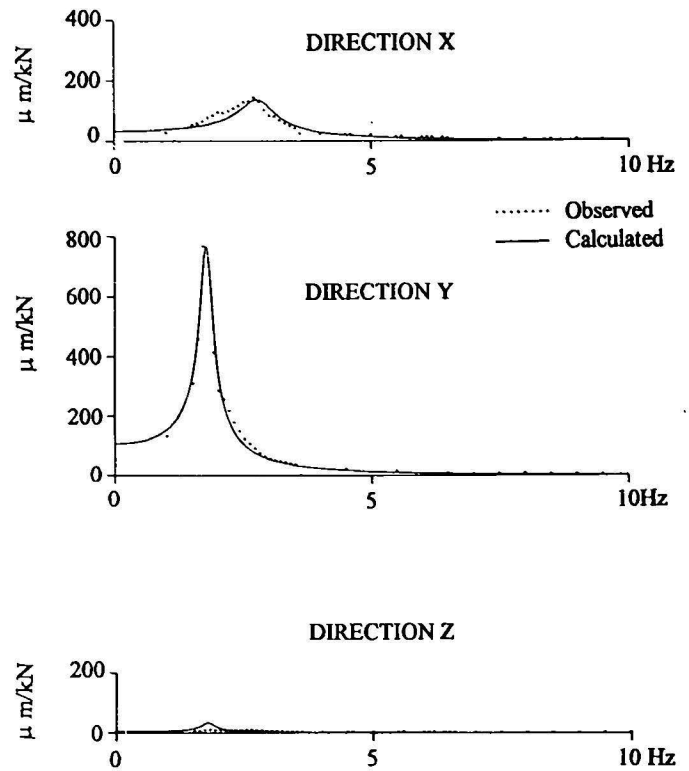
Fig. 33 Displacement transfer functions. Comparison between computed and observed values (adopted from Oliveira et al., 1996)

The results observed in the test and those computed by the mathematical model in terms of displacement transfer functions of the force applied by the shaker are shown in Fig. 33.
