# Assessment of Earthquake Size from Rock Fracture Dimensions of Seismic Source in Geotechnical Earthquake Engineering Investigations

L. S. Srivastava

**SYNOPSIS** The paper presents two case histories of rock fractures resulting in strong ground motion. Case I describes the November 27, 1971 rockburst involving 270 m long rupture with displacement of 15 mm in Nundydroog mine in Kolar Gold Field in Karnataka State, India, which resulted in damage to buildings on the surface and underground works in the mine. The event was recorded as an earthquake by seismic stations and the computed magnitude  $m_1 = 3.9$  of the rockburst compares well with magnitude  $m_b = 4.6$  determined from the recorded seismogram. Case II describes April 5, 1976 rockburst in an open cast granite quarry at Shravanbelagola, in Hassan district in Karnataka State, resulting in 60 m long fracture with estimated average displacement of 0.5 mm. The rockburst accompanied with loud noise produced strong ground motion in the area. The magnitude of the rockburst is estimated as  $m_1 = 2$ . The estimated intensity of ground motion in the area match well with the ground motion at the epicentre of an earthquake of si

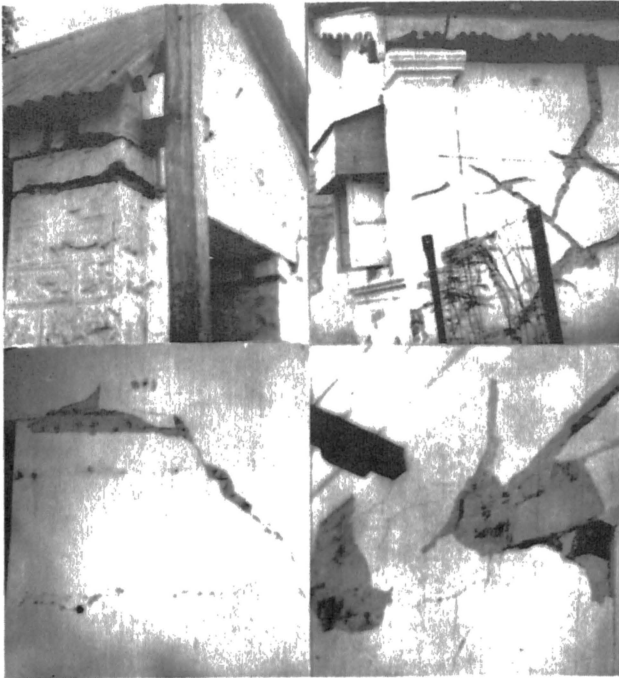
Fig.1 - Cracks in buildings during the rockburst

consisted of fall of plaster, cracks in masonry walls and arches, and collapse of portions of random rubble stone masonry walls. During the November 27, 1971 rockburst damage to buildings was of similar nature (Fig.1), but it extended over a large area of the Estate of Bharat Gold Mines Private Limited (BGML) and Factory and Township of Bharat Earth Movers Limited (BEML).

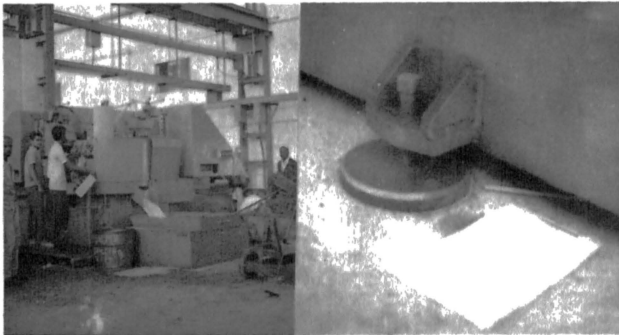
Fig.2- Link Boring Machine, 20 tons in weight, which was moved 1 cm towards south. Shaded area shown in the photograph on the right was exposed after resetting of the steel pad

In addition to damage to buildings, overtopping and sliding of loose objects was reported. Several heavy machines resting on circular steel pads in BEML were laterally moved to the extent of 5 to 10 mm (Fig.2). In several machines which were grouted, the bolts got loosened. The friction between the steel pads and the concrete was determined by test at

site, and the coefficient of friction was noted to be 0.5. This indicates that the peak ground acceleration during the tremor exceeded 0.5 g. But as the duration of strong shaking was not large the structures in BGML and BEML escaped major damage and collapse.

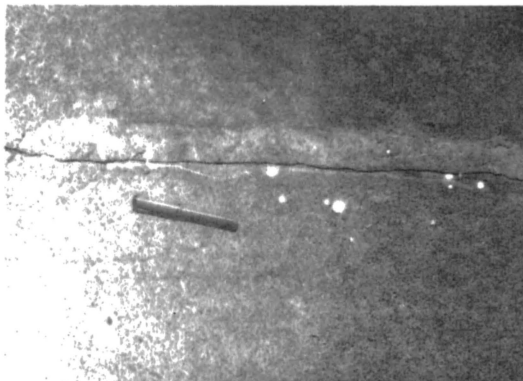
Fig.4 - Major Joint Rock Fracture along  $N70^{\circ}E-S70^{\circ}W$  direction

is feebly foliated. The granites are transversed by few basic dykes and pegmatite veins. Figure 3 shows the location of granite quarries in the area. The general trend of major joint set in the granites is along  $N 70^{\circ}E - S 70^{\circ}W$  and dips  $55^{\circ}$  towards north west. Two sets of minor joints trend along  $N20^{\circ}E - S20^{\circ}W$  with vertical dip and along  $N-S$  with  $75^{\circ}$  dip towards west. The rock fracture associated with rockburst follow the trend of major joint set along  $N70^{\circ}E-S70^{\circ}W$  (Fig 4). The set of joints exposed during excavations in the quarries were noted to extend upto one or two metres, and mostly fresh sheet granites in exposed in the quarries.
