(2004) - Fifth International Conference on Case
Histories in Geotechnical Engineering

Excavation of Open Pit “Zagrad” in Rijeka, Croatia, A Case History

EXCAVATION OF OPEN PIT “ZAGRAD” IN RIJEKA, CROATIA, A CASE HISTORY

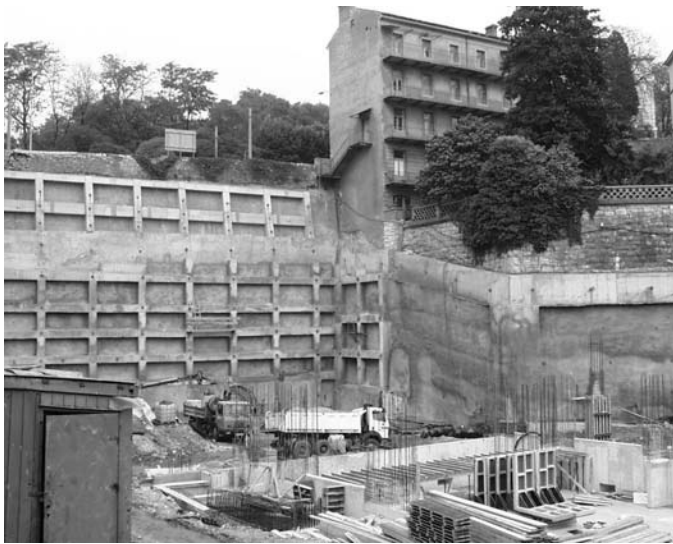
Fig. 2. Cut "North" and "East", in an excavation phase of the bottom of the open pit

Stability analysis for a total cut made for the purpose of achieving a required security factors, showed that there is a need for additional secure of the cut in a rock mass by the self-drilling rock bolts of nominal bearing capacity 500 kN, and calculated bearing capacity 100 kN/m', 16.0 m length, in the distance of 4.00 m, in 8 rows as well as the self-drilling rock bolts of nominal bearing capacity 880 kN, and calculated bearing capacity 180 kN/m', 12.0 m length, in the distance of 4.00 m, in 2 rows. Shift of rock bolts loading on a wider area, was predicted by execution of reinforced sprayed concrete in two layers, each 5 cm thick and adequate grid structure, Fig. 1,2.

On the south part of the open pit, with lower height of rock cuts, usual methods of reinforcement of rock mass by rock bolts and multi-layered reinforced sprayed concrete, were used, Fig. 2,3.

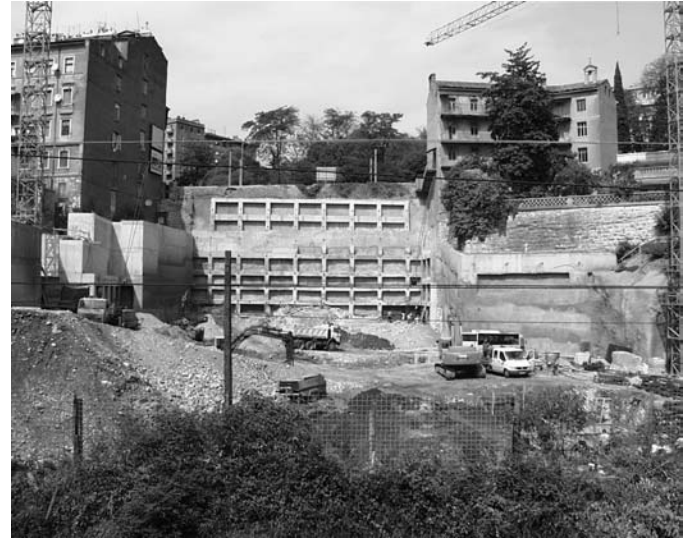
Fig. 3. A view of the open pit during the execution

In other parts of the open pit, complicated requests to secure rock cuts were also dealt, particularly in the excavation under the building Pomerio St. No. 19, Fig. 3.
