International Conference on Case Histories in
Geotechnical Engineering

DEEP EXCAVATION ON 3 SIDES OF A 21 STORY BUILDING: ACCOUNTS OF A SUCCESSFUL DEEP EXCAVATION PROJECT

TOOBA deep excavation project was conducted in a densely developed area in the North West of Tehran, capital of Iran, to provide space for 4 basement levels for multiple buildings around the already functional TOOBA tower. TOOBA tower is located in the northern leg of the excavation boundary in a way that the northern side of the building abuts the excavation edge. Hence, this project involved excavation on 3 sides of the roughly rectangular plan of TOOBA tower to the depth of 16.5 meters below its foundation level. The necessity for constraining the deformations of the tower commended the construction of contiguous bored concrete piles around the building supported at 4 different levels with tieback and wailing system. A monitoring program for measuring the deformations of the tower and supporting system was also enforced during and after excavation.

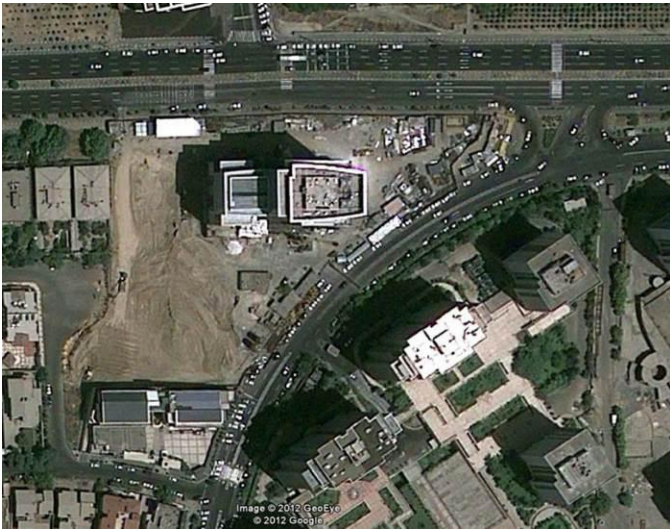
Fig. 1. Aerial photo of the site (Source: "Tehran." 35° 45' 58.41" N and 51° 22' 12.58" E. Google Earth. June 30, 2009. September 30, 2012.

The deep excavation project for TOOBA commercial complex is located in $35^{\circ} 45' 58.41''$ N, $51^{\circ} 22' 12.58''$ E in a densely developed urban environment in North West of Tehran, capital of Iran. This deep excavation project was aimed at providing space for 4 basement levels for hypermarket and parking spaces of multiple buildings around the already functioning TOOBA tower. The office building block, referred to as TOOBA tower in this paper, is located in the northern leg of the excavation boundary in a way that the northern side of the building abuts the excavation edge. Hence, this project involved excavation on 3 sides of the roughly rectangular plan of TOOBA tower to the depth of 16.5 meters below its foundation level. Other sides of the excavation boundary, on the other hand, were excavated to the depths varying from 9 to 28 meters depending on the sloping ground condition. Fig. 1 shows the plan of the site and the location of the adjacent structures. A 5 story school building and a 2 story residential building adjoin the excavation boundary from south and west, respectively.

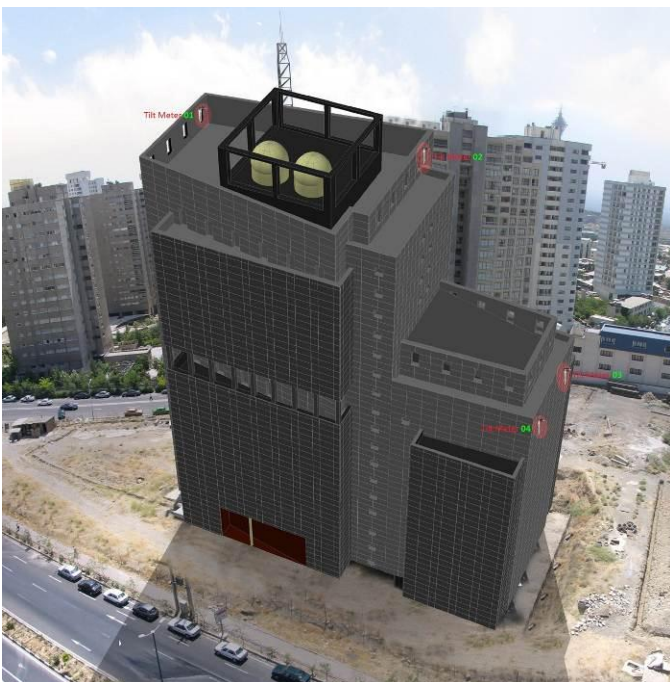
Fig. 2. 3D view of the building and the location of the tilt meters

The Building itself is quit irregular both in plan and in vertical cross section. Fig. 2 shows the 3D view of the building. As it can be seen the building is about 64 meters tall on the east side and about 42 meters tall on the west side. The vertical load exerted by the building is estimated to be 200 kN/m² on the taller side and 150 kN/m² on the other side. The excavation procedure was ensued with no excessive deformations occurring in the building during or after the

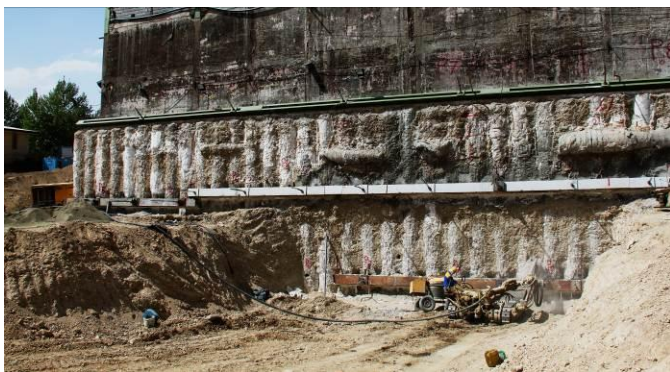
Fig. 11. Excavation of block 7 during the 2nd lift of excavation

Fig. 11 shows the excavation of block 7 during the 2nd lift of excavation and subsequent anchor and wailing installation.

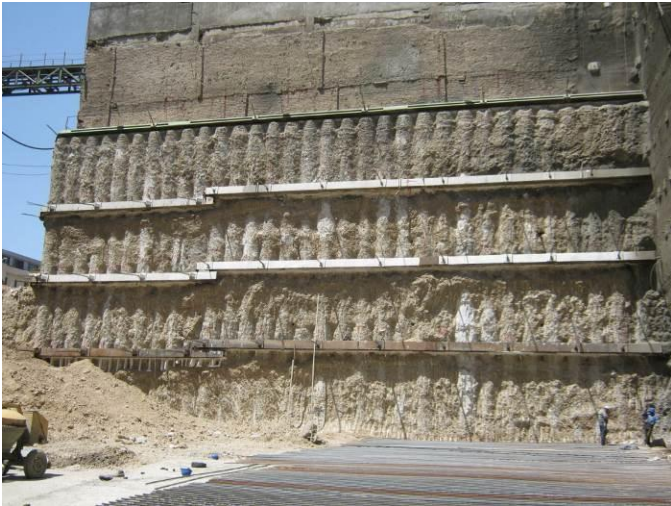
Fig. 14. A view from eastern side of the tower; at this point, excavation is complete and the construction of the foundation of the intended building has begun

Two samples of the details of anchor heads designed for this retaining structure have been provided in Fig. 12. Fig. 13, Fig. 14 and Fig. 15 provide some pictures taken by the second author of this paper from the construction site.

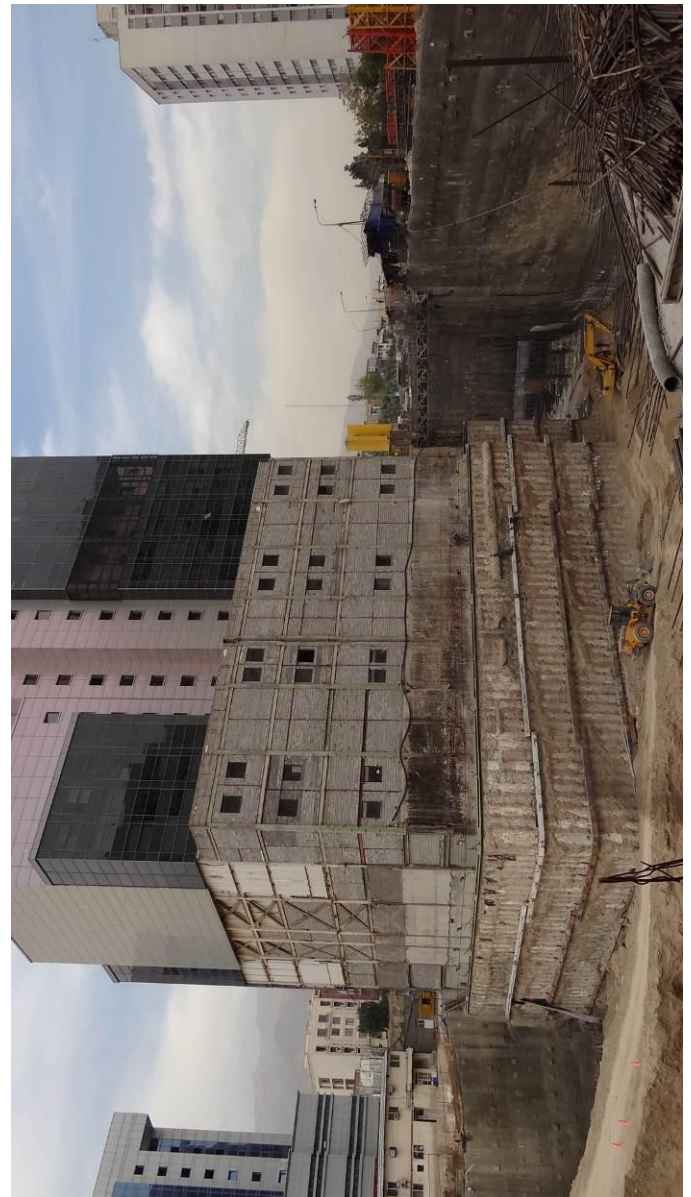
Fig. 15. A panorama view of the tower and the retaining system. In this image, all 4 levels of wailing have been installed.

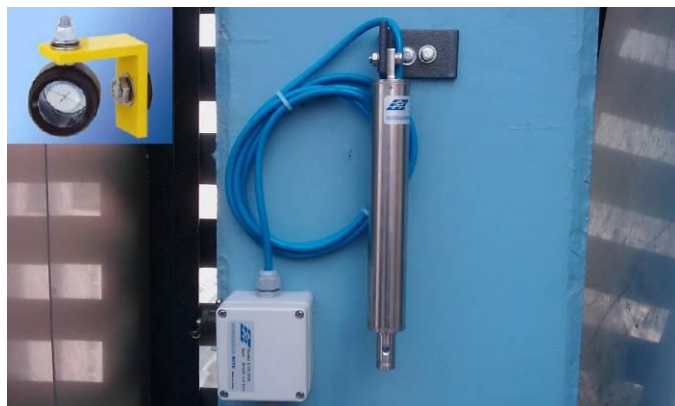
Fig. 17. Tilt meter number 01 on the tower rooftop and a sample of the mini prism targets used in the project

A monitoring program for measuring the deformations of the tower and supporting system was enforced during and after excavation. Instrumentations on the tower included 17 prism targets (PT) and 4 tilt meters (TM). Also 6 load cells were installed on the anchor wall to monitor the changes in the anchor loads. The location of the tilt meters on the tower was shown in Fig. 2. EAN-90M tilt meters are used in 2 perpendicular directions to measure tilt in both north-south and east-west directions. ERT-20P-MT mini prism targets, on the other hand, were installed on all 4 sides of the tower. These targets can yield displacements in x, y and z directions. Fig. 16, for example shows the approximate location of the prism targets on the east side of the tower. A TS09 total station was used to record the displacements from the pillars installed outside the excavation pit. Fig. 17 show the tilt meter number 01 and a sample of prism targets used on the tower.

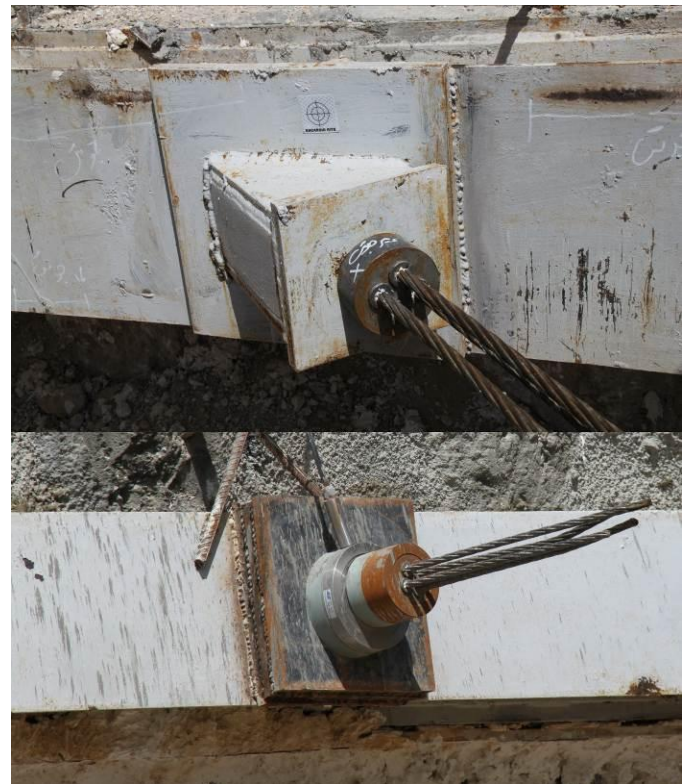
Fig. 18. ELC-30S Loadcell mounted on the anchor below to monitor the changes in the anchor pre-stressing load. Another anchor without a load cell is shown (above) for comparison.

have occurred at the tieback location and have further stretched the tieback. Fig. 18 shows the load cell mounted anchor head and another anchor head without load cell for comparison.

ELC-30S load cells were installed on the tieback wall in order to measure the changes in tieback pre stress loads. Normally a reduction in tieback load could signal relaxation in the tieback bond length; in a tieback wall designed to minimize deformations, on the other hand, an increase in tieback load normally indicates that the anchor lock-off load could not impede further deformations and that the wall deformations
