Full-Scale Load Testing of 57-Year Old Raymond Piles for Foundation Re-use

FULL-SCALE LOAD TESTING OF 57-YEAR OLD RAYMOND PILES FOR FOUNDATION RE-USE

Vishnu Diyaljee, P.Eng, Ph.D, F.ASCE
Managing Director, GAEA Engineering Ltd
33 Ashby Field Road, Brampton, Ontario
Canada, L6X 0R4

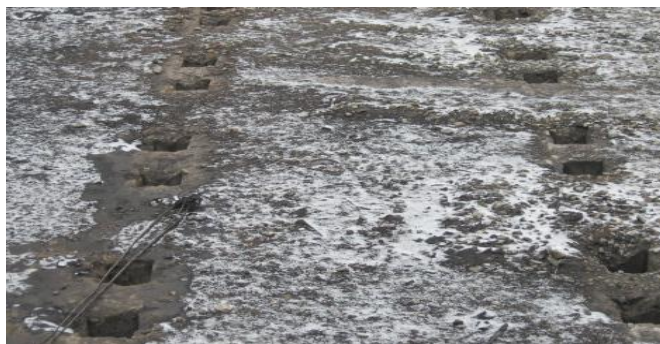
Fig.1. Existing Surface of Oven Pad - No. 6 Coke Battery

Openings shown in Fig.1 on the surface of oven pad are locations for flue gas pipes leading to the battery ovens.

Subsurface conditions relevant to the No.6 Coke Battery site were provided by two (2) boreholes logs, borehole (BH) 293 and BH 295 as indicated on Fig.1. These were shown on the drawing sheet titled “Ovens Battery Foundations Piling Bid Sheet For 45 ton Piles”. The borehole logs were illustrated as plots of Standard Penetration Resistance (SPT) values versus depth and with stratigraphic descriptions with elevation and depth. Borehole 295 was the most relevant as this was in close proximity of the piles tested.

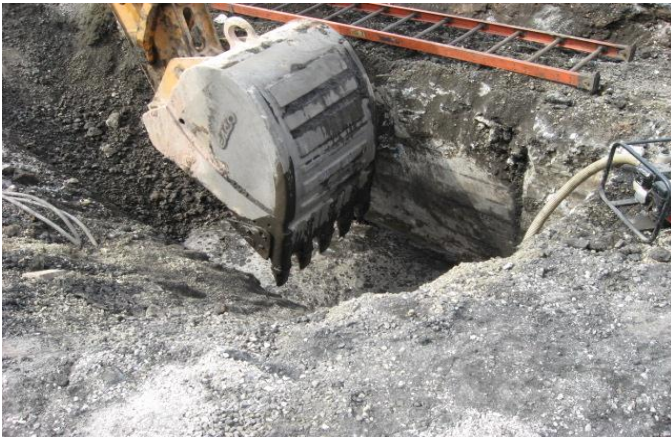
Fig.6. Excavation to Expose Pile under Pusher Track

The excavation process was slow as ground water was encountered around 3ft below the existing ground as had been advised. In order to be able to dig deeper and counteract the backfill sloughing a sump pump had to be used continuously as the excavation progressed. After a few hours of excavating and searching for the pile location, the pile was finally located.

The exposed section of pile above the ground water approximately 2ft appeared to be in good condition from visual observation. The outside of the pile appeared to be ribbed but this was later confirmed after excavation of pile No. 2 to be part of a corrugated/ribbed metal shell. The operation ceased for the day as the pile was identified found toward the end of the working day. Figure 6 shows the excavation in progress and Figure 7 the ground conditions encountered as the excavation progressed to locate and expose the pile under the pusher tracks.

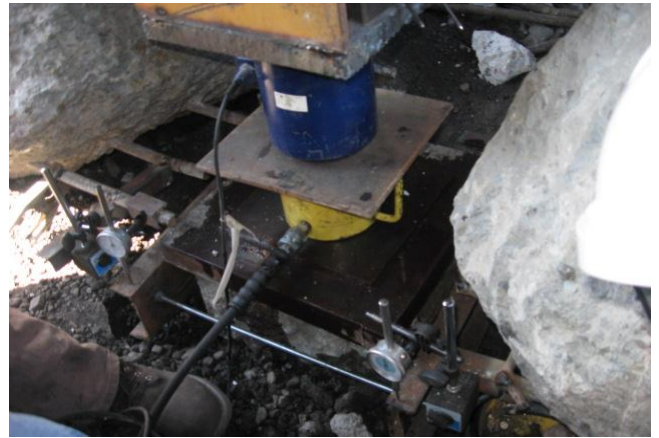
Fig. 8. Test Set Up For Pile Load Test

Preparation for the pile load testing was discussed with the excavation contractor and it was agreed that on site available steel plates will be used to provide the dead load reaction. Since there was significant preparation to be made for field setup and testing, the load test was scheduled for April 14th 2009. The test setup developed is shown in Fig. 8. The dial gauges were anchored outside of the pile but with the stems resting on C-channels attached to the exterior of the pile.

The pile load test was started around 10.30 am on April 14 and was conducted as shown in the Photo above. The loads were applied through the hand pump that was used to transmit the hydraulic pressure to activate the jack. A digital readout gauge from the load cell was used to record the load in pounds or kilograms provided by the jack through a load cell located above the jack and bearing on the H-beam.

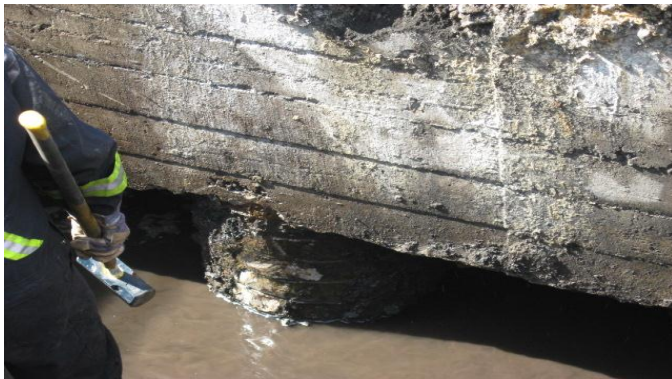
Fig.7. Located Pile under North Side of Pusher Track

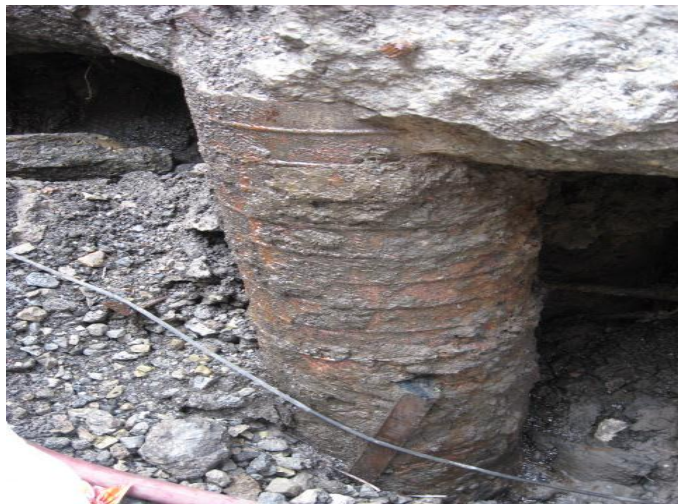
Fig.9. Exposed Pile Showing Thin Steel Casing

Excavation to locate and expose Pile No. 2 began on April 15. This pile was exposed the same day and was in alignment with Pile No. 1 and under the south beam of the pusher track. The location of this pile is shown in Fig 3. The excavation was undertaken in almost completely dry conditions since groundwater was drawdown by pumping from one compartment to the other within the adjacent Coke Battery Foundation. Quite noticeable was the steel shell/casing on the outside of the pile (Fig. 9). This observation confirmed that a casing was driven and left in place and confirmed that the pile was of the Raymond Type which was popular in those days. Since the entire pile was not exposed there was no way to assess whether the pile was tapered. The diameter at the top of the pile was around 20 inches.

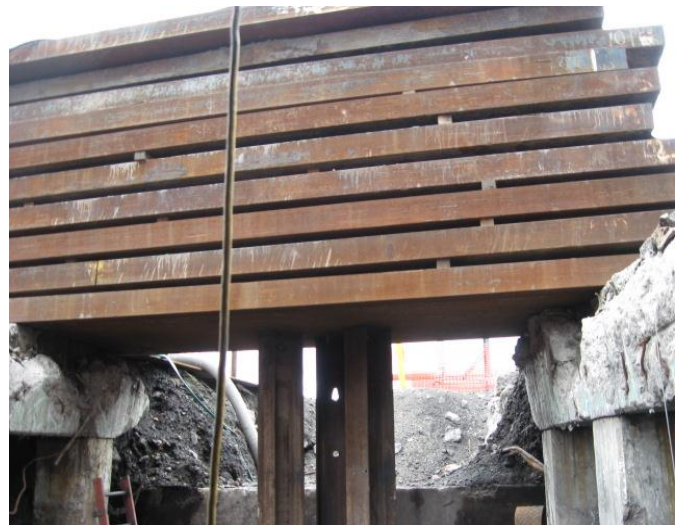
Fig.10. Reaction Weights- Steel Slabs

individual piles by demolishing the columns they supported and breaking the beams interconnecting the pile tops. The dead load reaction consisted of nine (9) slabs weighing about 252 tons. This load was increased to 276 tons by the addition of an additional slab after the testing of the first two-pile group was undertaken. This additional load was required to avoid lift-off of the weights observed when increasing taking the jack load to between 150 and 200 tons.

Two H-Sections were welded to the underside of the lowermost slab at about the centre spacing of the piles to allow the transfer of the jack loads to the reaction weights thereby allowing for testing two piles in a single set-up of the reaction weights. A load of about twice the anticipated failure load was aimed at for the total reaction weight. Figures 7 and 8 show the reaction weights and set-up for applying the load to the piles, respectively.

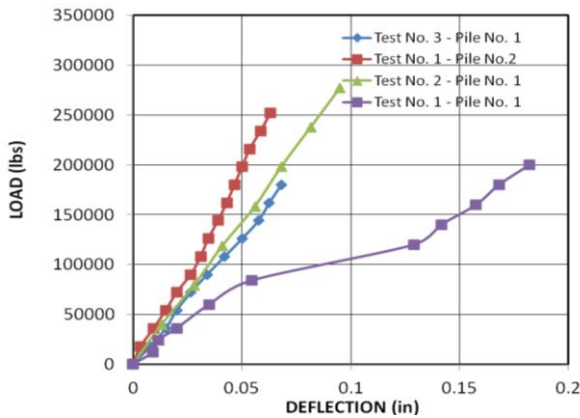
Fig.16. Loading Graphs for Piles No.1 and 2

The loading curve for Testpile 2 is shown in Fig. 15 along with the loading curves from Testpile No.1. The greater stiffness and smaller deflections can be readily seen when compared with the other tests. Testpile No.2 being not too far away from Testpile No.1 would be expected to have encountered similar ground conditions. Very likely, this pile would have attained a toe elevation of at least 21 ft below ground level.
