On Short-Term and Long-Term Behavior of Large Diameter above Ground Steel Storage Tanks Founded on Glacial Tills

ON SHORT-TERM AND LONG-TERM BEHAVIOR OF LARGE DIAMETER ABOVE-GROUND STEEL STORAGE TANKS FOUNDED ON GLACIAL TILLS

The paper summarizes settlement records taken over periods of weeks and up to 45 years on above ground steel storage tanks 20 m to 50 m in diameter, 14 m to 20 m high, founded on fine-grained glacial tills. Soil information for each of the tanks is provided from different sources such as conventional boreholes, test pits, and sometimes Dilatometer tests. Three newly constructed tanks have been instrumented with piezometers and a tank base hydraulic profiler for monitoring during hydrotesting. The presented long-term settlements for the older tanks, and the short-term monitoring data collected from the hydrotested tanks are examined and commented on with respect to the face value of the records. The ability to apply practical geotechnical engineering methods to provide reasonable predictions of the behavior of tank foundations is also discussed.

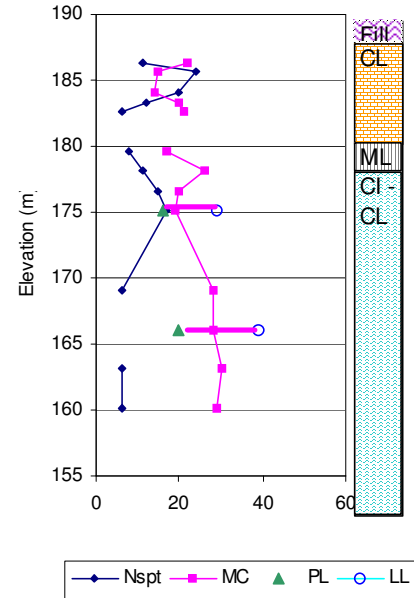
Fig. 7. Tank E209. Borehole summary

Also in 2002 one conventional sampled borehole using the Standard Penetration Test (SPT) method and one flat-blade Dilatometer Test (DMT) were advanced in the close vicinity of the tank. From test pits excavated right below the tank rim it was found that the tank base was essentially flush with the surrounding grades (near El. 187.1 m asl) and was supported by an average of 300 mm of and gravel fill over about 150 to 200 mm of fine sand fill over old clayey topsoil followed by native inorganic weathered silty clay soils. The borehole and the DMT were advanced to a maximum depth of about 28 m and encountered silty clays with lenses of silt and silty sand that are typical for the region. A summary of the determined soils properties are provided in Fig. 7 and Fig. 8 of below.

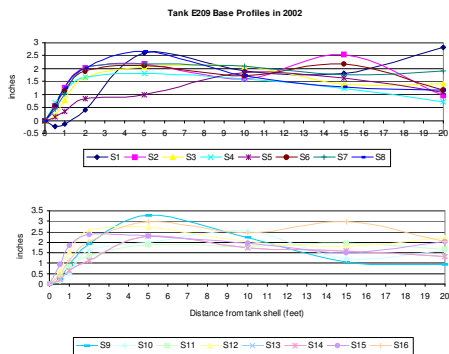
Fig. 10. Tank 209. Base deflection profiles

In April 2002 the tank was completely emptied and subjected to a condition survey which included the tank base elevation. Elevation shots were taken along 16 radial profiles, S1 thru S16, at distances measured from the tank shell of 0.5 feet

(0.152 m), 1 foot (0.304 m), 2 feet (0.608 m), 5 feet (1.52 m), 10 feet (3.05 m), 15 feet (4.57 m) and 20 feet (6.1 m) within each profile. The profile S16 was oriented along the site North and the remaining profiles S2 thru S15 were counted in the clockwise direction at equal intervals of 22.5 degrees. In Fig. 10 are plotted the tank bottom deflections relative to the edge of the tank base. It should be noted that the edge of the tank itself was undulating up-and-down along the tank perimeter, so that the shape of the tank base was even more complex than suggested by the charts.

Recognizing that the thin steel tank base plate does not follow strictly the ground surface beneath the tank because of random flexural distortions caused by welds, plastic yielding, especially under the floating roof supporting posts, etc., yet there appears to be an almost consistent pattern of a 3 to 4 inches (75 mm to 100 mm) elevation differential (crossfall) within about 5 feet (1.5 m) from the edge (rim) of the base plate. The construction drawing of 1968 consulted by us does not provide for such local crossfall; instead, the drawing calls for a general slope of one inch (25 mm) over 15 feet (4.57 m), which represents a gradient of 0.55% between the tank center and its edge. The recorded local crossfall is about 10 times steeper than the presumed “as-build” condition, which could reflect a “sinking” of the tank rim, possibly due to local subgrade failures along the tank perimeter.

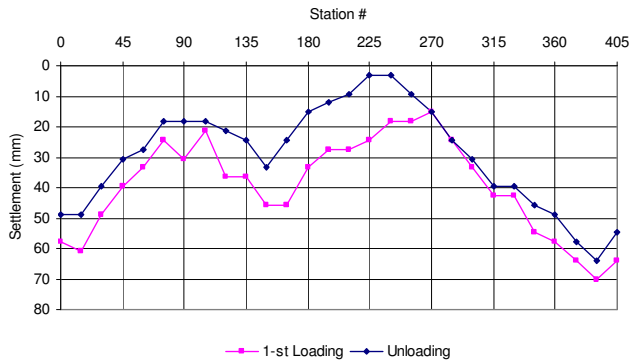
Fig. 13. Tank E204. Rim profile of maximum and residual settlements during 2003 hydrotest

To help visualize the actual distortion of the tank rim, the maximum settlements reached during the hydrotest along the tank rim, and of the immediate residual settlements one day after the tank unloading are plotted in Fig. 13 below.

Maximum settlements of 60 to 70 mm were reached around the North stations. At Stations 225 and 240 (close to the West rim), the maximum recorded settlements were only 16 mm.

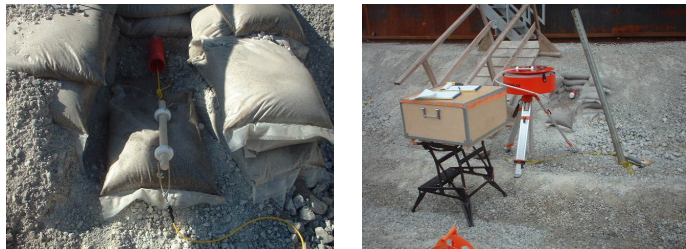
Fig. 16. PVC pipe, sensor and Consoil profiler setup

Prior to placement of the steel floor plates, a 100 mm diameter PVC pipe was installed in a shallow trench cut within the granular pad along a tank diameter to accommodate the sensor of the “Consoil” hydrostatic profiler (Fig. 16) used to measure the deflection of the tank base.

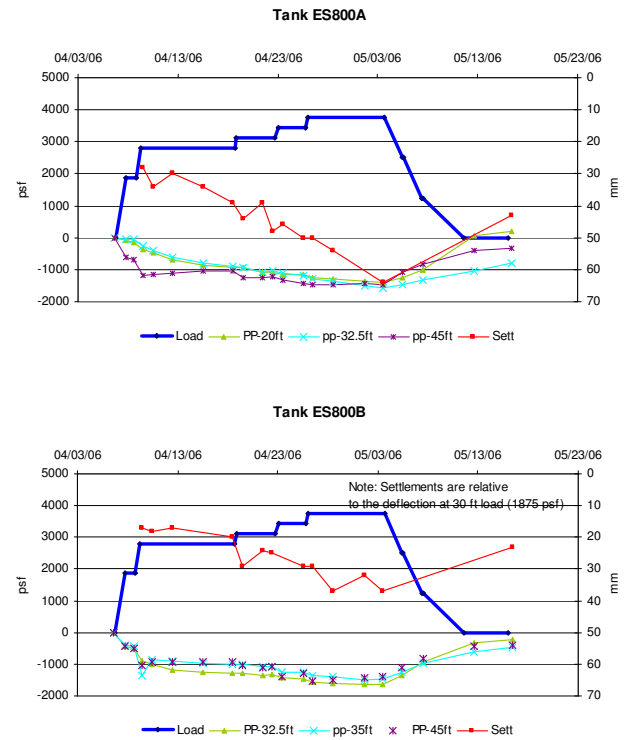
Fig. 22. Tank ES800s Piezometer readings, loading history and inferred maximum settlements during hydrotest

The load test history and the associated averaged porewater pressures along with maximum deflections inferred from the profiler readings are provided in Fig. 22. As before, the porewater pressures were plotted also as piezometric pressure increases to help compare directly to the applied total tank load. The porewater pressures were all positive but have been plotted as negative values to reduce the congestion of the chart. The porewater pressure increases for both tanks approached 1500 psf (72 kPa) which represents 40 % of the nominal maximum test load.

The settlements plotted in Fig. 22 were inferred from the maximum deflection readings at the hydraulic profiler. There were some issues with the profiler baseline reading at ES800B so that the settlements plotted for this tank are only the incremental values for the last 2/3 of the total hydrotest load.

related to this origin. Obviously, the deflections which occurred before reaching this load step were lost.

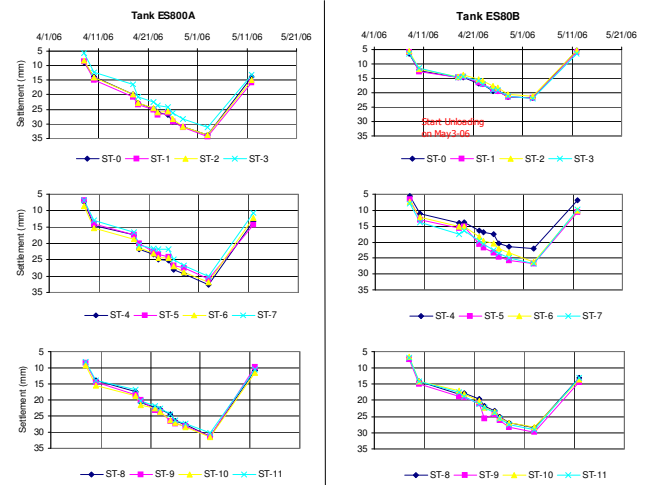
Fig. 23. Tanks ES800. Rim Settlement during hydrotest

The rim elevation survey at the two tanks is provided in Fig.23. Back calculation of the ‘elastic’ moduli on the basis of the recoverable rim settlements from the recorded maximum settlements yielded quite narrow ranges: of values from 87 MPa to 113 MPa for Tank ES800A and 107 MPa to 129 MPa for Tank ES800B. The similarity of these values with the results at Tank ES600 is notable. The same discussion raised for Tank ES600 about the unknown consolidation and creep component that is incorporated in these estimates for the elastic moduli applies to the current tanks.
