Excavation Support for the Newseum Development at 555 Pennsylvania Avenue in Washington DC, USA

EXCAVATION SUPPORT FOR THE NEWSEUM DEVELOPMENT AT 555 PENNSYLVANIA AVENUE IN WASHINGTON, DC, USA

Victor Omelchenko, P.E.
Senior Principal
Schnabel Engineering
Gaithersburg, Maryland-USA 20878

Mamoud Hosseini, P.E.
President
Clark Foundations/Civil, LLC.
Bethesda, Maryland-USA 20814

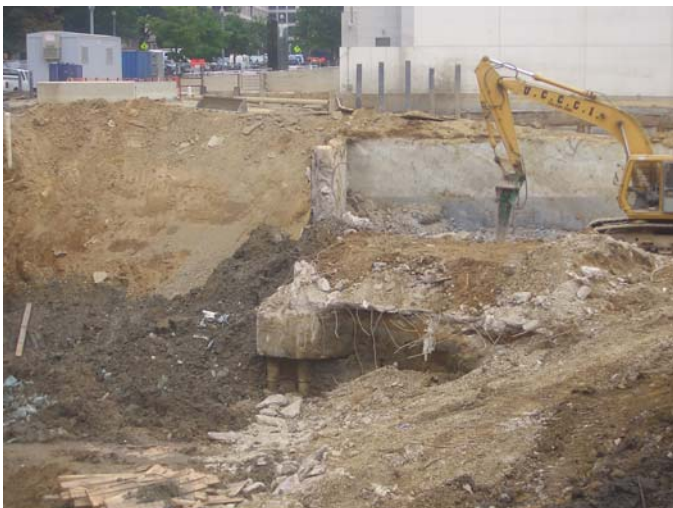
Fig. 2. Existing foundation system with Raymond Step Taper Piles

The foundation structure of the previous buildings that occupied the site consisted of concrete pile caps with steel cased concrete Raymond Step Taper piles (see fig. 2). Clark Foundations was concerned with the constructability, cost and performance of the specified soil-mix wall as the equipment involved with the soil-mixing operations would not be able to go through the existing foundations if encountered. Therefore additional costs and time would be entailed in the removal of such obstructions. Clark Foundations looked for other innovative methods of providing a watertight and rigid system. The substitution of a reinforced slurry wall in lieu of the soil-mix wall was cost prohibitive due to the additional cost of concrete placed under tremie.

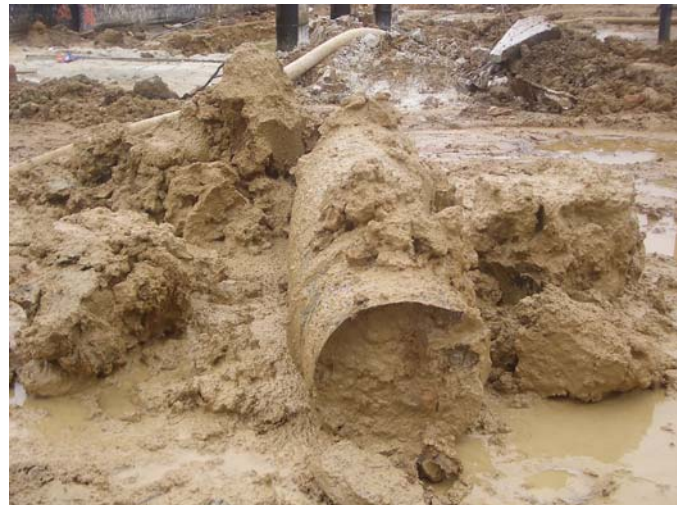
Fig. 3. Raymond Step Taper Piles removed with clam bucket.

The PSHG wall construction consisted of trenching 32 inch wide by 22 feet long by 59 feet deep panels under self-hardening slurry. Once the excavation for the panel was completed, a 60 feet deep prefabricated soldier beam and lagging panel was placed in the slurry. With this method of construction, if Raymond Step Taper piles were encountered they could be removed by trenching along the sides of the pile, making space to grab the pile with the clam bucket and pulling the pile over and out of the excavation (see fig 3.).

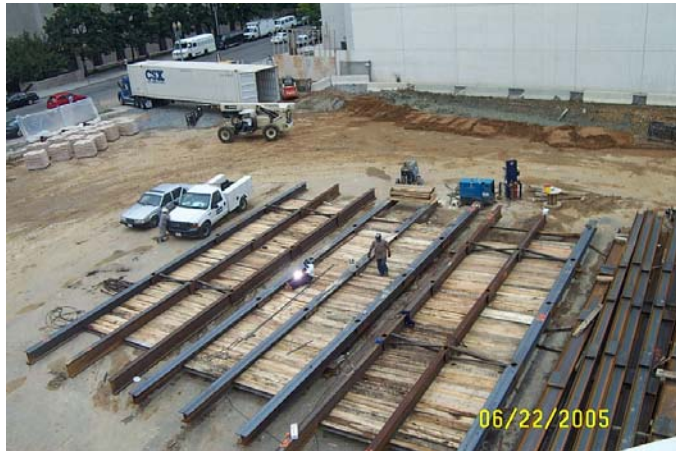
Fig. 4. Panel fabrication

In lieu of excavating a panel under slurry and displacing the slurry with tremie concrete and a reinforcing steel cage, the slurry is self hardening. The soldier beams and lagging are prefabricated as a panel and placed in the liquid slurry. The soldier beams were pre-fabricated with reservations for future tiebacks, and paired together with wood lagging to make a panel (see fig. 4). Each panel once assembled weighed eleven tons. Conventional waterproofing was later applied to the face of the lagging, prior to the construction of the building foundation wall.

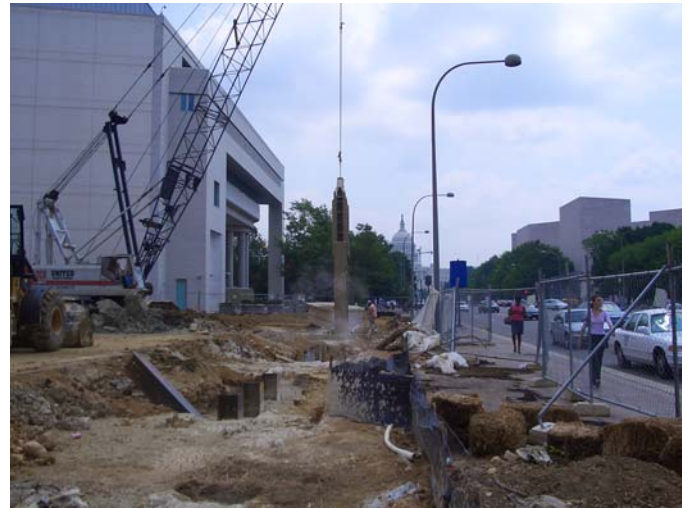
Fig. 5. Clamming operation for PSHG wall.

- a) 15 feet deep by 5 feet wide pre-excitation was performed along the alignment of the PSHG wall to remove the shallow underground obstructions, including the gravity stone walls and the footings of the existing buildings.
- b) A steel template was set in place to guide the clam bucket.
- c) Trenching for the 32 inches wide by 59 feet deep panels under self-hardening grout was performed using a clam bucket, attached free hanging, to a 100 ton Link-Belt crawler crane. Since the majority of the panels were 22 feet wide, three sub-sections of steel H-pile and wood lagging were required for the construction of each panel.
- d) The excavated materials (spoils) from the trenching operation were temporary stored on site in a pre-excavated glory hole, for off site disposal by the excavator at periodic intervals.

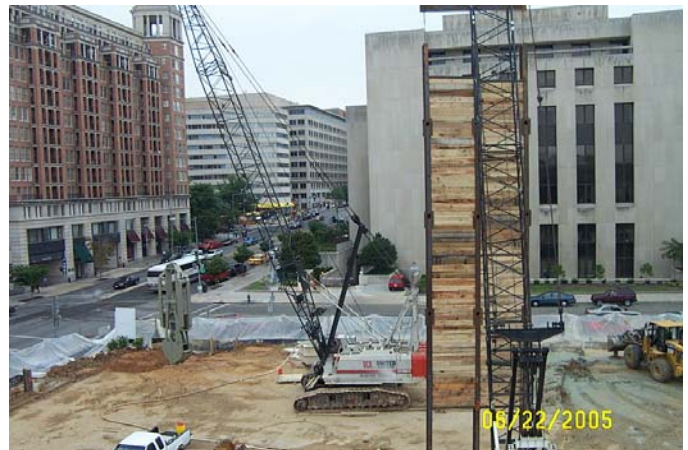
Fig. 6. Setting of Prefabricated Panel.

- e) Once the panel excavation was completed, the reinforcing panel, which consisted of prefabricated soldier beams and lagging, was lowered into the self-hardening grout with a 75 ton Link-belt crawler service crane.
- f) In order avoid communication of open excavated panels a sequence was planned to allow each “primary” panel to cure for seven days before the “secondary” panels were trenched. The secondary panels were installed in such a way that it bit 12” into the sides of the primary panels to ensure a water tight system.
- g) Upon completion of all panels, excavation from within the PSHG walls began. As the excavation proceeded to sub-grade and the wall was exposed, the 7-foot gap between the embedded soldier beams in adjacent panels were lagged to sub-grade.
