## A Landslide in Glacial soils of New Jersey

### Paper No. 3.19

On August 13, 2000, a massive landslide occurred in Northern New Jersey following an extreme rainfall event during which at least 381 mm (15 in) of precipitation fell during a 4-day period. The composite earth slide-earth flow, with an estimated volume of 22,800 m<sup>3</sup> (29,821 yd<sup>3</sup>) traveled up to 365 m (1200 ft) in a short period. While landslides do occasionally occur along the coastal bluffs of the Atlantic Coastal Plain, slides of this magnitude are uncommon in the glacial soils of the New Jersey Highlands section, where the slide occurred.

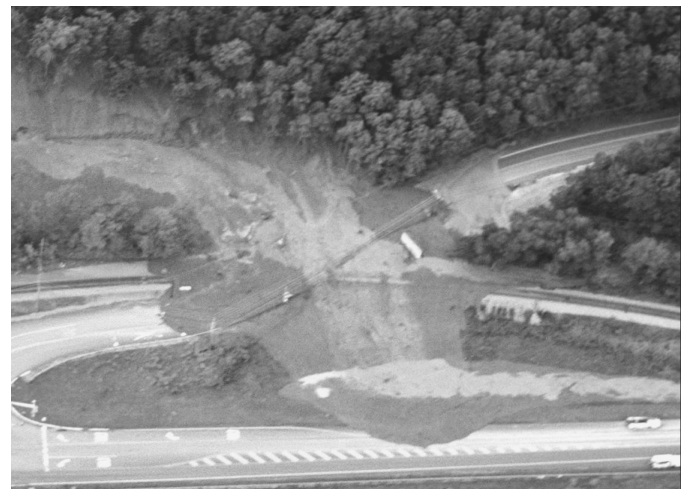
Fig. 3. Aerial view of lower foot of Sparta landslide.

The Sparta landslide occurred on the west side of a north-south trending ridge of the Sparta Mountains, initiating about halfway up the ridge. The slide mass traveled down slope eventually coming to rest at the base of the ridge where the slope flattened considerably. An aerial view of the lower foot of the slide, which was photographed by a private pilot about two hours after the slide, is shown in Fig. 3. It can be seen that the slide engulfed two roadways (Main Street and Route 517 By-pass) and a railroad track (NY Susquehanna & Western), covering them with mud to an average depth of around 1.2 m (3.9 ft). According to an eyewitness account, the slide traveled at a rate such that “one could easily walk fast ahead of the advancing mud.” This corresponds to an estimated velocity of around 1 m/sec (3.3 ft/sec), which classifies as “very rapid” on the scale of landslide rate of movement (Varnes, 1978). Fortunately, no injuries were associated with the slide, although traffic on both roadways and a railroad line was interrupted for almost two days. An unoccupied pump house was in the path of the slide and was surrounded by mud up to 1.5 m (4.9 ft). It sustained minimal structural damage consisting only of collapsed doors and windows.

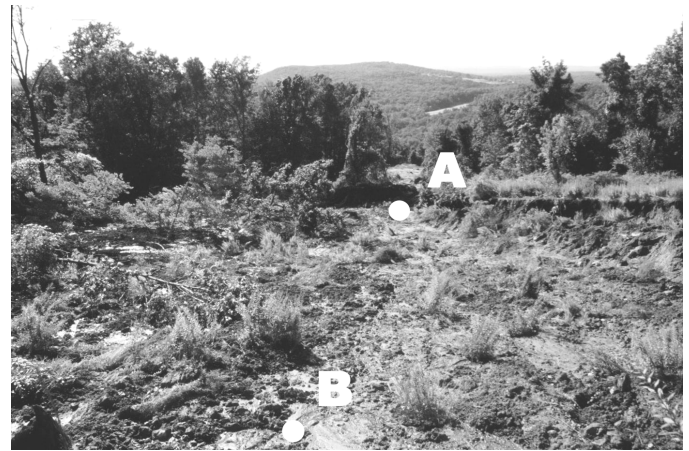
The rupture zone was visited for the first time the day after the slide. At that time the depleted soil mass within the scar was still fully saturated and totally unstable. A saturation line was observed along the head scarp about 2.5 m (8.2 ft) below the ground surface, and groundwater was daylighting out at several locations to the extent that the noise of running water was audible. The head and side scarps remained nearly vertical, although column-shaped wedges of soil were still sluffing occasionally into the depleted zone. The photo, shown in Fig. 5, taken the day after the slide, provides an additional perspective of the failure. The photo was taken standing at the crown (point B) looking straight down the slide rupture surface towards point A. Note the irregular soil surface and the clumps of detached grassy vegetation.

Fig. 5. View standing at landslide crown looking down the rupture zone.

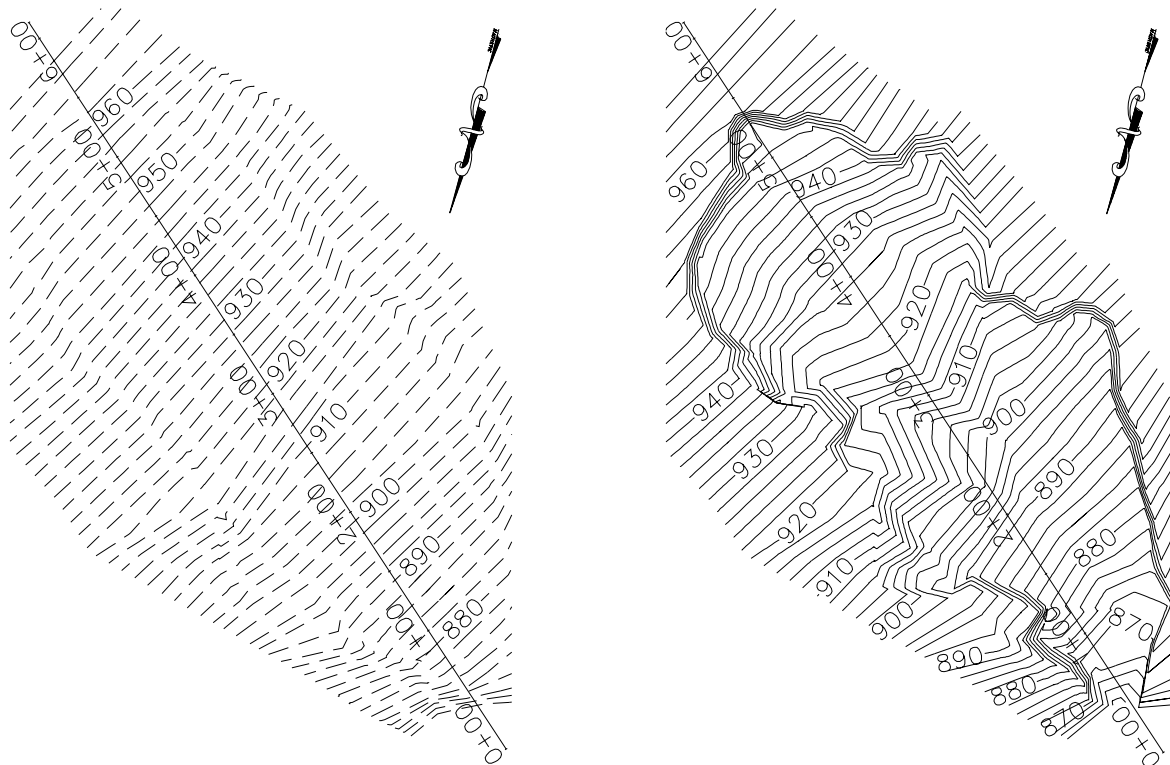
to develop topographic views of the rupture area before and after the incident, which are shown in Fig. 6. A centerline profile of the slide was also generated and is shown in Fig. 7. The massiveness of the slide becomes readily apparent by comparing these topographical maps. The rupture zone is roughly oval-shaped measuring a maximum of 67 m (220 ft) between flanks and 148 m (485 ft) from crown to toe of surface of rupture. The average depth of the slide as measured from the original ground surface to the failure surface was 4.3 m (14 ft). The total volume of the slide mass is estimated at 22,800 m<sup>3</sup> (29,821 yd<sup>3</sup>), of which 17,050 m<sup>3</sup> (22,300 yd<sup>3</sup>) of soil traveled down the mountain forming the foot (zone of accumulation), while 5,750 m<sup>3</sup> (7,521 yd<sup>3</sup>) of displaced soil remained in the rupture zone (zone of depletion). The original ground slope before the slide ranged from 15% to 20%. The surface slope of the depleted mass after the slide was similar, although the ground surface was hummocky and had been lowered an average of 3 m (10 ft).

Fig. 6. Topography of rupture zone prior to the slide (left). Topography of rupture zone after the slide (right).

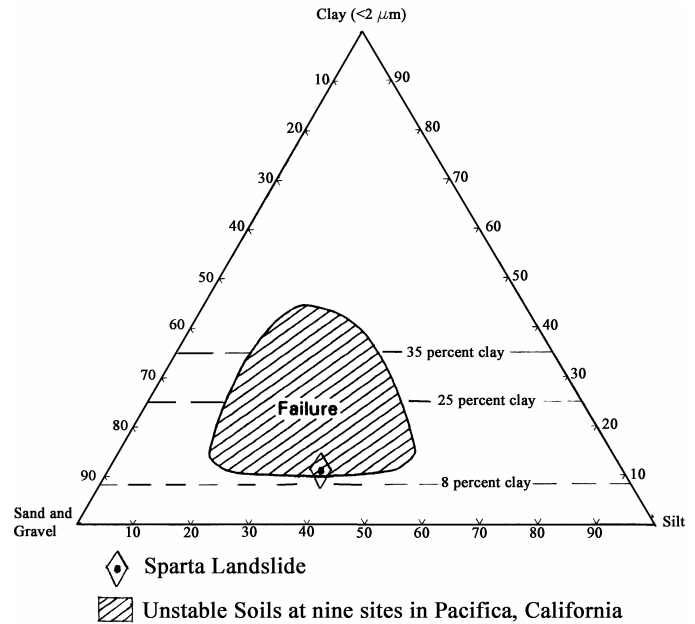
Numerous studies of landslides have established the range of soil grain sizes that are most susceptible to sliding. Soils containing large amounts of clay or gravel are less susceptible, since these soil components have a stabilizing influence on a soil mass. In this context, the texture of the Upper Till at the Sparta slide was analyzed and compared with historical data from nine landslides in the area of San Francisco, California, which occurred as a result of a record storm (Howard, *et al*, 1988). The California landslides are genetically similar to the Sparta slide, i.e., composite slide-flows. The results of the comparative analysis are plotted on the grain size triangle shown in Fig. 9. As indicated, the Upper Till falls within the zone of historic landslide soils, which is centered on silty and sandy soils. This demonstrated that the glacial soils at the Sparta site qualify as landslide prone.

Fig. 9. Correlation of landslide occurrences with soil classification (modified from Howard, *et al*, 1988).

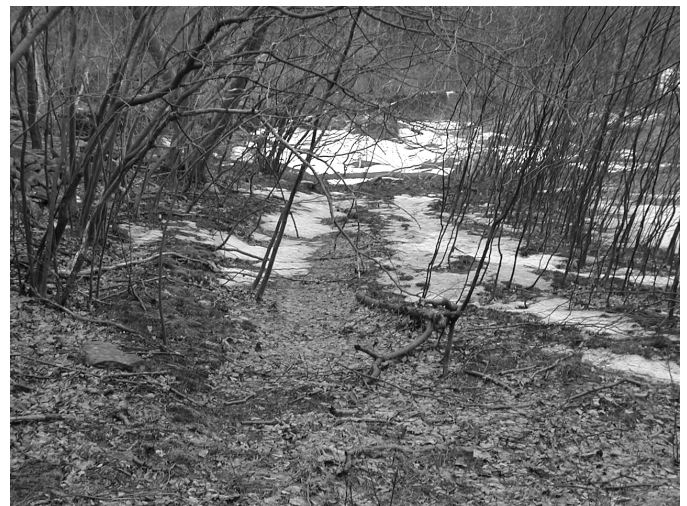
Two other conditions likely exacerbated the build-up of groundwater pressure. First, a small, but definite, topographic swale was observed directly above the rupture zone (see photo in Fig. 10). Minor topographic deviations can concentrate infiltration and increase groundwater pressures locally, and are often associated with slope failures (Domenico and Schwartz, 1998). Such swales, which are often non-obvious on topographic maps, help to answer the question: why did the slope fail here and not there? A second condition that likely contributed to groundwater build-up was the bedrock outcrops located on the slope above the rupture zone. The granite bedrock, with its characteristic low permeability, likely concentrated the groundwater in the overlying tills.

*Fig. 10. Photograph of natural swale located above the crown of landslide.*
