Ancient Landslide Reactivation at the Viaduct No. 1 Located on the Caraca-La-Guaira Highway in Venezuela

ANCIENT LANDSLIDE REACTIVATION AT THE VIADUCT NO. 1 LOCATED ON THE CARACA-LA-GUAIRA HIGHWAY IN VENEZUELA

ABSTRACT

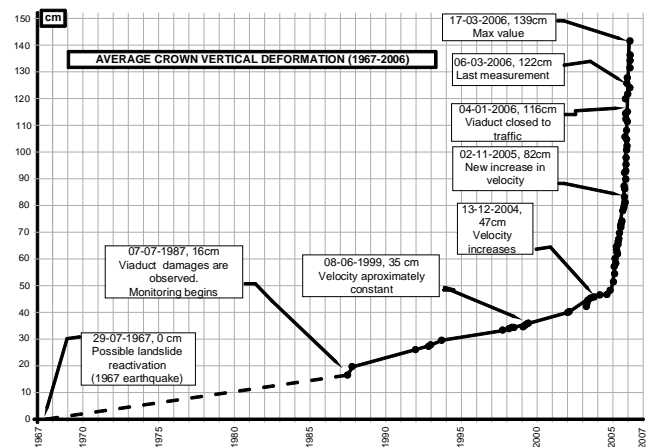
As mentioned by Salcedo (2006), an alternative that could explain the landslide reactivation would be the effect of earthquakes. Speculating one could think that the landslide was reactivated during the Caracas July 29, 1967 earthquake (Mw = 6.5 Richter scale). A mental exercise based on the measured landslide displacement based on the position of the Caracas Pilaster in 1987, leads to the conclusion that the hill must had moved at a rate of approximately 1.0 and 1.5 cm/year in the longitudinal direction of the Viaduct, velocity that was also measured in the following years, as shown in Figure 10. As will be described later, a 1:1 ratio was monitored between the average vertical deformation of the arch ribs, measured at the crown and the landslide displacement in the Viaduct’s longitudinal direction.

Fig. 10 Landslide displacement vs. time (1967-2006) (Salcedo, 2006)

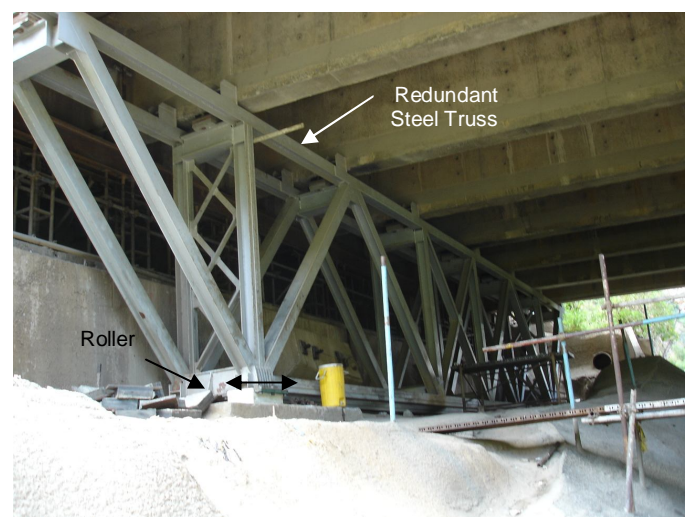
Fig. 14 Redundant truss at the Caracas Abutment

A redundant gravity load resisting system was constructed for the entire access Viaduct located on the Caracas side. New gravity load resisting elements were placed at the Caracas Abutment, piers 9' and 10' and inside the chamber located at the upper part of the Caracas Pilaster. A redundant steel truss was placed on the Caracas Abutment, as shown in Figure 14, that could eventually replace a concrete rocker that receive the beams at this location. The steel truss was supported on Hillman rollers placed transversely to the longitudinal axes of the Viaduct. A set of redundant reinforced concrete piers were constructed at either side of piers 9' and 10' to support paired trusses which received the precast girders, as shown in figures 15a and 15b. The trusses were also supported on rollers free to displace in the transverse direction. A redundant gravity load resisting system was placed inside the upper chamber located inside the Caracas Pilaster. It consisted of metallic struts, which received the precast girders. Similarly as it was done at the Abutment and piers 9' and 10', the steel struts were supported on Hillman rollers placed transversely to the Viaduct's longitudinal axes, as shown in Figure 16.

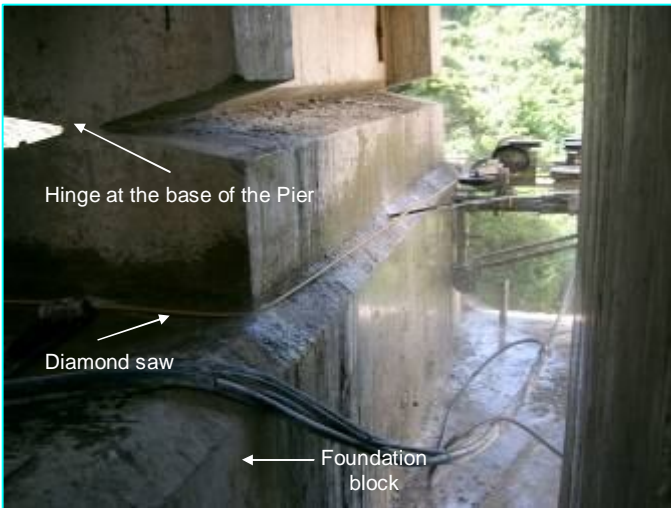
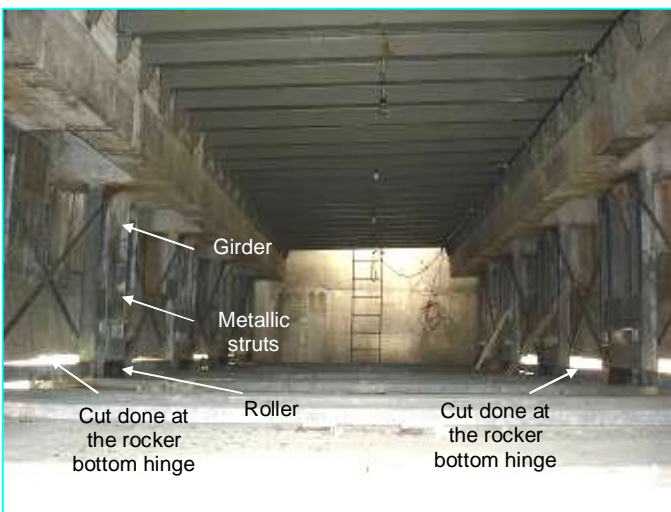
Fig. 17 a Diamond saw performing a cut at the base of Pier 9'

Fig. 17 b Cuts done at the bottom hinge of the concrete rockers located inside the chamber at the Caracas Pilaster

intentionally cut at their bottom bases to allow the structure rest on the redundant gravity load resisting system described before. Subsequently, the tension on the cable system at piers 9' and 10' was slowly release. Figure 17 shows sketches of the concrete surfaces that were cut using a diamond saw, at the base of the piers (Figure 17a) and at the base of the concrete rockers located inside the upper chamber at the Caracas Pilaster (Figure 17b). As a result, it was possible to recover approximately 23 cm of the Viaduct's transverse deformation at Pier 9', as shown in Figure 18.

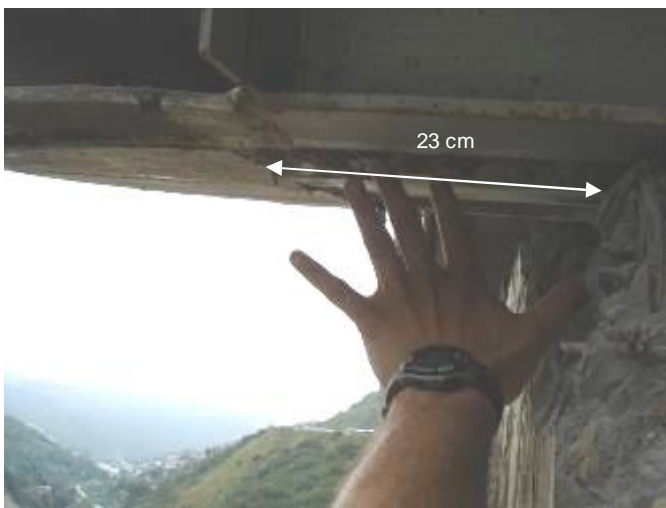
Fig. 18 Transverse displacement recovered at pier 9'

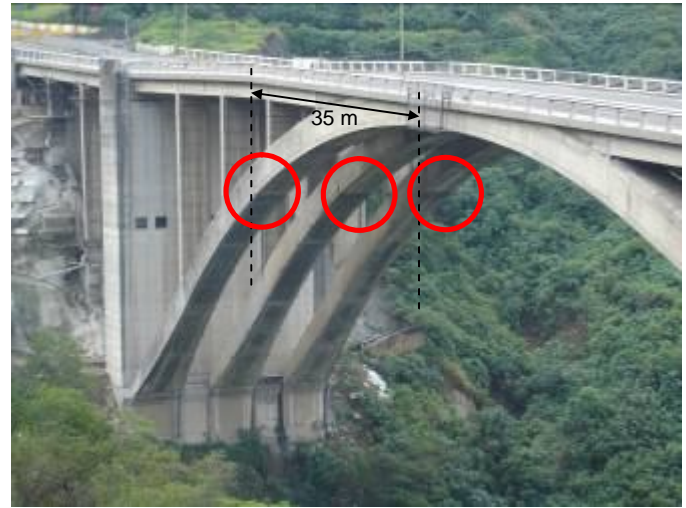
The thrust continued at a rate of approximately 0.8 cm/day, and the Viaduct remained closed. In March 19th 2006 the Viaduct collapsed, at a vertical deformation of the arch ribs of approximately 1.90 m. Immediately after the collapse, three seismic stations located at 3, 14 y 19 kilometres from the Viaduct allowed to estimate the impact of the fallen structure as an equivalent earthquake of magnitude $M_w = 1.6$, as reported by Salcedo (2006). No deaths nor injuries were associated with the structural collapse.

Fig. 23 Location of the fracture at the arch ribs

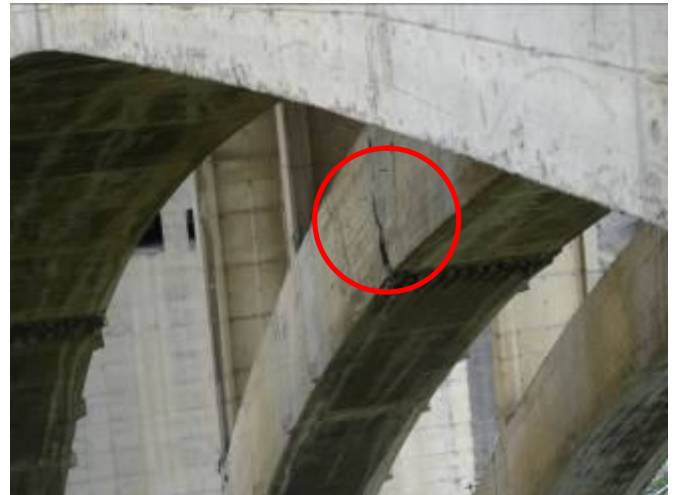
Fig. 24 Fracture of the arch ribs
