International Conference on Case Histories in Geotechnical Engineering (1993) - Third International Conference on Case Histories in Geotechnical Engineering

## Performance Evaluation of a Hydraulic Asphalt Concrete Pavement Capping a Hazardous Waste Site

**SYNOPSIS** Hydrologic Consultants, Inc. was contracted to undertake the closure of a former pesticide facility. While pesticide compounds were present on the site, they were located primarily in the top two feet of soil. Five remedial action alternatives for the site were reviewed; the remedial action selected was to cap the site. Because of the expense of obtaining clay in sufficient quantities, a less costly alternative to clay was adopted: a high-bitumen-content hydraulic asphalt concrete (HAC) pavement. For preliminary design purposes, a performance assessment was conducted utilizing the Hydraulic Evaluation of Landfill Performance (HELP) model to compare the relative performance of clay and asphalt capping material. The results of model simulations indicated that the asphalt pavement design with a permeability value of  $10^{-8}$  cm/s and a cover thickness of 4 inches, would perform better than a clay cap in terms of the

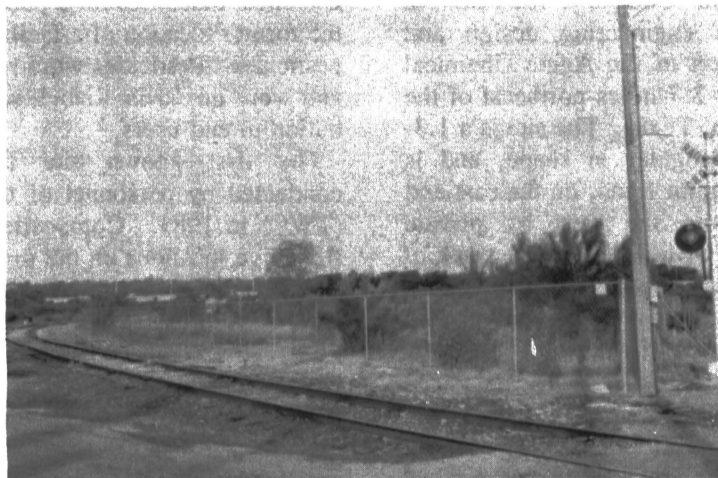
Figure 2. The Aggie Chemical Site in January 1989, Looking West

Buildings that had been present on the site were demolished in 1982, so that at the commencement of remedial activities in 1989, the site consisted of an open lot covered with a dense stand of brush and undergrowth, and a few small trees (Figure 2). The parcel was level and at grade with Edgar Street and Seguin Road along its northern, eastern and southern boundaries; however, the land surface fell off steeply towards the west, down a three-foot embankment, to bordering residential property.

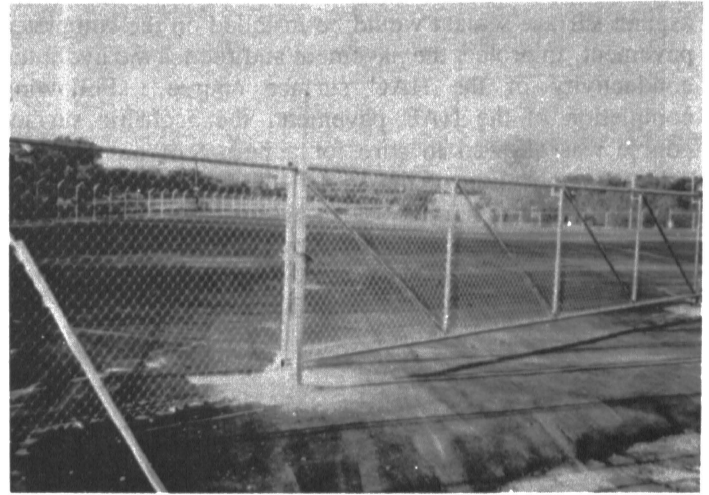
Figure 5. The Completed Pavement, Looking Southwest from the Intersection of Edgar Street and Old Seguin Road
