(2013) - Seventh International Conference on
Case Histories in Geotechnical Engineering

Stabilisation of Deep Soil Cut Using Micropiles and Soil Nailing

STABILISATION OF DEEP SOIL CUT USING MICROPILES AND SOIL NAILING

The initial failure of one of the slope at Chainage 344/900 Km was stabilized by Gabion walls. West side of the Soil cutting was about 100 m long and a lateritic hilly slope steeply rises to 20 m above the track level at the collapse location. Initially the cutting line was 15m away from external track edge. However, after the heavy monsoon in June 2000, the soil slope collapses causing the lateral movement of the gabion wall and lateral shifting of the nearby railway track.

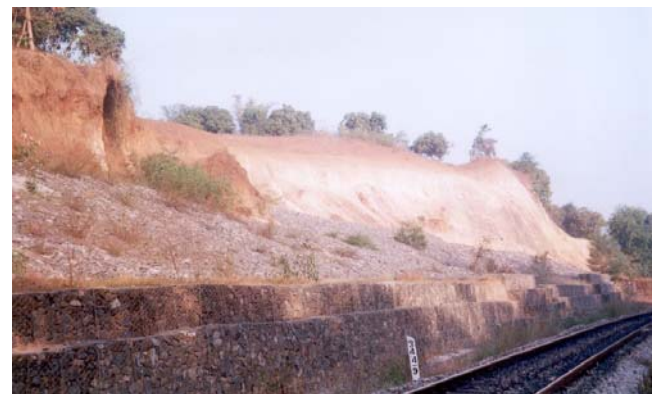
Fig. 2 Construction of Gabion wall along the track

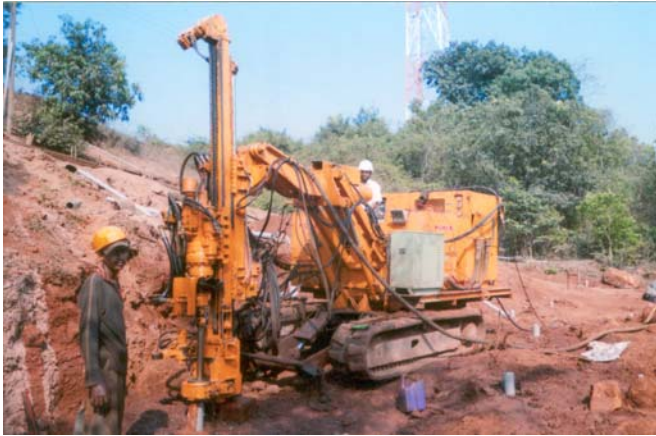
In addition, to reduce the lateral load on the 200 mm diameter piles additional 2-rows of 125 mm diameter Micropiles at 1.00 m center-to-center spacing at upper bench were installed.

Soil nails of 76 mm diameter and 10.50 m long with horizontal and vertical spacing of 1.5 m each were installed. From the study of the Borelogs, a layer of lateritic soil of thickness around 3.5 m was observed. Hence, to transfer the load to firm strata an additional row of soil nail of diameter 112 mm and inclined at 45 degrees was designed and installed at the bottom of the vertical cut.

Fig.4. Construction of Micropiles for upper bench and Soil Nails

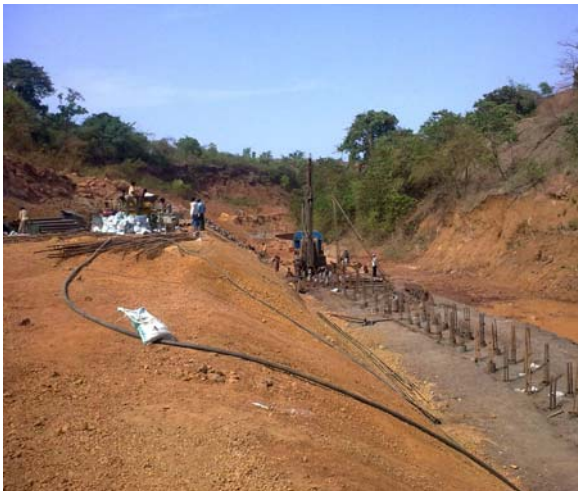
At RL. 25.72 m., 200 mm diameter staggered Micropiles were installed in 2-rows at spacing 1.0 meter center to center. These Micropiles were encased with Mild Steel Casing till the rock level. Further 4 meter was drilled in the rock to achieve proper socketing.

Fig. 3. Construction of Micropiles for the First Bench at RL 25.72.

Initially drilling of 219 mm diameter was carried out in overburden with percussion drilling method.

After the hole is drilled upto overburden, the permanent liner was lowered with boring tools through overburden. Thereafter the drilling of 200 mm diameter was continued to the required depth of rock socketing.

Once the full depth of the hole was reached, it was cleaned with air flush to remove unwanted sediments at the base of the borehole. After the drilling and flushing, the reinforcement assembly of four Nos. of 25 mm ϕ , bound together of suitable lengths was lowered in upto the bottom of the pile. Reinforcement laps were welded in position.

Water was flushed through the central grout pipe until the clear water from hole emerged. Grouting was started only after the clear water emerges out of the drill hole. A stable sand cement grout (Sand: Cement = 0.5: 1.0) with water cement ratio of 0.4 was prepared in a colcrete mixer and sent down through the grout pipe with the help of Colomono pump. This pipe was lowered to a depth about 50 mm above the bottom of the hole. As the grouting proceeded, the pipe was raised gradually such that at least 2 to 3 m of grout will remain above the tip of the grout pipe. Grout cubes were casted during the grouting and tested. Results showed that grout had compressive strength of 200 to 300 kg/cm².

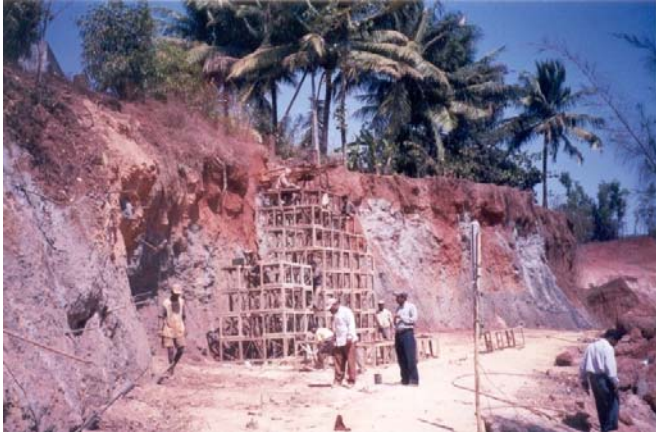
Initially drilling of 76 mm diameter was carried out horizontally with percussion drilling method to the required depth of nail. Once the full depth of the hole was reached, it was cleaned with air flush to remove unwanted sediments at the base of the drill hole.

After the drilling and flushing, the reinforcement - 1 No 25 mm ϕ - was lowered upto the full depth of the soil nail.

Water was flushed through the central grout pipe until the clear water from hole emerged. A stable cement grout with water cement ratio of 0.40 was prepared in a mechanical mixer and sent through the grout pipe. As the grouting proceeded, the pipe was removed gradually. Grout cubes were cast during the grouting and tested. Results showed that grout had compressive strength of 270 to 465 kg/cm².

Fig. 4. Construction of Soil nail
