Vertical Excavation below Footing Solved by Compaction Grouting

Synopsis: One of the problems regularly facing engineers in designing additions to buildings or other structures is dealing with excavating for footings directly adjoining existing footings but at a deeper level.

One of the problems regularly facing architects and engineers designing additions to buildings or other structures is dealing with excavation directly adjoining present structures where new footings need to be placed below the existing foundation level. That typical problem presented itself at the Harrison Conference Center in Glen Cove, NY, on the north shore of Long Island.

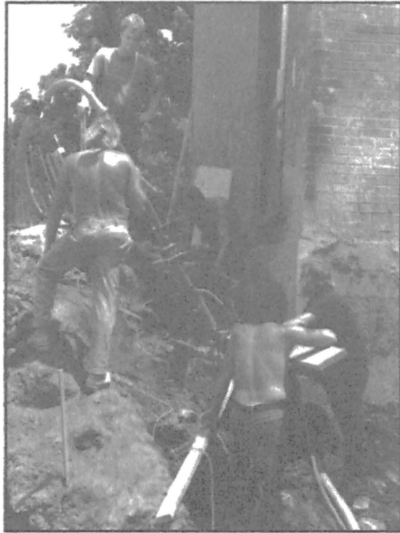
Grouting an anchor pile

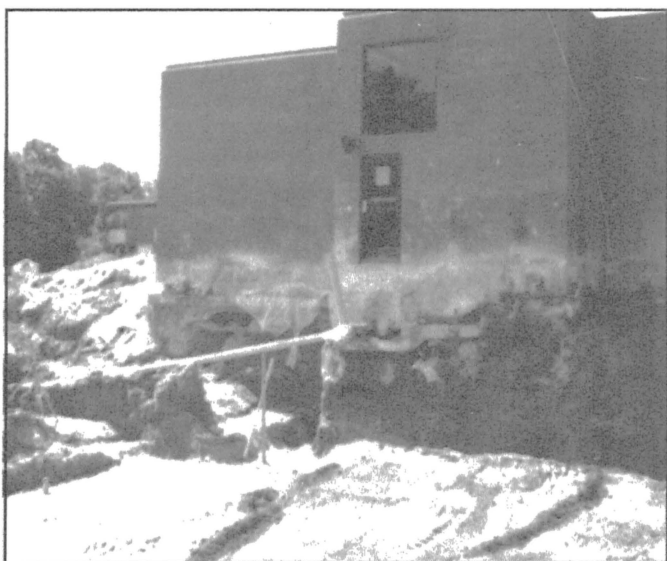
Corner showing sewer connection

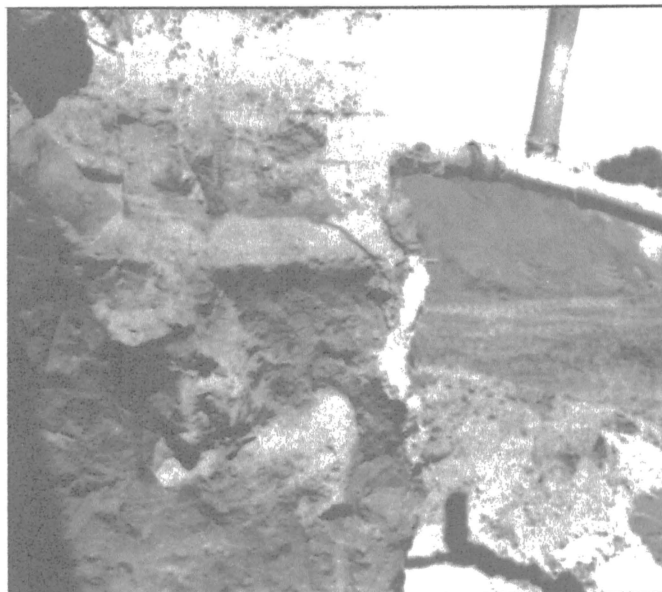
Final excavation before new footings

No special precautions were observed during excavation. Because of construction scheduling, the vertical face was exposed and unsupported for about a month. The soil between the piles along the face had been compressed so densely during grouting that there was no noticeable difference in appearance after the month passed.

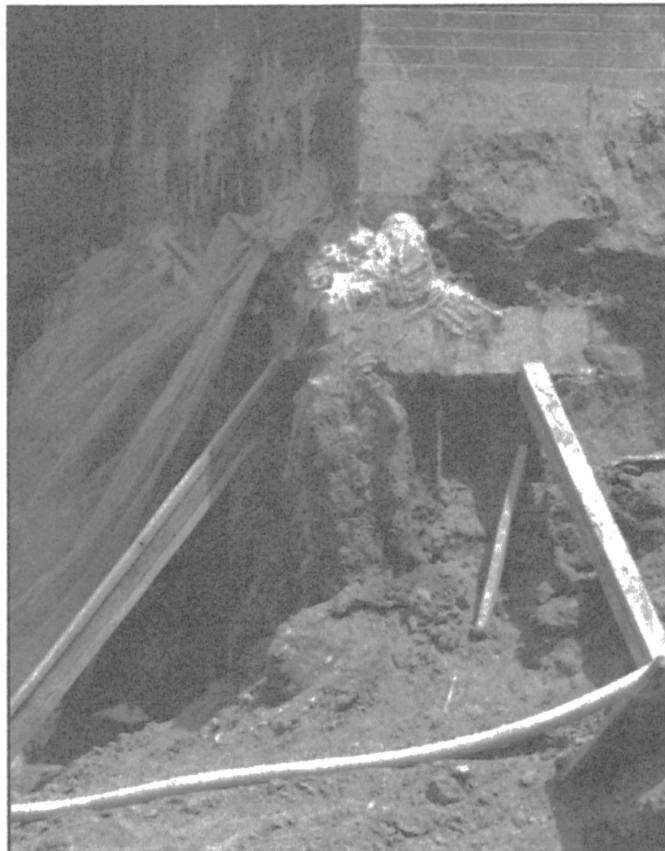
Pile #34 bracing is for personal protection, not structural support

During excavation, a few piles were partially exposed. Close digging in the area of section B scraped against the grout at the top. On the right corner, pile number 34 was hit during excavation by earth moving equipment breaking away sizable sections. In the end, no harm was done and the digging contractor returned to using a backhoe rather than a bulldozer for excavation near the structure. It is interesting that the shape of the exposed pile, number 34, is roughly square rather than roughly round as might be surmised.
