Performance Monitoring of a Bridge Abutment Spread Footing From Construction Through Service

PERFORMANCE MONITORING OF A BRIDGE ABUTMENT SPREAD FOOTING FROM CONSTRUCTION THROUGH SERVICE

ABSTRACT

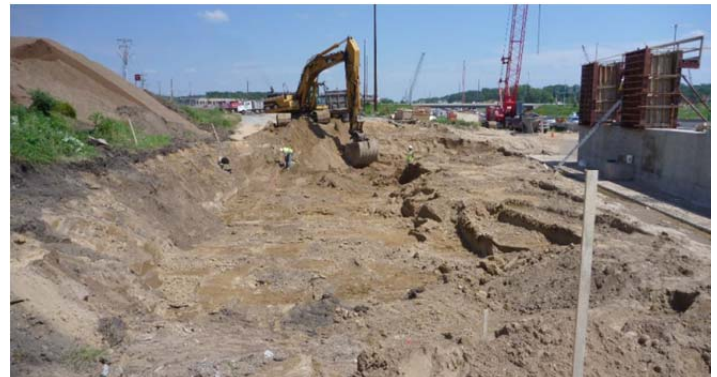
Fig. 3. Excavation of the north abutment area of BR 27R29 prior to placing preload, August 04, 2011.

was defined to have a top at the future roadway elevation and a width and length based on a vertical projection of the footing with side slopes extending down at a 1:1 (Horizontal:Vertical) or flatter slope. Excavation for the preload construction, as seen in Figure 3, began in early August of 2011.

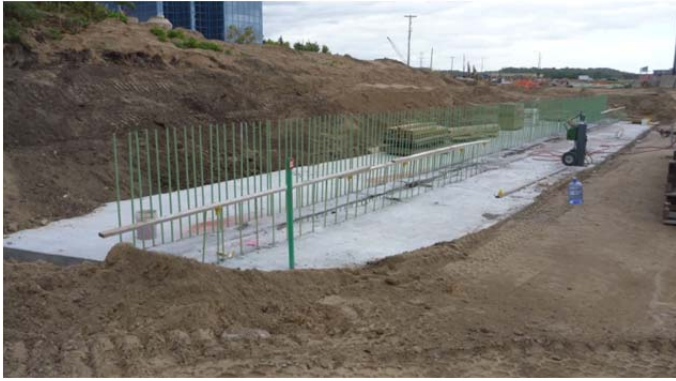
Fig. 5. The footing is cast with an optical target located in the foreground, September 20, 2011.

rebar was placed the following two days. The footing was poured on September 16, 2011 and is shown in Figure 5.

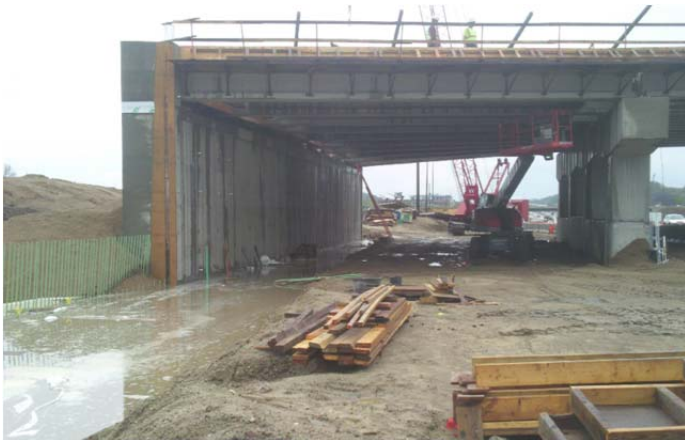
Fig. 6. North Abutment beams were placed October 12, 2011.

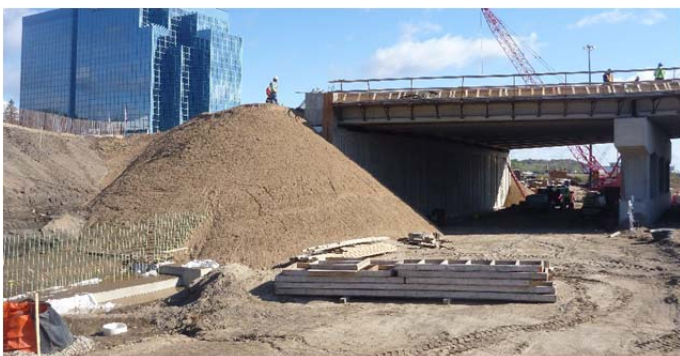
Fig.7. Adjacent retaining wall construction continues adjacent to the North Abutment, October 15, 2011.

Over the next two weeks portions of the abutment stem were formed and poured. The final section of the abutment stem was completed by October 1, 2011. The bridge beams were placed on October 6, 2011, as seen in Figure 4. Backfilling took place between October 11 and 12, and the bridge deck was cast during an overnight pour beginning on October 17, 2011. Intermittently, to accommodate the adjacent retaining wall construction, portions of the bridge abutment backfill were removed and replaced, see Figures 7 and 8 and 9.

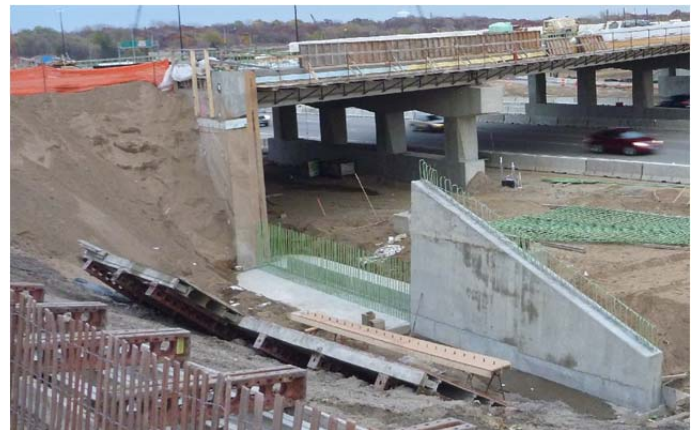
Fig.8. Adjacent retaining wall construction occasionally required the removal of some of the bridge backfill as seen in this photo from November 11, 2011.

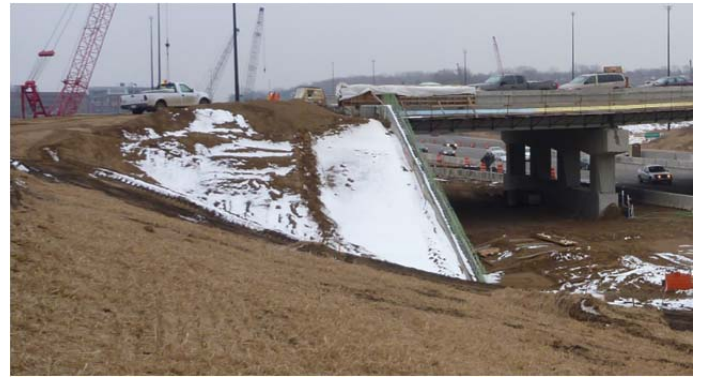
Fig.9. Adjacent retaining walls construction is substantially completed at the North Abutment, November 22, 2011.

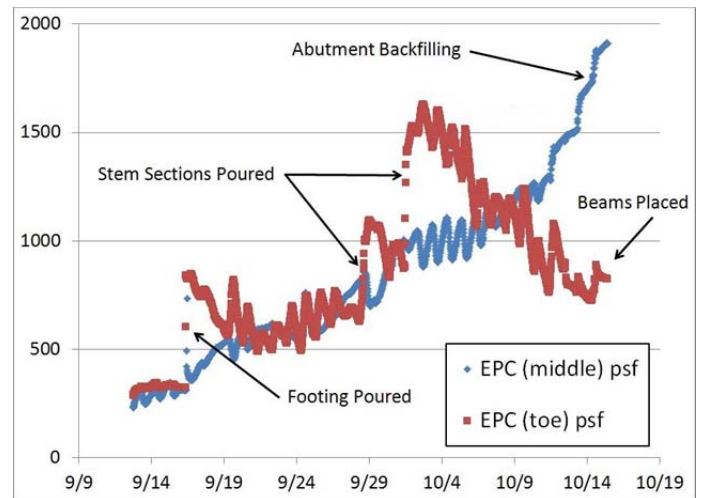
Fig. 10. Early EPC data showing trends in movement at the center of the foundation (blue) and the toe (red).

Both EPC sensors appeared to show consistent loading behavior, reading up to about 500 psf (25 kPa) for about two weeks. After this time there were some spikes observed on the EPC at the toe of the footing, which are believed to be caused by the construction of the stem, which was offset slightly toward the toe, as shown in the abutment diagram, Figure 13. Casting and placing these elements probably induced slight outward rotations, as shown in the early EPC data plotted in Fig. 10. About 0.01 to 0.02 in (0.25 to 0.50 mm) of movement is observed on the SAA at this time.

As the EPC sensors were not field calibrated at the site, the measured values are not expected to accurately represent the actual in-situ pressures below the foundation. However, as the sensors were installed similarly, it is anticipated that their relative behavior will be similar and the pressure ratios may be compared, as presented in Fig. 10 and Fig. 11.

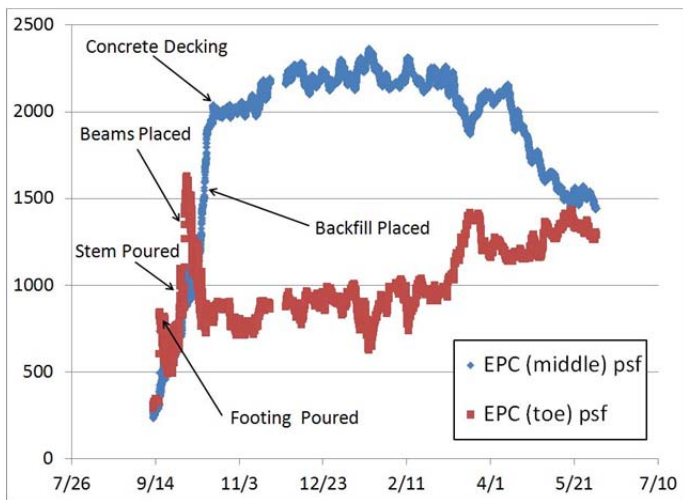
Fig. 11. The full EPC dataset shows differing trends in movement observed at the center of the foundation (blue) and near the foundation edge at the toe (red). The most significant difference in behavior is observed during, and after, the backfill placement.

Coinciding with the placement of the bridge beams and embankment backfill operation, the next major increase in pressure occurs in mid-October, at about day 30 in the construction timeline. At this time a change of about 0.08 to 0.12 in (2 to 3 mm) of downward deflection is observed by the SAA sensor. The largest changes in pressure, and deformation, were observed during this period. Unfortunately, for the monitoring program, the contractor was beginning to place backfill on the footing heel at the same time the bridge beams were set, making it difficult to resolve the cause of the observed pressure responses during this period. It is proposed that there would be an overall deformation and pressure increase but the weight of the beams may cause some forward rotation of the stem while the backfill would cause backward rotation. The change in EPC pressures is shown in Fig. 11 and the corresponding SAA deformation is shown in Fig. 12.

As beams were set and backfill was placed, the pressure on the middle EPC continued to increase, but the pressure on the toe EPC changed from increasing to decreasing. After backfilling was substantially complete, the EPC placed at the toe of the footing had a steady-state reading of about 750 psf (36 kPa), while the EPC under the abutment stem showed a loading of 2250 psf (110 kPa). The results appear to indicate some possible amount of backward rotation into the fill. As time progressed, from 175 to 250 days during the monitoring period, the earth pressure readings began to become more uniform with both sensors having a pressure reading of about 1000 psf (50 kPa) at the end of the monitoring period at 266 days.

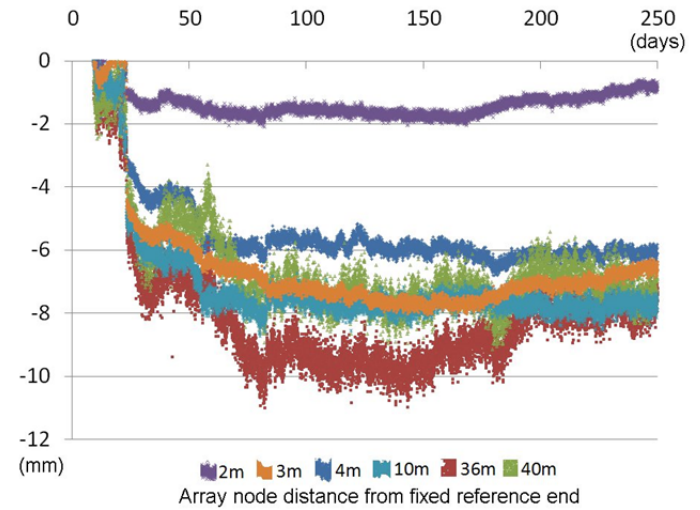
Fig. 12. Settlement of the ShapeAccelArray at the North Abutment plotted for 6 selected nodes (of 80) along the length of the 132 ft. (40 m) array.

The SAA data showed good correlation between the loading events and observed deformations. A plot of the SAA data can be seen in Fig. 12. Less settlement was observed by the SAA close to the toe edge of the foundation (the top, purple trace, in Fig. 12.) Overall, the SAA behavior was generally very regular, as seen by the behavior of the nodes relatively distant from the free edge of the foundation (all colors except the purple trace, at top, in Figure 12.)

As seen in Fig. 12, there are some small differences observed in the overall deformation along the SAA as it enters the footing from the toe edge and arcs into a line below the abutment wall. This appears to suggest the footing has some small amount of flexibility and differences in deformation appear to be up to 0.16 in (4 mm) across the length of the array placed below the foundation. As the array was laid on the top of the well compacted foundation material in a circular conduit, it is believed to have been cast intimately with the base of the footing. Considering the size of the footing in relation to the observed deformations, it seems reasonable to consider it a rigid body.

Figure 12 also shows that the maximum downward deformations are also observed between the period of 75 and 175 days after footing preparation; after this time there appears to be some measured upward deformation. This can also be seen in Figure 14 which depicts all the nodes along the SAA instrument at 3 different points in time, December 2011, April 2012, and June 2012. Figure 14 shows that there appears to be slightly more time dependent movement along the array embedded further into the foundation, and that the movement is curiously upward with respect to the earlier datasets. The cause of this is not well understood, but potentially involves some settlement of the reference end over time, temperature effects, or possibly some rebound in the soil below the foundation due to time dependent effects. The overall shape of the array appears similar and vertically offset, so tilting of the array reference end appears less likely. Additionally, the readings from the reference end to about node 25 are similar and they appear to be further apart for the portions of the array that are directly under the stem. The error is on the order of the sensitivity of the array, so it is not judged to be problematic or significant with respect to the overall findings.

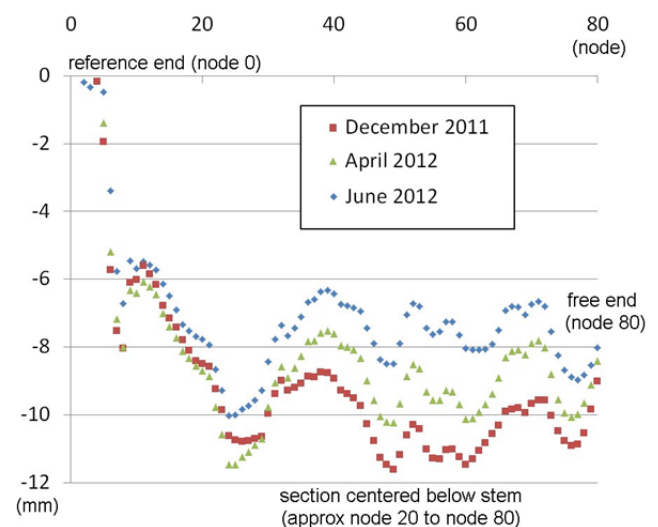
Fig. 14. Movement of all ShapedAccelArray (SAA) nodes with time. Much of the deformation occurred when backfill loads were initially placed, although there were also some subtle changes over time.
