International Conference on Case Histories in Geotechnical Engineering (2008) - Sixth International Conference on Case Histories in Geotechnical Engineering

## Support of Rock Cuts at Washington-Dulles International Airport

## **SUPPORT OF ROCK CUTS AT WASHINGTON-DULLES INTERNATIONAL AIRPORT**

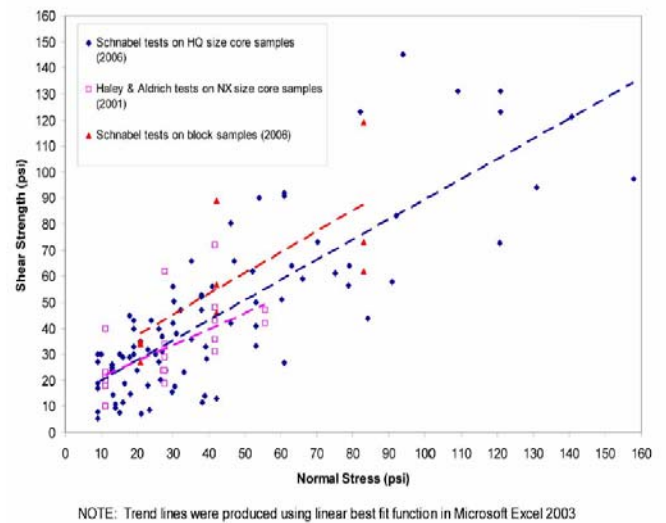
Figure 4: Summary of bedding plane and joint sample shear strengths measured in direct shear tests on HQ and NQ core and block samples. All samples tested exhibited a discrete open bedding plane

A summary of the results for the direct shear results is given in Figure 4. The test results were consistent and suggest an average internal friction angle of approximately  $30^\circ$  and a cohesion intercept that varied from 9.8 to 18.1 psi (68 to 125 kPa) with a mean of 13.9 psi (96 kPa). Although the cohesive strength is not present in open fractures, some cohesion contribution can be considered due to the non-persistence of the discontinuities. The direct shear tests on these open bedding planes showed that there was little difference between the peak and residual (post-peak) strength for most of the samples tested. Hence, if the excavation-induced displacements remained small and blasting procedures were well controlled, the cohesion indicated by the laboratory tests could be preserved near the rock face.

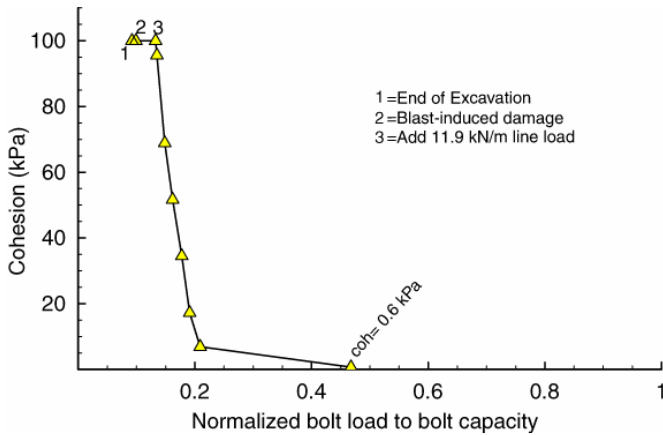
Figure 10: The reduction in cohesion along the bedding planes and the corresponding load increase in the anchor bolts from the numerical analyses.

Figure 10 shows the reduction in cohesion at each stage in the numerical analysis versus the anchor load normalized to the anchor capacity. At the end of construction, and assuming limited blast induced damage occurs, no instability is observed along any of the joints or bedding planes. The Triassic red beds encountered at the Dulles Airport site are known to deteriorate when exposed to the natural elements. Therefore, the rock cuts were covered with shotcrete to minimize the potential for deterioration. Because of this weathering sensitivity and the potential for a loss in cohesion during and after excavation the cohesion was gradually reduced to assess the impact on anchor loads. As the cohesion is reduced there is only minor increase in the anchor load until about 1.2 psi (8 kPa, Figure 10). However, even with 0.1 psi (0.6 kPa) cohesion, the anchor loads are still well below the anchor capacity. Reducing the cohesion to zero results in complete failure along the deepest daylighting bedding plane (see Figure 9).

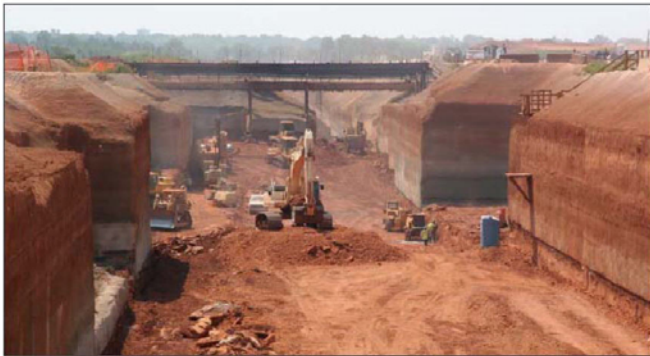
Figure 11: Typical rock cuts at Dulles Airport site (Tier 3 Excavation, photo from McQuinn et al 2006)

Today there have been several thousand lineal feet of rock cuts at the Dulles Airport site, varying in height from 16 to 65 ft (5 to 20 m.) All of the cuts in rock have been vertical and excavated using either blasting, saw-cutting, or roadheader techniques (Figure 11). In excavations adjacent to buildings and equipment blasting is very carefully controlled.

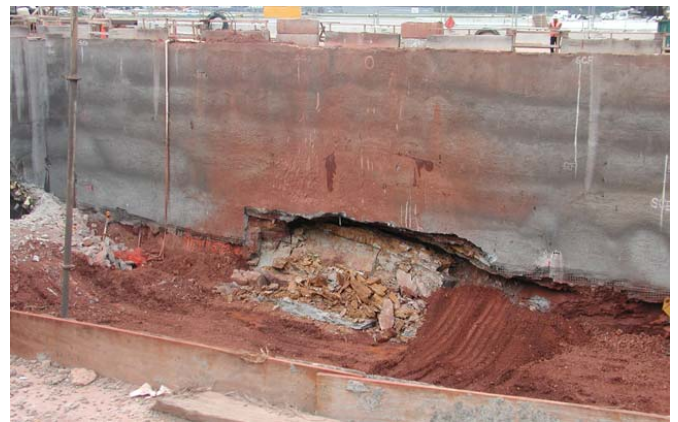
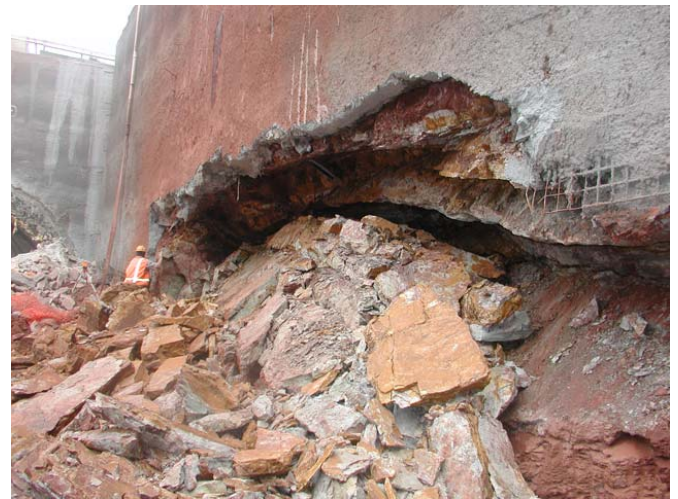
Figure 12: Localized failure along a bedding plane when a double-height bench was excavated.

In one excavation, a double bench height was taken and this extra bench height resulted in localized failure along a bedding plane (Figure 12). Inspection of the failure suggested that the instability was bounded by the bedding planes and the sub-vertical joint planes, similar to the mechanism shown in Figure 5. Periodically, smaller (<3yd<sup>3</sup> or 4m<sup>3</sup>) wedge falls have formed, but these have typically formed near horizontal and vertical corner excavations where confining stresses have been reduced.

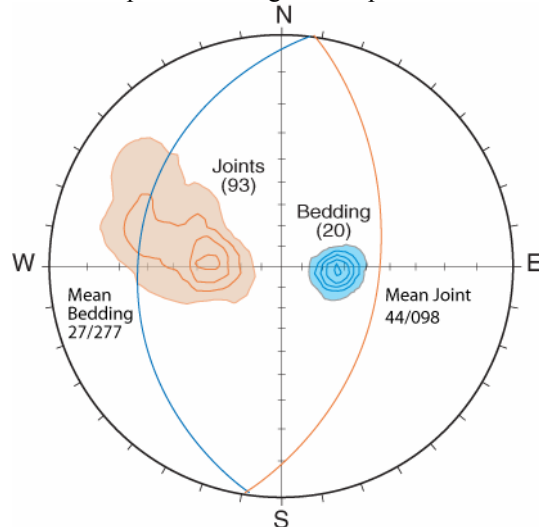
Figure 14: Lower hemisphere stereonet of the field mapping of the rock cut giving the large scale dip of the bedding and the joints.

scale bedding planes infilled with clay, particularly in the upper part of the rock mass below the weathered zone. Figure 14 gives the results from detailed field mapping of several rock cuts and confirms the results from the original site investigation (see Figure 3). In addition block diameter samples of the bedding planes were collected and tested in direct shear as discussed above. These results were also within the previous design assumptions.
