Use of Geofabrics for Controlling Landslides – Case Histories

USE OF GEOFABRICS FOR CONTROLLING LANDSLIDES - CASE HISTORIES

Paper No. 2.17

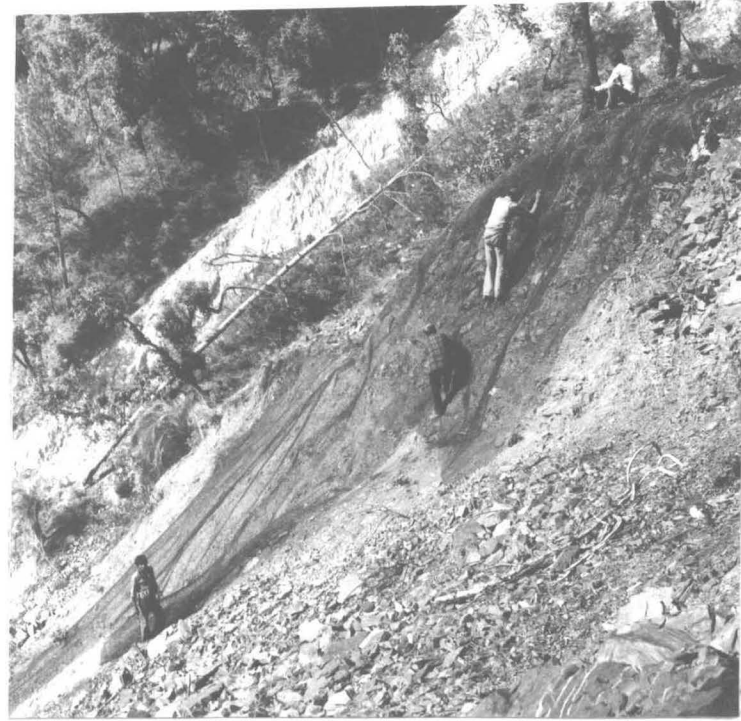
Fig.1 Fixing of the synthetic geogrid for rock fall control.

biologically inert. Several numbers of geogrid rolls were stitched together to cover the entire rock fall prone surface. The upper end of each roll of synthetic geogrid was fixed by (i) surficial bolting technique and (ii) trench bolting technique.

In the surficial bolting technique, four holes of 15cm to 20cm dia extending to a depth of about 80 cm were dug on a long flat bench having 1.5m width constructed slightly beyond the periphery of the crown. Four bolts of 1cm dia and 90cm length with one end threaded and exposed to the surface for a distance of 5cm above the ground and other end bent in the form of "L" inserted in the holes were fixed by lean concrete. A pair of drilled iron flats in the form of brackets holding the synthetic geogrid mesh by nuts and bolts were then fixed with these four bolts on the bench. In the other procedure of trench bolting technique, holes of 20 cm dia and 90cm depth at an interval of 2m were dug at the base of a long trench having 0.5m width and 0.5m depth for fixing bolts in the similar manner as explained earlier. Afterwards with these bolts the synthetic geogrid mantle which was held by a number of small pairs of drilled iron flats (each of which is 50cm long) by nuts and bolts arrangements was fixed at the base of the trench. The trench was then refilled with

boulders and soil as such to achieve the original slope profile. After fixing the upper end of synthetic geogrid mantle, the remaining portion of the mantle including the other free end was rolled down over the rock fall prone slope. The lower edge of the mesh was then fixed within the slope either by directly driving "T" shaped iron rods into the rock or by making cement concrete bolting arrangement. To maintain a firm contact of the geogrid with the rock slope surface, several number of "T" shaped rods were also driven into the rock slope face at several locations as seen Fig. 1.

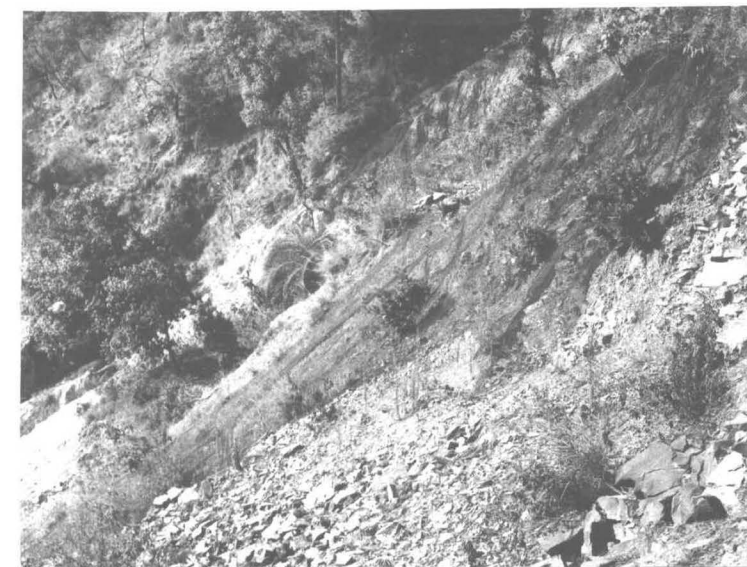
Observation made for three years revealed that this methodology is very effective and useful for not only controlling rock fall activity but also it helps for promoting natural growth of vegetation which improves stability of the affected hill slope area as seen in Fig.2.

Fig.2. Panoramic view of the treated area.

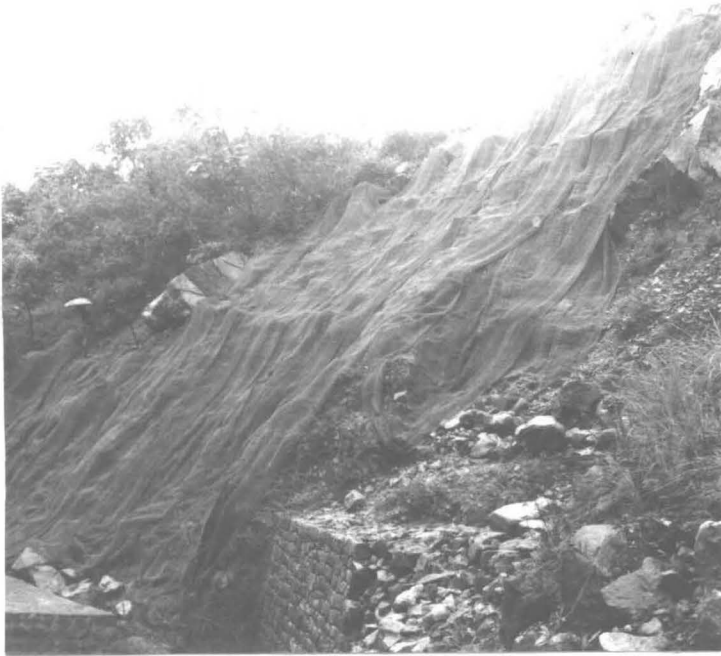
prepared by stitching several number of rolls together were fixed into the trench by inserting wooden pegs or "U" shaped iron nails. The trench was then refilled with soil so that it resembled the existing slope profile. To keep a firm contact of the coir net mantle with the treated hill slope area several number of wooden pegs or nails were driven in to the slope, Fig.4.

Fig.4. Slope treatment with coir netting.

Post observation and monitoring of the treated area showed very good effective results which was evidenced by good growth of vegetation and no further incidence of slope failures.
