## Lessons Learned from a Full-Scale Dyke Failure Test

## LESSONS LEARNED FROM A FULL-SCALE DYKE FAILURE TEST

A full-scale failure test has been performed on an old river dyke in the Netherlands, to determine its actual strength against failure due to the uplift mechanism and to validate the Van model for the stability analysis of dykes prone to uplift induced failure. The test has been a success and clearly showed the relevance and significance of the uplift mechanism. In combination with earlier verifications, the Van model was found to be suitable, which has already led to significant reductions on dyke reinforcement projects. The large gap between the actual strength and the calculated strength was confirmed. This gap appeared to be partly necessary because of the large variation in the results of dyke stability analyses by different geotechnical consultants. For the near future, the test may serve as an important benchmark for the development of a more rationally based safety philosophy.

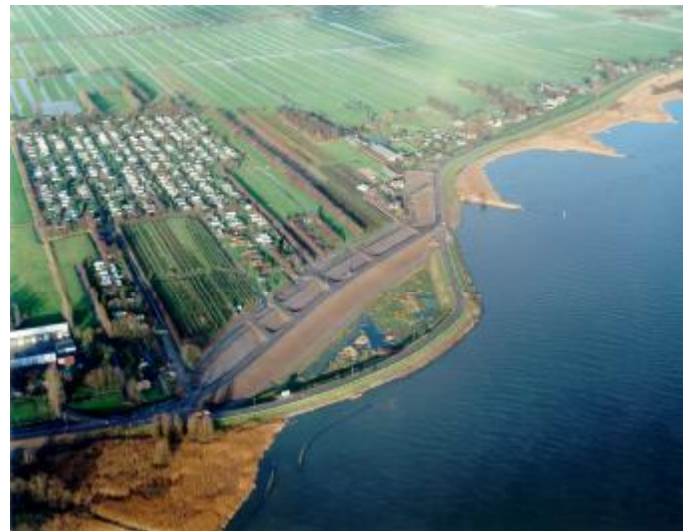
*Fig. 1. Test site at Bergambacht.*

Normally, it is impossible to perform failure tests on real dykes, due to the large risks involved. A few years ago however, the unique possibility to perform a failure test on a real dyke arose at a location along the river Lek, at about 30 kilometres east of Rotterdam, near the village of Bergambacht. Due to local widening of the river bed, in order to decrease the water level during extremely high water (by 7 millimetres) a new dyke was built behind the existing dyke, as shown in Fig. 1.

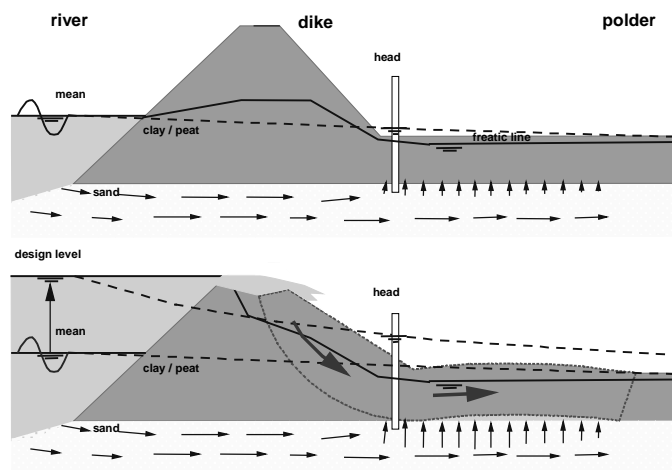
The uplift failure mechanism, which is a special case of a slope stability problem, is primarily caused by the loss of shear strength at the bottom of the soft layers underneath and behind the dyke, as a result of high pore pressures in the underlying sand layer. The effective contact stresses at the interface between both layers eventually decreases to zero,

Fig. 2. Uplift induced dyke failure.

giving rise to uplift of the soft layers and sliding, as indicated in Fig. 2. This mechanism mainly occurs in tidal river basins.

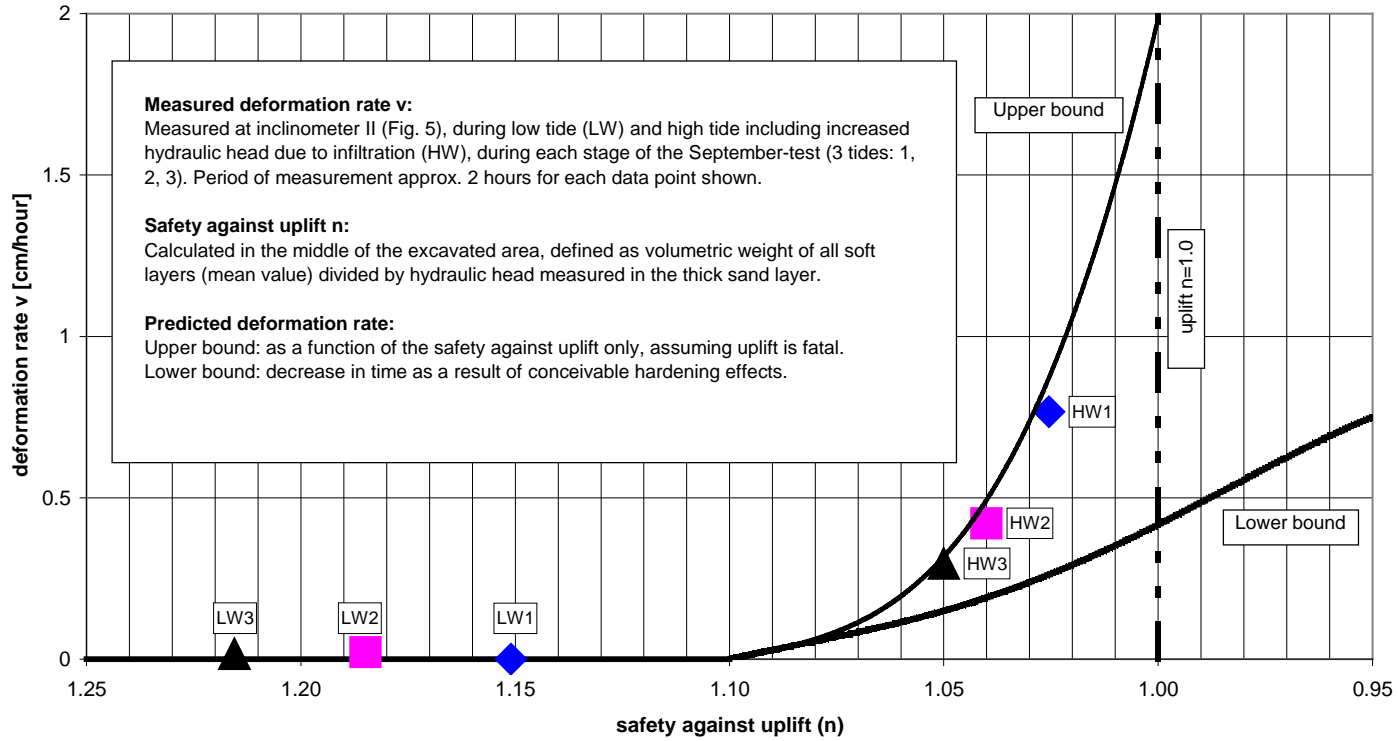
Fig. 6. Deformation rate against uplift safety, as measured in September.

In Fig. 6 the deformation rate below the toe of the old dyke during the various stages of this test is shown against the safety against uplift in the centre of the excavated area, indicating that the deformation rate strongly depends on the safety against uplift.

During the first two days of the test, with an achieved safety against uplift between 1.01 and 1.10, the deformations were comparable to those in September, cf. Fig. 6. In this period already three infiltration wells failed, probably as a result of the deformations which had already started.

Because of the rather sudden collapse of the tested dyke, the hope that an early warning system can be based on monitoring the deformations of dykes has proved to be idle. A more positive outcome of this test is the observation that uplift does not necessarily lead to failure: the dyke only collapsed when the safety against uplift as defined in Fig. 6 was significantly below 1.0.

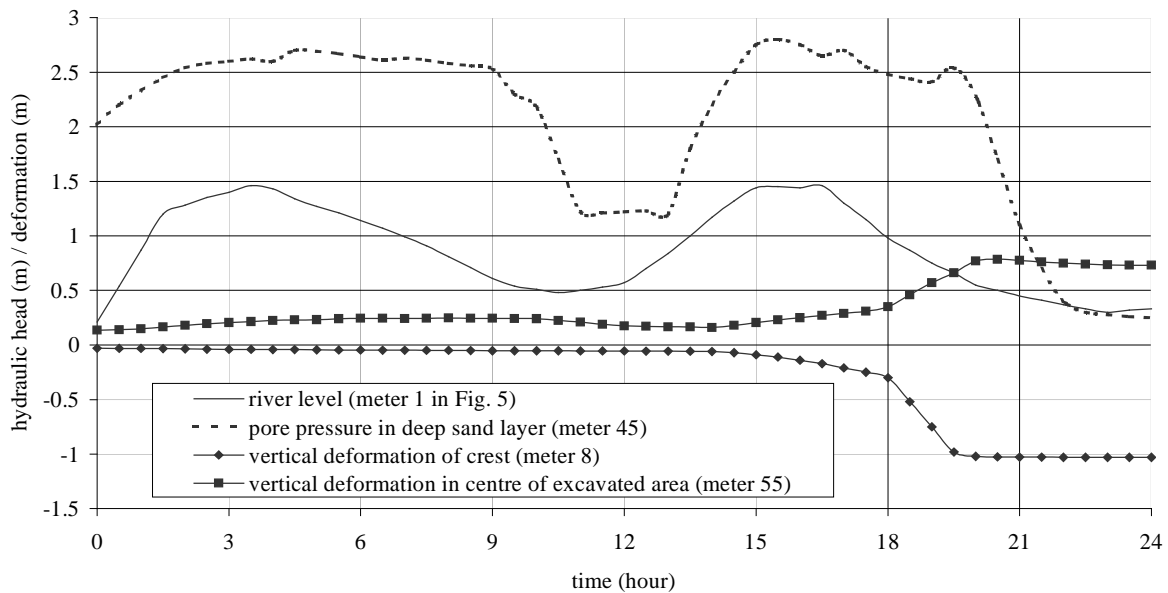
Fig. 7. Main measurements during day of dyke collapse.

In the afternoon of the third day, around half past three the maximum hydraulic head underneath the old dyke and the excavated area was reached, with a calculated safety against uplift of about 0.95. At this point the deformation rate increased strongly with a further increase after another few hours when the pore pressures were somewhat lower again. As shown in Fig. 7, deformations of the old dyke of over one metre occurred. The extent of the failure was much larger than expected: 110 metres instead of 50 metres only. As a result the image processing system failed, as the cameras stood within the area of the slide. Figure 8 shows the collapsed dyke. To the left in this picture the risen part of the excavated area is clearly visible.

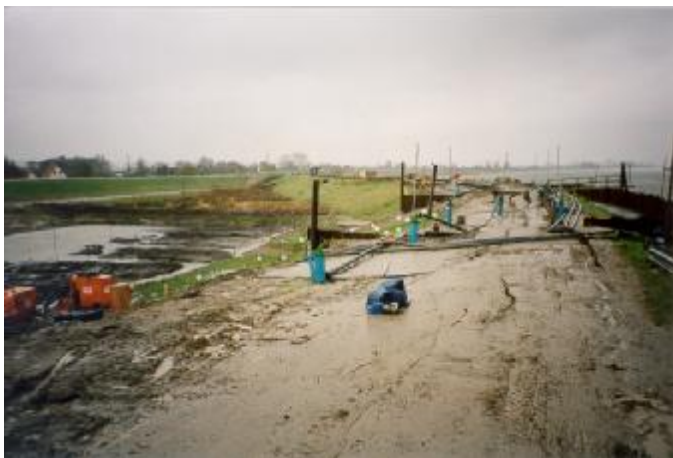
Fig. 8. Dyke failure due to uplift mechanism.

Regarding the width of the failure, it has been concluded that the remoulded shear strength near the sides of the sheet pile wall was too high to allow for a failure with a limited extent. Instead, a failure occurred with much larger side wedges and a less sharp transition between the collapsed and the undamaged part of the dyke. This has been confirmed by three-dimensional stability analyses made afterwards.
