International Conference on Case Histories in Geotechnical Engineering (2008) - Sixth International Conference on Case Histories in Geotechnical Engineering

Educating Students Through Understanding the Pathology of Geotechnical Projects

EDUCATING STUDENTS THROUGH UNDERSTANDING THE PATHOLOGY OF GEOTECHNICAL PROJECTS

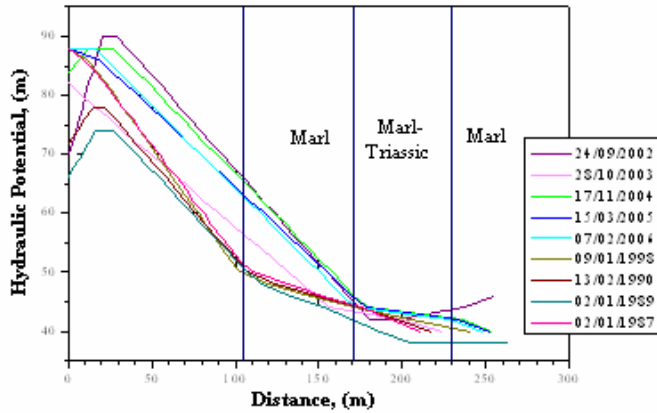
Fig. 3. Loss of water potential under the slabs of spillway

Numerical simulation showed up full saturation of the soil under the spillway, excepting a minor part at downstream side. Consequently, water flow is up charged and leads to uplift pressure to be thoroughly quantified. The predicted outflow debit is of about 0.001 m³/day. Hence, if lateral flow under the spillway is not taken into account the difference in hydraulic potential is fully transmitted to the slabs of spillway in term of destabilizing uplift pressures which lead to significant destabilising upward force.

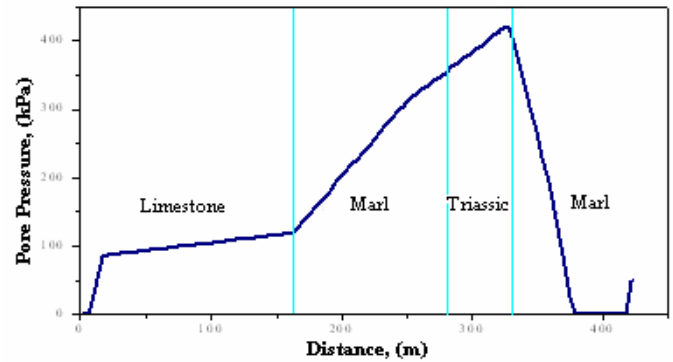
The pore pressure variation as a function of distance between piezometers is given in Figure 4. Note that water pressure increases up to maximum value of 423 kPa within Triassic zone (Bel Hadj Ali and Louati, 2007). Maximum values of pore pressure are predicted at the interface marl - Triassic where disorders between slabs 44 and 46 are localized. Hence, the numerical simulation confirmed pore pressure as one of the main causes of disorders.

Fig. 4. Pore pressure variations along the spillway

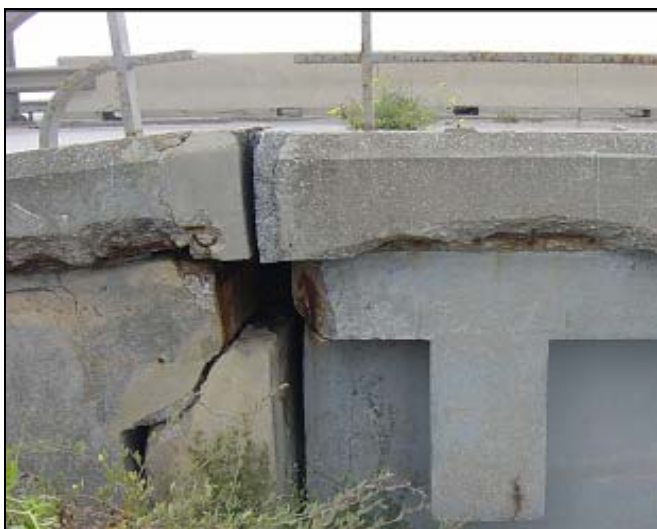
From visual observations on the access ramps of all structures, settlement is apparently the main cause of disorders and caused damages as illustrated by photo 3 and 4. As a matter of fact, very significant settlements were recorded respectively of about 50 cm for PK 0+200 structure and about 40 cm for PK 0+600 structure.

Rotation of access slabs is due to differential settlements between embankment of access resting on high compressible soil and abutments founded on deep end-bearing piles foundation. The same pathology was detected between adjacent piers from which resulted concrete surface bursting favoured by steel corrosion.

Photo 3. Rotation of approach slabs followed by structure damages.

To stop the evolution of disorders due essentially to continuous settlement of primary consolidation it revealed necessary the design of soil improvement (reinforcement) techniques aimed at substantial settlement reduction or acceleration of remaining consolidation. Then, two solutions were studied. First is the installation of rigid inclusions by means of metallic or concrete piles manufactured on site. Second are sands columns which play the role of vertical drains associated with light weight embankment material (unit weight equals 8 kN/m^3). The ground surface of improved soil is covered by a spreading mattress made up of drained sand to complete the outward drainage process from sand columns. This technique was finally approved because of moderate cost compared to rigid inclusions solution, (Bouassida et al, 2004).

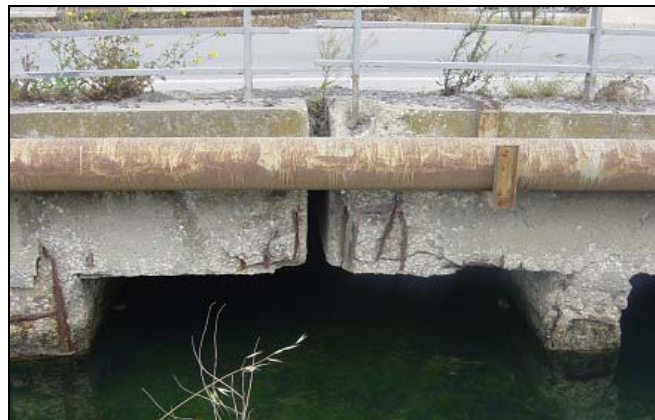
Photo 4. Rotation of piers

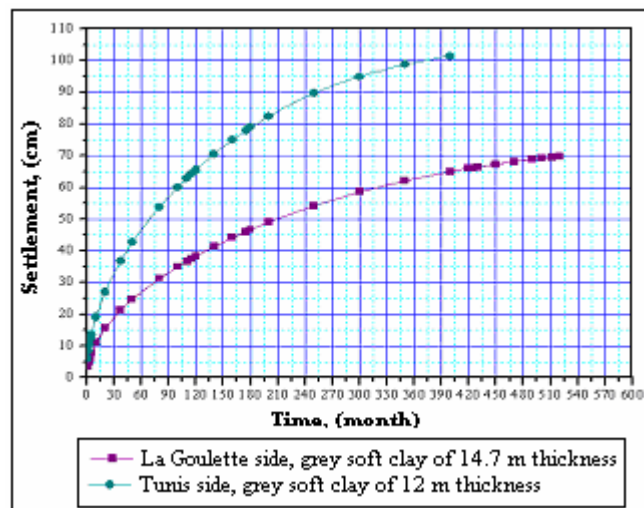
The predicted differential settlement, s_d , well explained the disorders observed on access ramps. Other useful information was the prediction of remaining settlement of consolidation under each foundation element and the corresponding time evaluated by equivalent coefficient of consolidation of compressible layers (figure 10).

Fig.10. Settlement evolution in time: Structure KP8 + 170
