## Some Aspects on the Faiyum-Egypt Earthquake of October 12, 1992

**SYNOPSIS:** A moderate size earthquake shooked the southern west part of Cairo by 35km at 15:15 P.M. local time on October 12, 1992 causing wide spread devastation leading to loss of many lives and structure damages along the surrounding big cities. The paper describes the behavior of two identical residential buildings constructed on two different site soil conditions. The lesson learnt from the performance differences are highlighted, and some geotechnical and structural aspectes are recorded.

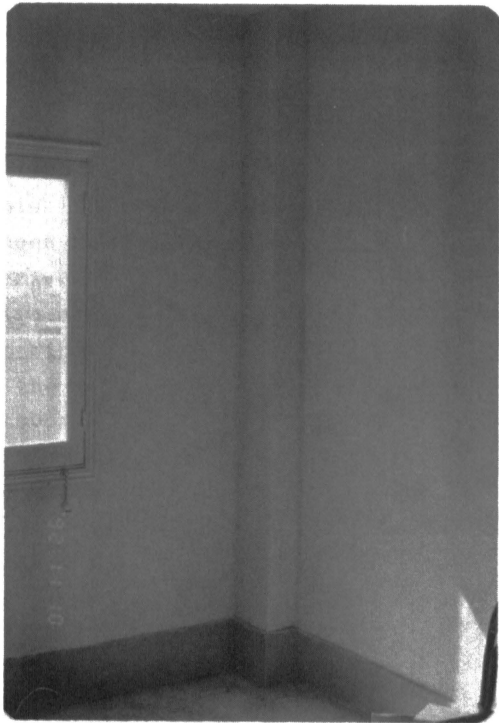
Photo 3 Same Column of Photo 2 in the Western Site Building

with that of soft soil site. Photo 2 and 3

2. There were horizontal and diagonal cracks are clearly observed on the internal and external walls of firm soil site as shown by photo 4.
3. The common type of failure in the element of soft soil site is light cracking between walls and concrete elements.
