Geotechnical Challenges in Highway Engineering in Twenty First Century: Lessons from the Past Experiences and New Technologies

GEOTECHNICAL CHALLENGES IN HIGHWAY ENGINEERING IN TWENTY FIRST CENTURY: LESSONS FROM THE PAST EXPERIENCES AND NEW TECHNOLOGIES

Abdul Aziz Khandker, Ph.D., P.E. Adjunct Professor, Civil Engineering Wayne State University Detroit, Michigan, USA Vice President, Haengel & Associates Engineering, Canton, Michigan, USA Jeffrey T. Anagnostou, P.E., CPG Principal Engineer and President, Applied Geotechnical Services, Inc. Livonia, Michigan, USA Purushottam Deo, (PD), Ph.D., P.E. Consulting Engineer Principal Emeritus CTI & Associates, Inc. Wixom, MI, USA Adjunct Professor, Civil & Environmental Engineering University of Detroit Mercy Detroit, MI, USA

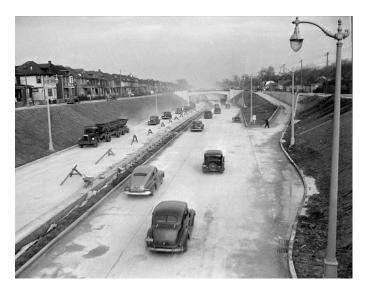
Fig. 1 Davison Highway, Detroit, Michigan - 1946

Figure 1 shows the Davison Highway in Detroit, Michigan, the first depressed highway built in the United States of America. Figure 2 shows a seven level urban highway interchange in California, USA.

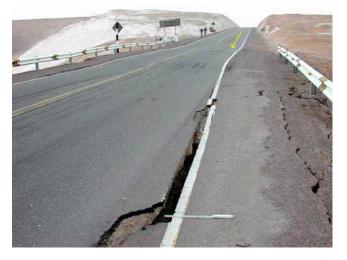
Figure 4 Pan American Highway Bridge Abutment Damage in Moquegua, Peru After 2001 Earthquake

Figure 4 is another example of damage during seismic event showing the Pan American Highway Bridge Abutment Damage in Moquegua, Peru after 2011 Earthquake. The yellow arrow in the picture shows the start of the abutment.

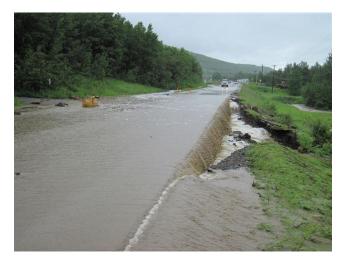
Fig. 7 Flooded Highway 97, Pinepass- Chetwynd - USA

As a recent example of flood damage after severe storm event in 2011, Figure 7 shows the flooded Highway 97 from Pinepass to Chetwynd and Figure 8 shows the damage of a section of the same highway.

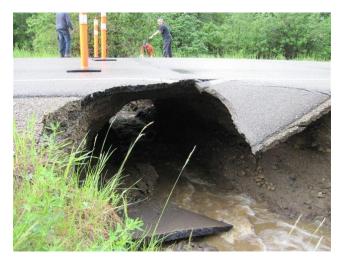
Fig. 8 Highway 97, Pinepass- Chetwynd – USA Flood Damage

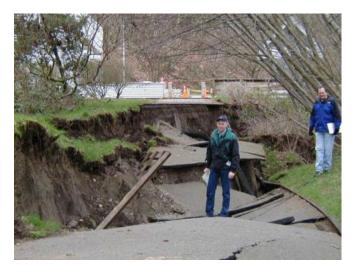
Fig. 9 Landslide Damage – Capitol Lake, Olympia after 2011 Nisqually Earthquake in Washington

The example presented in Figure 9 shows Landslide damage at Capitol Lake, Olympia during 2011 Nesqually Earthquake in Washington, while Figure 10 shows the Road Damage due to the same seismic event.

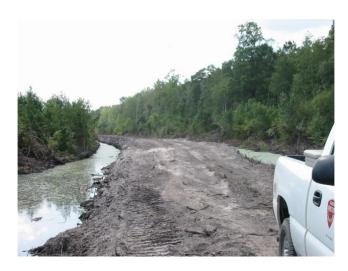
Figure 15 above shows the collapsed section of Santa Monica Freeway (I-10) in Los Angeles, California and Figure 16 shows a one mile long road under construction in Mississippi.

Fig. 16 Mile long road under construction through wetland
