International Conference on Case Histories in
Geotechnical Engineering

Landslides in Rock Slopes During January 19, 1975, Kinnaur Earthquake in Himachal Pradesh, India

Landslides in Rock Slopes during January 19, 1975, Kinnaur Earthquake in Himachal Pradesh, India

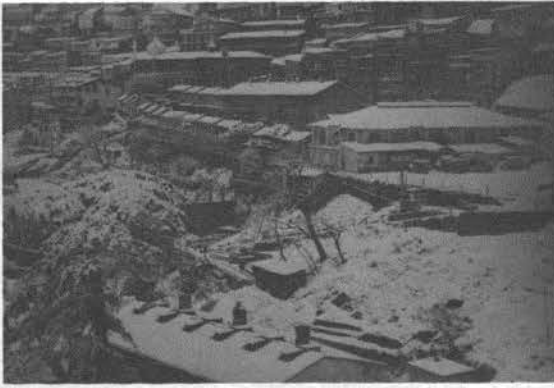
Fig. 4. Buildings constructed on stable ground in Kinnaur.

(Fig. 3 and 4). Extensive fissures were developed in the frozen ground in glacial moraines overlying bed rock. Figure 5 show fissures passing through Kaurik village which was completely destroyed, and individual fissures extended to 50 ft to 100 ft (15-30m) in length trending N 335° to N 35° (Fig. 6). Width of openings varied from fraction of an inch to several feet (few cms to a metre) with down throw towards west. A fracture zone with opening of 4 to 6 in (10-15 cm) with individual en echelon fractures could be traced over 1100 yards (1 km) extending from the edge of the terrace south of Kaurik village, towards hill slopes north of the village. Fissures in the ground transverse to the ridge covered with frozen glacial moraines with openings from a fraction of an inch to 6 in (15 cm) developed between Sumdoh and Kaurik with their general trend along N 25°.

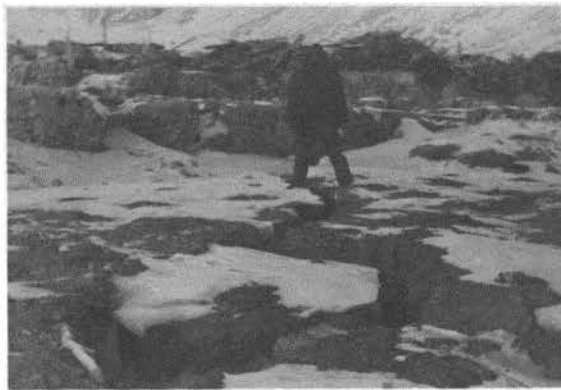
Fig. 5. Ground fissures which cut across Kaurik village.

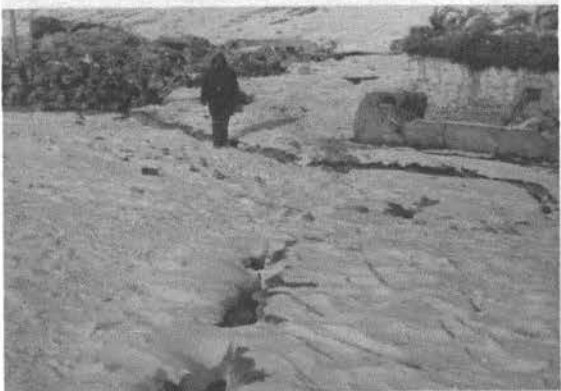
Fig. 6. En echelon ground fissures (partly covered by subsequent snowfall) near Kaurik village.

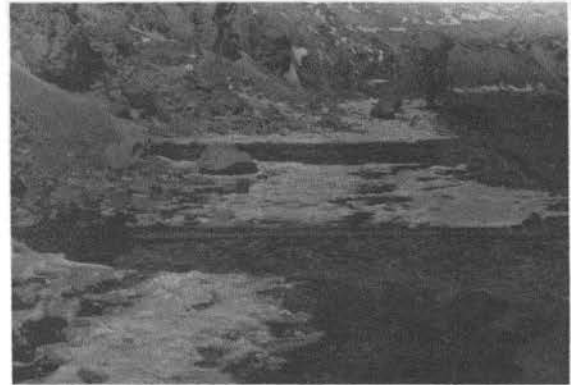
Fig. 7. Step faults across road between Sumdoh and Kaurik.

Figure 7 show step faults across India-Tibet road between Sumdoh and Kaurik with fractures trending along N 350° and continuing towards hill side, with openings upto 2 ft (60 cm) width and extending to depths of 10 to 20ft (3 to 6m). At Sumdoh fissures overlapping each other were observed on top of river terrace with openings upto 2 in (5cm) in width extending over 55 yards (50m) length in N 40° to N 60° directions. Carbonaceous shales on left bank of spiti river near Shalkar developed fractures along preexisting north - south trending vertical joints. Similar vertical to steeply dipping fractures trending N 35° to N 5° were observed in lacustrine clay deposits with opening upto 6 in (15 cm) in width, and tabular slabs of clay were dislodged from vertical cliff transverse to such fractures. Similar fractures trending N-S, were observed in limestones at a distance of 2.5 miles (4km) from Shalkar.

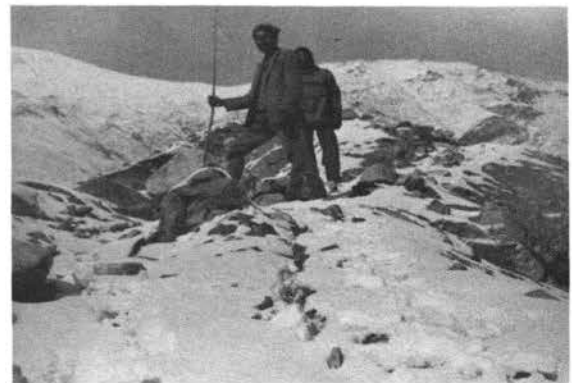
Fig. 12. Dislodging and overturning of boulders at the top of the ridge near Leo.

Overturning and sliding of boulders and rock blocks at the top of ridges (Fig. 12) and steep slopes took place by development of tension cracks. Seismic stress waves incident at the frozen ground surface on reflection as tensional stress wave shriveled and blighted the frozen ground and rockmass. The resulting scabbing and slabbing of rock mass along joints, partings and other weak planes caused loosening, dilation and crumbling of hill sides, often with deafening sounds in heap of debris. The reflected tensile stress wave caused separation along discontinuity surfaces filled with frozen ice and weathered material, frozen-glacial maraines and fluvio glacial deposits forming flat terraces and mounds along the river valleys developed similar tension fractures resulting in dislodging, overturning and heaving up of large boulders (Fig. 13) and chunks of rock mass. Boulders at hill tops were reported to toss up and down. Fragments from steep rock slopes on rupture flew off with seismic (P-wave) velocity and hit telegraph poles (fig. 14), trees and roof tops and some of the flying fragments pierced through telegraph poles. Large dislodged boulders and chunks of rock at many places fell on road (Fig. 15) disrupting and damaging hillside and roadside houses (fig. 16).

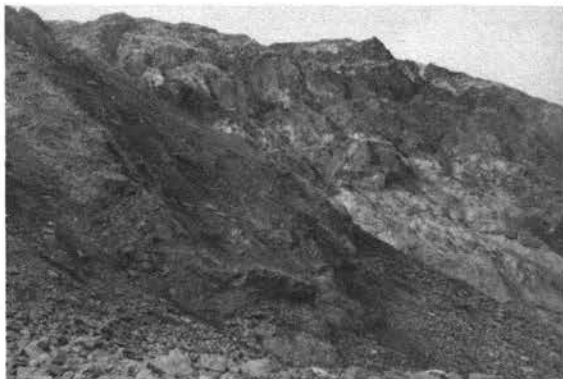
Fig. 10. Sliding of rock wedge in carbonaceous shales on India-Tibet road between Shalkar and Sumdoh.

letely destroyed. Flat topped hill slopes in glacial moraines developed extensive cracks, indicating initiation of failure of slope towards the valleys. Similar fissures were observed parallel to road pavement on glacial moraines with wide openings upto 20m (50cm) in width. Loosening of rock mass along preexisting joints and fissures was noted on hill slopes. Figure 9 shows separation of rock mass along pre-existing discontinuity surfaces (bedding and joints) and sliding of a rock wedge in carbonaceous shales with rock debris fall at its bottom on India-Tibet road between Shalkar and Sumdoh. However such failure were of small size and very few in number and in general insitu rock mass remained stable during the earthquake. Widening of relief joints was observed in cuttings transverse to hill slopes. Figure 10 shows loosening of rock mass and widening of openings during the earthquake along relief joints in hill slope cutting near Kah between Khab and Mallang. Loosening and readjustment of rocks resulted in changing the seepage outlets in some of the surface springs in the area. Figure 11 shows the outlet of a spring in limestone near Shalkar village, which ceased to flow due to readjustment along joints. This spring has emerged due to opening of joints at a lower elevation after the earthquake.

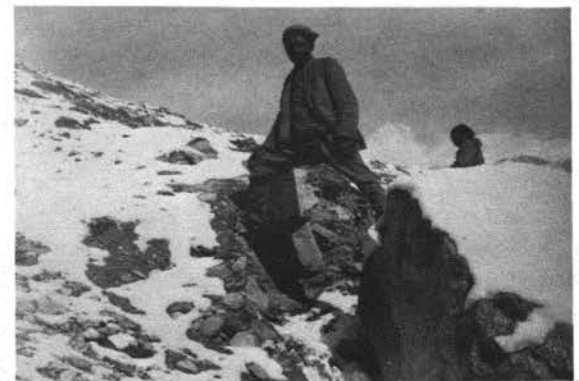
Fig. 13. Overturning and heaving up of large boulders at the crest of hill slope near Leo.

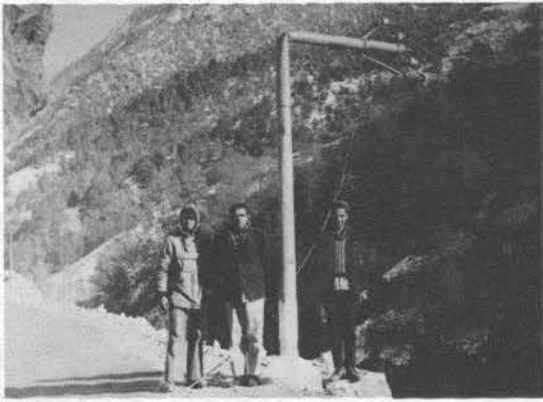
Fig. 14. Bending of telegraph pole resulting from impact of flying rock fragments.

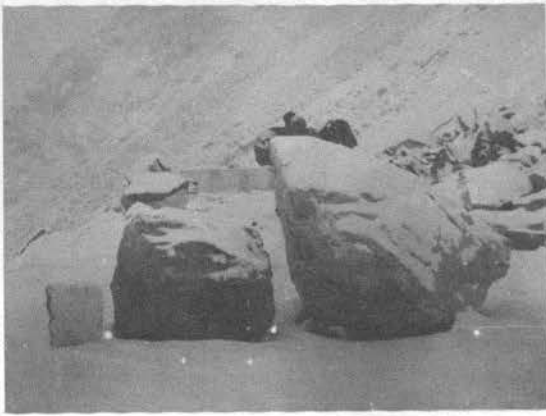
Fig. 15. Large boulder fallen on road pavement between Mallang and Chango. Landslide in the back ground has obliterated the road.

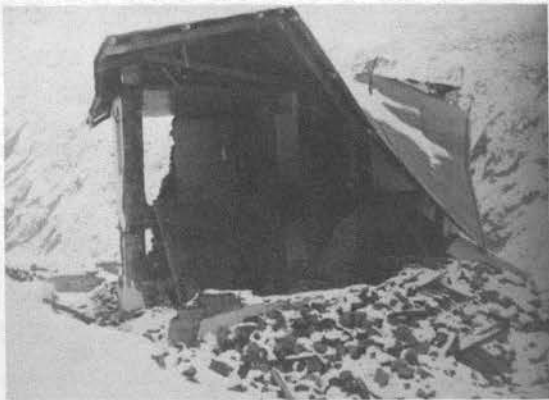
Fig. 16. Collapse of check post at Shalkar on India-Tibet road. Big boulder rolling down from hill slope caused collapse of the building.

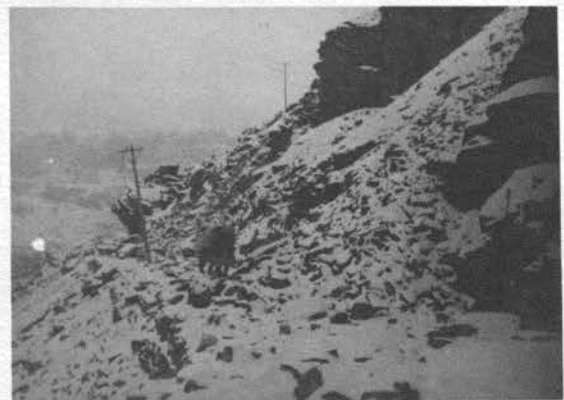
Fig. 17. Rock avalanche debris in quartzites along India-Tibet road between Chango and Shalkar.

and prismatic slabs of clay, carbonaceous shales, phyllites, quartzites, schists, gneisses, and unconsolidated materials, which cascaded along the hill slopes (fig. 17) obliterating the roads and other constructions lying on its way. Such surface runs and rock avalanches caused extensive damage to the India-Tibet road, which disrupted rescue and relief operations. There were catastrophic failures and landslides along a four kilometer stretch of the road on the right bank of Spiti river (fig. 18) and in some stretches the road was completely obliterated. Such slopes were composed of variety of thinly bedded carbonaceous shales with close spaced joining, quartzites, phyllitic schists, and granite gneisses. Fig. 19 shows landslide mass in thinly covered foliated phyllitic schists which entombed three ponies and a cow moving on the road which was completely destroyed.

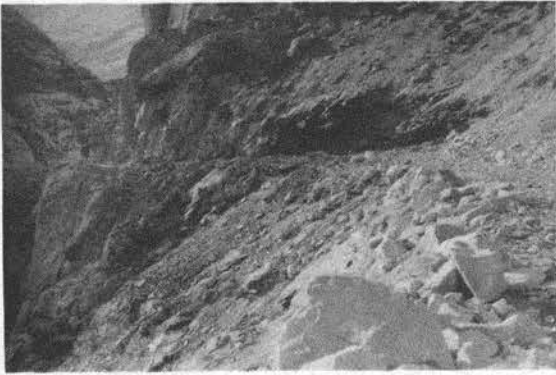
Fig. 18. Catastrophic failure of slopes along India-Tibet road in weathered and jointed granitic gneisses.

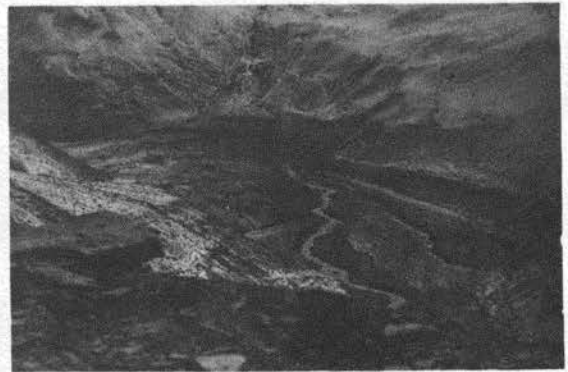
Fig. 21. The new path carved out by Parachu river on the left of its original course. Fissures are observed on the right hand side of the photograph.

Majority of catastrophic hill side failures were in steep rock slopes with surficial cover of scree material and loose fragmented aggregates, which in general had negligible soil and vegetal cover. Due to the dynamic amplification of ground motion at the hill tops, sliding, overturning and rolling of rock fragments initiated the slip at the higher elevations which gathered momentum in their descent hitting and dislodging other rock pieces and such bombardment gradually grew into a large mass hurling down slope with great speed forming huge rock debris in the valley base. Parachu valley was filled by such a debris from its right bank at a location between Sumdoh and Kaurik (fig. 20). The debris filled the valley upto a height of about 200 ft (60m) and blocked the flow of water creating a reservoir behind it. The debris dam of about 200 ft height and 500 ft (150m) in length was formed. The water started overflowing the debris in about six days and carved out a channel (fig. 21) shifting the course of Parachu by about 200 to 250ft (60-75m) from its original course towards its left bank within the flood plain of the valley. The newly created meander joined the original course of the river at a distance of about 1500ft (450m). Fissures forming linear scarps with up throw of 20-40m (50-100cm) were formed in the river bed (fig. 21).

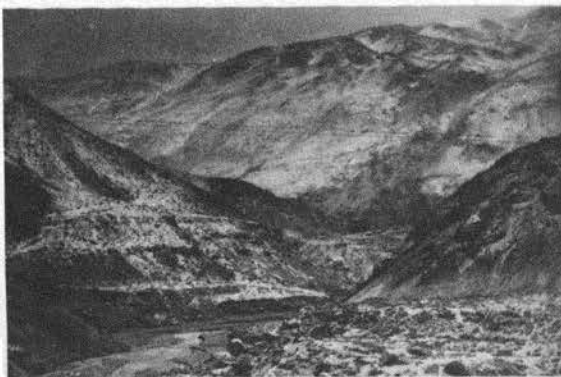
Fig. 20. Formation of debris dam across Parachu river between Sumdoh and Kaurik.
