International Conference on Case Histories in Geotechnical Engineering (2008) - Sixth International Conference on Case Histories in Geotechnical Engineering

Prevention, Mitigation and Engineering Response for Geohazard in Thailand

PREVENTION, MITIGATION AND ENGINEERING RESPONSE FOR GEOHAZARD IN THAILAND

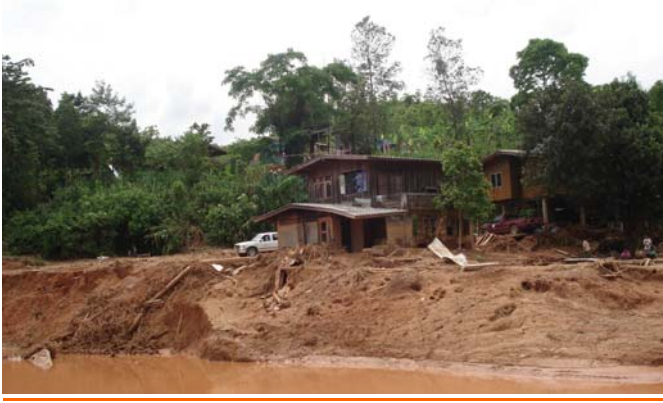
Fig. 5 A photograph showing piles of sediments washed down from the flash-flooding of the area. .

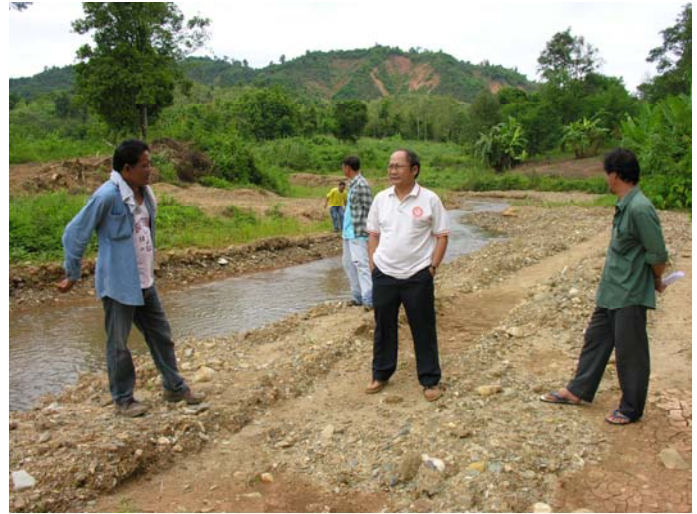
Fig. 6 A photograph showing a general view of the Ban Nam Ta area showing a stream and sediments (foreground) washed down from the land-slump area (hills at the background).

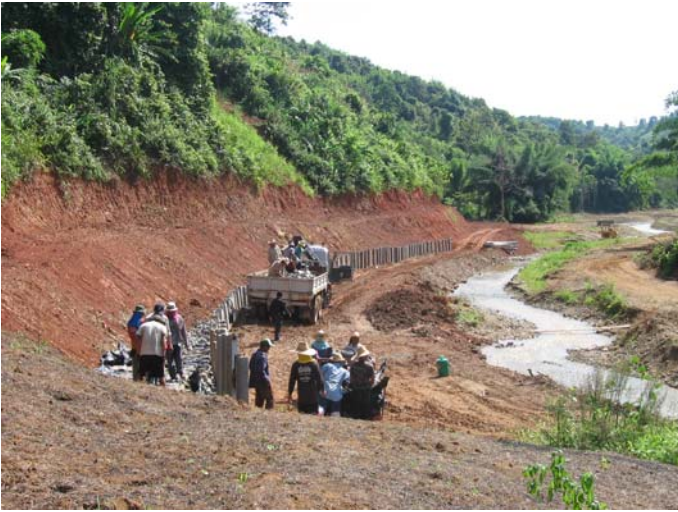
Fig. 8 A photograph showing the preparation of the reinforcement site at the base of the hill slope next to the stream channel.

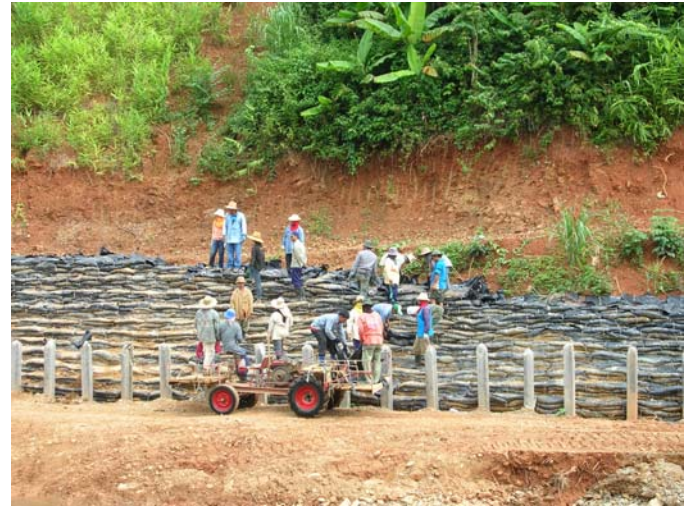
Fig. 9 A photograph showing the piling of soil bags as a part of the reinforcement of the slope at its base carried out by local people task force.

The prevention work includes the adding of enforcement fence along the base of the hill's slope, especially along the stream channels. This would prevent the lost of lives and properties of the local people whose houses are located along the streams. The works include: the enforcement of the base part of the hills through the use of I-shaped driven piles (Fig. 8), adjustment of the slope angles, making of the revetment slope, and the piling of soil bags along the hill's base for a distance of 200 m with the height of 5 m.
