International Conference on Case Histories in Geotechnical Engineering (2008) - Sixth International Conference on Case Histories in Geotechnical Engineering

## Heave Problem in Spread Footing in Jordanian Expansive Soil

## HEAVE PROBLEM IN SPREAD FOOTING IN JORDANIAN EXPANSIVE SOIL

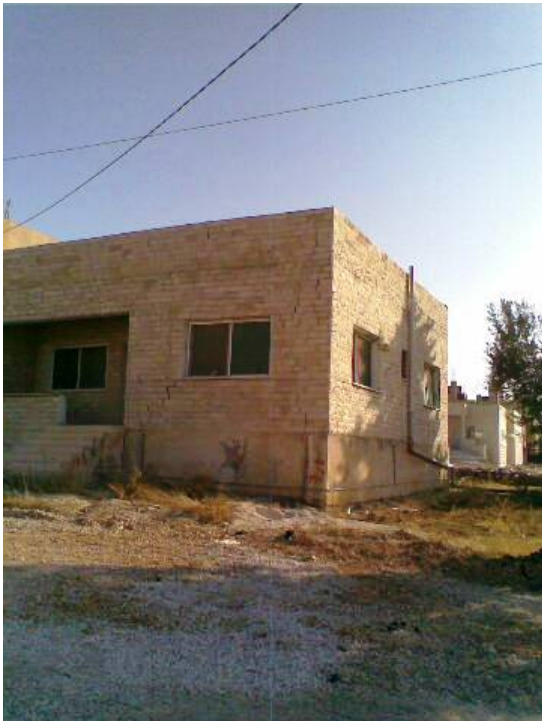
The owner first noticed hairline cracks in the building walls one year after the construction. The width of these cracks increased with time, and 7 years after construction the cracks in the external walls became noticeable. In 2003, the owner enforced to evacuate partially the house since the repair cost as estimated by civil engineer exceeds the original cost of the structure. Figure 3 shows the north and west face of the damaged portion of the structure. Only the northern face suffers from severe cracking while nothing noticeable on the west face. Figure 4 shows a closed view of the northern face. From this figure a diagonal and vertical cracks are shown from the top edge of the wall until the grade beam. Figure 5 shows a measured crack opening.

Fig: 3 Damaged Building: evacuated damaged portion

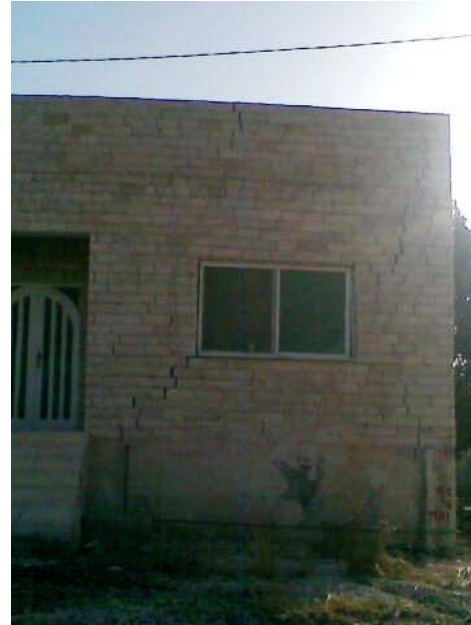
Fig: 4 Damaged Building: diagonal and vertical cracks

The expansive soil in the sites as states before is subject to long dry periods and periodic heavy rains of short duration. The dry periods tend to desiccate the soil, as is clearly appear through the deep surface crack present in the back yard of the building, thereafter, in the rainy season cause large amounts of swelling in the top soil layer. In the dry season the water vapor immigrates from water table and entrapped underneath building. If it condenses it leads the soil to swell whilst the soil in the perimeter of the building shrinks due to the presence of large olive and pine trees. The swelling of inner soil zone and the shrink of soil in the perimeter of the building leads to a differential settlement which causes the cracks as shown in Fig. 4 and Fig. 5.
