Chacao Channel Bridge – the Design Challenges

CHACAO CHANNEL BRIDGE – THE DESIGN CHALLENGES

The Chacao Channel bridge, a planned privatized/concession bridge project, is to link the island of Chiloé with continental Chile through the Chacao Channel. When completed, it will be the longest suspension bridge in South America (2,365 m) with two approximately equal spans linking three pylons. The location of the bridge presents a combination of unprecedented challenges in the design and construction making it very unique, including: extreme seismicity with the largest earthquake recorded to date anywhere in the world having occurred very close to the envisioned bridge location (the 1960 Valdivia Earthquake with a moment magnitude of 9.5!); extremely strong sea currents and tide fluctuations within the channel (up to 5-6 meters/sec and 6 meters, respectively); the general area being surrounded by active volcanoes; and a history of Tsunamis. The above extreme challenges resulted in construction cost escalations; inevitably, in 2006, after a significant portion of the investigations and design was completed, the Chilean ministry of Public Works put the project on hold. The above extreme

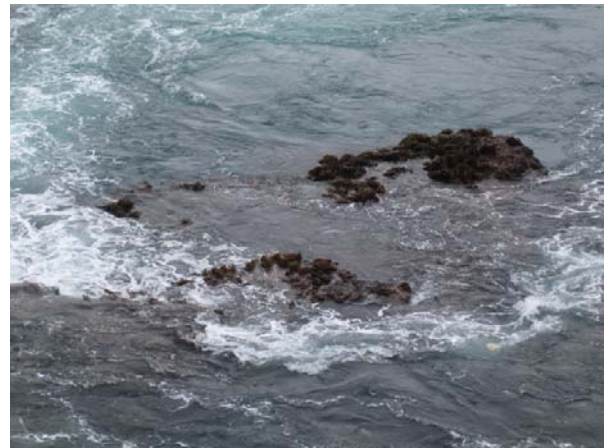
Fig. 3. Top of Roca Remolinos. Picture taken from a boat during low tide.

This very long span would drive the cost too high for the bridge to be built. However, roughly in the middle of the channel there is a submerged islet (called Roca Remolinos, see Figure 3) that could potentially be used to support a third pylon and cut the span in half. The biggest concern from the beginning of this project was if Roca Remolinos was strong enough to support a bridge pylon. Geotechnical investigations and several studies provided a design where the bridge with three pylons could be constructed.

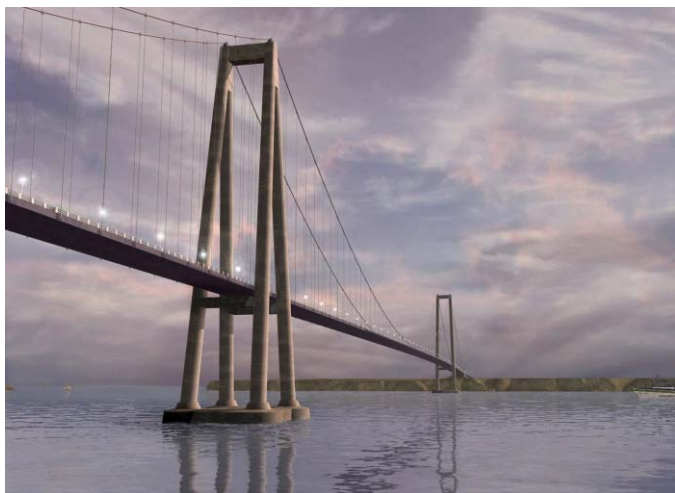
Fig. 5. Rendering of Final Bridge Concept (Ingenieria Cuatro/Cowi, 2001)

The bridge scheme is a suspension bridge, with two main spans supported by three Pylons (North, Central and South) and having a continuous deck. The North (Continent) and South (Island of Chiloe) Pylons are to have a distance of about 1050 m and 1100 m from the Central Pylon. The three Pylons will rise about 180 m above the mean sea level (Figure 4 and 5). The positioning of the central pylon has to be in the middle to provide the symmetry necessary for the design (equal spans), and symmetry is what drove the positioning of the North Pylon in the water. If Roca Remolinos was closer to either shore a different scheme would be needed.

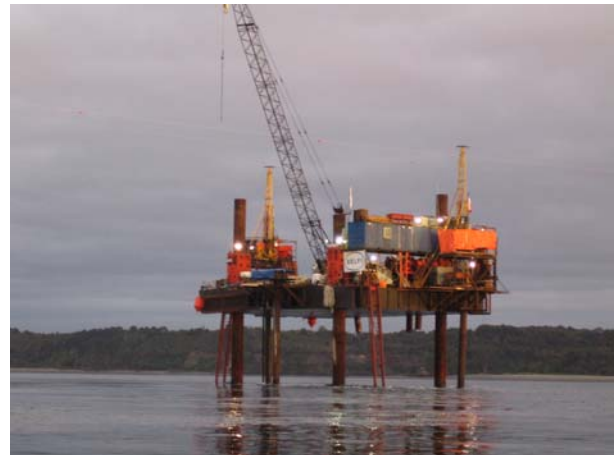
Fig. 7. Jack-up Platform on top of Roca Remolinos

The borings were drilled using state-of-the-art drilling equipment from a jack-up platform (Figure 7). Two different core barrels were used, the NQ 3 (required for the pressuremeter tests), and the GEBOR S with an inner diameter of 101 mm. The GEBOR S was chosen for increased core recovery to identify the different soil layers. This larger diameter of sampling, together with the use of a jack-up platform were the two critical improved factors over the preliminary investigation, and proved that the soil cementation in Roca Remolinos is generally higher, and consistently so, than presented in the preliminary investigation.

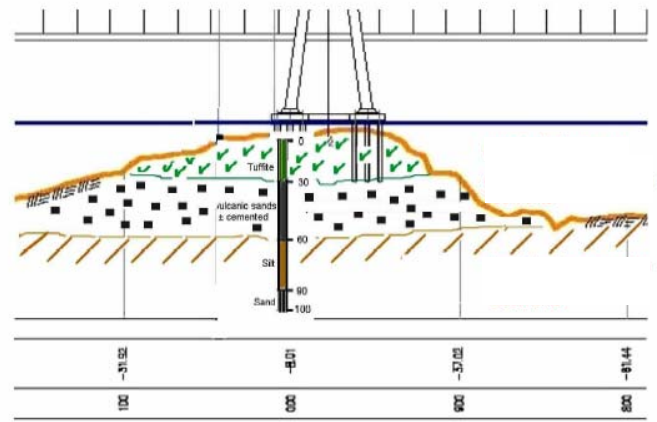
Fig. 8. Roca Remolinos soil layers (W. Romberg, 2006)

Roca Remolinos. Based on the sample visual inspection and test results, four different layers were identified (W. Romberg, 18 January 2005, Figure 8). All elevations given herein are below the Mean Sea Level, in meters.

1. A Tuffite (Caprock) layer exists (grey color), about 40-meter-thick, comprising of fine to medium sands, well to highly cemented, with low to medium silt content.
2. Below the Tuffite layer is a layer comprising of Pleistocene Sands about 35-meter-thick, comprising of medium sand, well to low cemented, with a few layers of gravel. Within the same layer are sublayers with concentrated gravel and low silt content. The layer colors vary from medium to dark grey and grey-brown.
3. Below the Pleistocene Sand layer, there is a layer of Pliocene/Pleistocene Silt about 30-meter-thick, comprising of hard or cemented Silt, with light brown to yellow color.
4. Below the Pliocene/Pleistocene Silt there is a layer of Pliocene/Pleistocene Sands, comprising of very densely compacted, partly cemented medium sands. The soil investigation was terminated about 20 meters inside this layer.

The Central Pylon is envisioned relatively close (30 to 40 m) to a relatively steep slope at Roca Remolinos (Figure 8 and 15). The lateral capacity of the foundation was estimated conservatively during the design. The stability of the steep slope of Roca Remolinos was not examined in such detail as for the North Pylon mostly because of the generally high cementation of the caprock material. However, during the final design, a more complete study will be carried out to assess the slope stability given that in a case of a slope failure, the cantilevering length of the piles will increase, along with the scour susceptibility of the foundation. Such a situation would worsen in case of repeated lateral loading before or after a potential slope failure. The interconnection of slope stability, large cantilevering lengths and scouring is further discussed later in the “future steps” section.

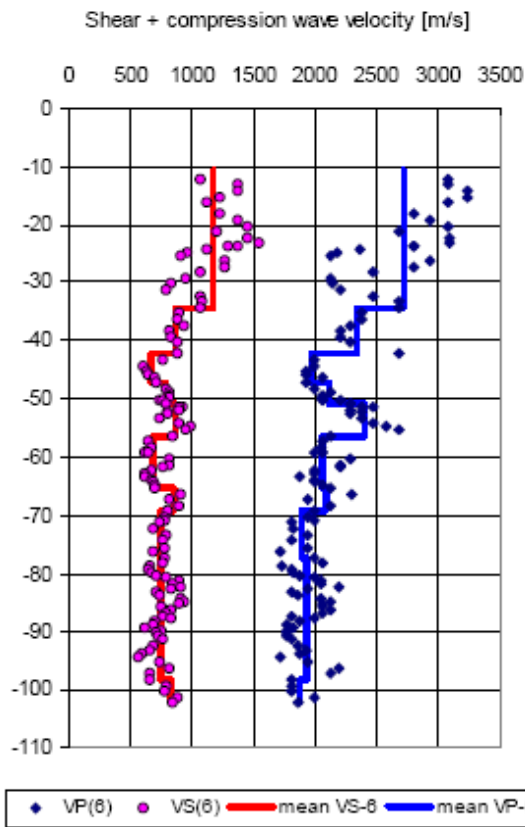
Fig. 9. Shear and compressional wave velocity profile at Roca Remolinos from suspension logging (boring A.SM-6, W. Romberg, 2006)

- The P-S suspension logging results showed shear wave velocities with typical values between 1000 and 1400 m/s for the Caprock layer, between 600 and 800 m/s for the Upper-Sand layer, and about 700 m/s for the Silt layer. No measurements were taken for the Lower-Sand layer (see Figure 9). The high shear wave velocities for the Caprock layer are indicative of a rock material. It is noted, however, that the material cementation varies (see below) and once broken the material behaves like soil rather than rock.
- The mass density varied from about 1.7 to about 2.5 gr/cm^3 with typical values of about 2.1 gr/cm^3 for the whole depth.

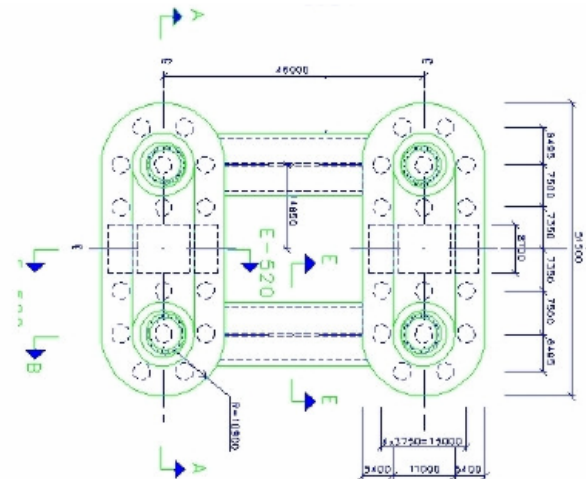
Fig .10. Plan view of Central Pylon foundation (COWI, 2006)

The Central Pylon foundation is to be placed on a combined pile cap, with each pile cap being supported by 16 piles (Figure 10). The combined pile cap consists of two separate pile caps connected with two transverse beams. These beams are hollow with dimensions 4 m deep by 11 m wide by 24.2 m long. The piles are cast-in-place concrete piles, 3 m in diameter at the top with an external steel casing, 70-mm-thick. The pile diameter is reduced to 2.7 m after the top 13.5 m and continues for another 28 m. The total length is about 42 m.

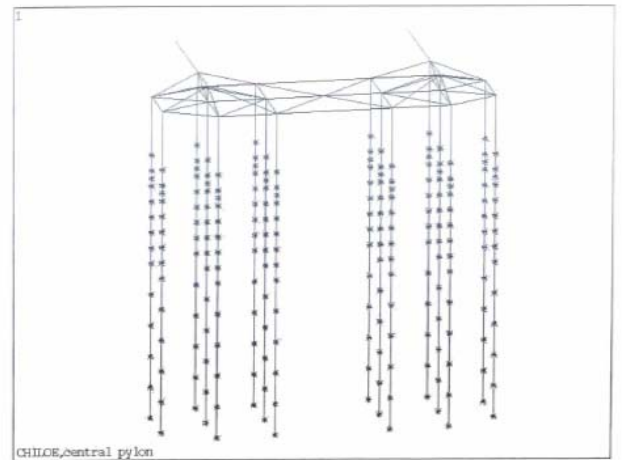
Fig.11. SASSI finite element model of Central Pylon (GDS, 2006)

design spectra at each foundation location. The rock design spectra for the subduction event were defined at the referential study (ICUATRO-COWI 2001). GDS estimated the acceleration time histories that matched the rock spectra and using wave propagation theory estimated the acceleration time histories at the surface of the shallow foundations. Using SASSI (Lysmer et al., 2000), a finite element computer program, the designer accounted for soil-foundation interaction and estimated the acceleration time histories at the center of the pile caps (central and north pylon) and at the top of the anchor blocks. Figures 11 and 12 show the finite element models of the central pylon foundation and the anchor blocks. Figure 13 shows one of the many design response spectra at the top of the foundation level (central pylon) accounting for soil-foundation interaction. GDS used SASSI to estimate the acceleration time histories, spectra and foundation impedances (springs and dashpots) and provided them to the bridge designer to be used in a global finite element bridge model and identify the seismic forces at the bridge.

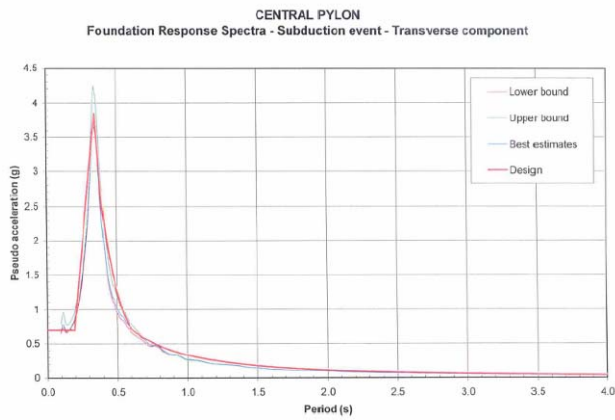
Fig. 13. Indicative design acceleration response spectrum at foundation level of the Central Pylon, accounting for soil-structure interaction (GDS, 2006)

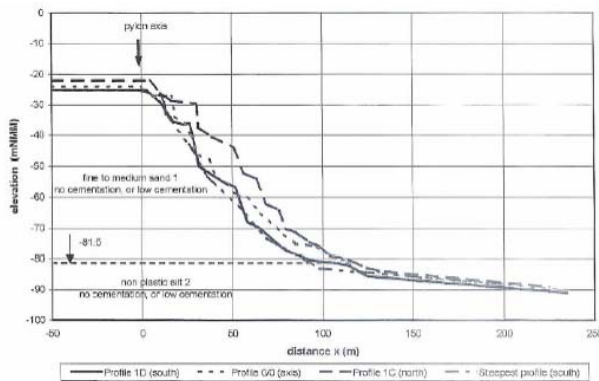
Fig.14. North pylon- longitudinal profiles (GDS, 2006)

As mentioned earlier, the north pylon was placed close to a relatively steep slope at the north bank (Figure 14) and the slope stability and slope displacements during the design seismic event were estimated.

Limit equilibrium methods were used to estimate the factor of safety for static conditions. The assumptions and methods used were simple and conservative given that the static slope failure was not a driving factor in the design. This is true for the static and seismic stability as well as the calculation of permanent displacements. A slope of about 35.5 degrees was considered in the calculations.

For the analyses, a ϕ angle of 40 degrees and zero cohesion were used and were deemed reasonably conservative. The overall factor of safety for a slope failure was approximately 1.2. A factor of safety of 1.5 was achieved by moving the north pylon foundation 20 m to the north.

From the above analyses, the conclusions were to move the north pylon 25 m to the north towards the shore to ensure a factor of safety of about 1.5 against slope failure for static conditions and 1.15 for post-earthquake conditions.

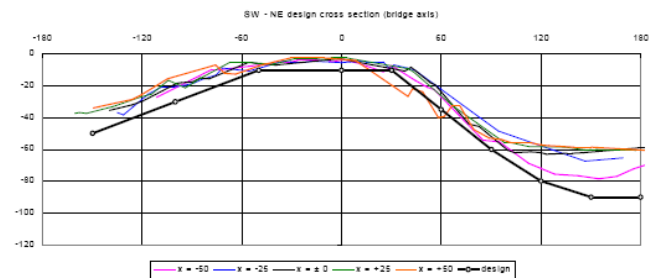
Fig. 15. Cross-sections with the steepest slopes at Roca Remolinos (W. Romberg, 2006)

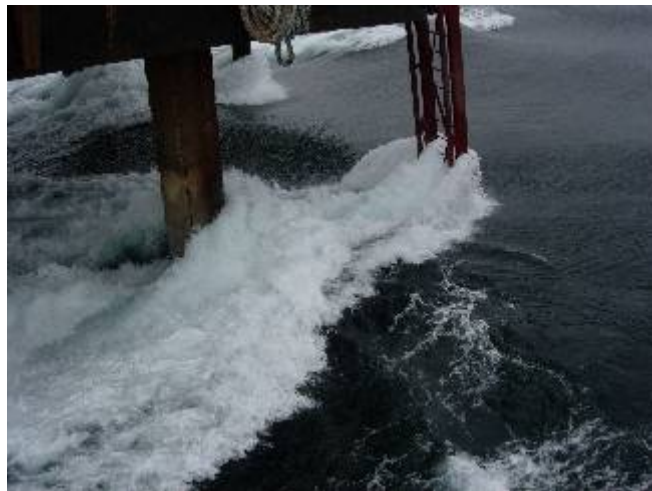
Fig.16. Currents at the legs of the jack-up platform at Roca Remolinos

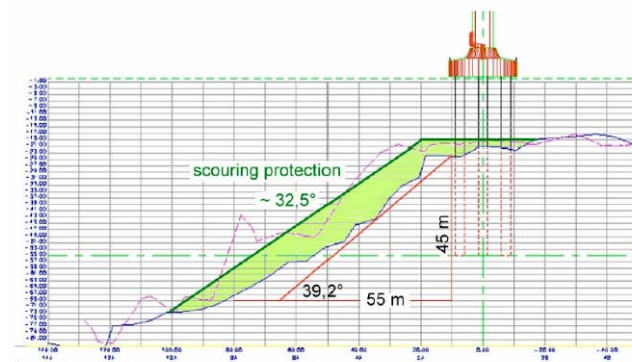
Fig.17. Recommended scouring protection measures for the North Pylon (W. Romberg, 2006)

the north pylon location. Based on the above data and the north pylon soil material information collected during the geotechnical investigation, it was estimated that the rate of material loss the North shore will suffer in the next 100 years, is about 0.2 to 0.5 m per year. Changes in the bathymetries taken in 2000 and 2005 suggest that 0.5 m per year is the more reasonable value to follow. Figure 16 is representative of the strong currents in the channel. These findings suggested moving the North Pylon 50 m to the North. This 50-m displacement due to scour considerations is independent of the 25-m displacement due to the slope stability considerations. However, since both displacements consider extreme events that will not occur simultaneously, a 50-m displacement of the north pylon to the north was decided. This distance would provide adequate factors of safety at all times for slope stability and give the necessary time to repair the scour protection when necessary. Figure 17 shows a recommendation for the scouring protection measures.
