## Relook at Foundation Design of RE Structures in Indian Environment Based on Case Study

Seventh  
International Conference on  
**Case Histories in  
Geotechnical Engineering**

## **RELOOK AT FOUNDATION DESIGN OF RE STRUCTURES IN INDIAN ENVIRONMENT BASED ON CASE STUDY**

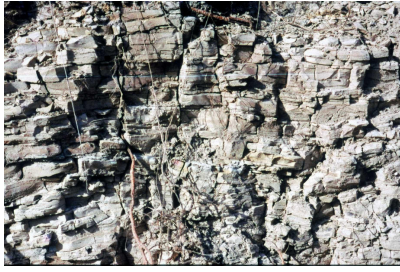
Fig. 4. Photo showing desiccated Clay Profile.

This strata in summer will be hard clay  $N_{SPT} > 10$  blows/30cm but in post monsoon it will have  $N_{SPT}$  3 to 5 blows/30cm. The insitu CBR  $> 15$  in field in summer reduces to CBR  $< 2$  for top cracked crust in monsoon days. Field open excavation shows cracked zone extends from 2 to 3 m at top. Thus for such soils, present practice of adopting soil profile from limited soil exploration of bores for deep pile for abutment was misleading. Time of exploration, rain cycle vis-à-vis construction schedule and flooding by river/topography or existing rail, road, irrigation embankments are critical for design. As life of structure being 70 years, the land use nearby over 7 decades cannot be anticipated. It also cannot be overlooked. Nearby borrow pits / deep excavation when flooded induces swelling /shrinkage in subsoil damaging well designed expressways. The bearing capacity and differential settlement of RE wall block for different heights will govern the depth of foundation in such cases. The above practice is not safe always.

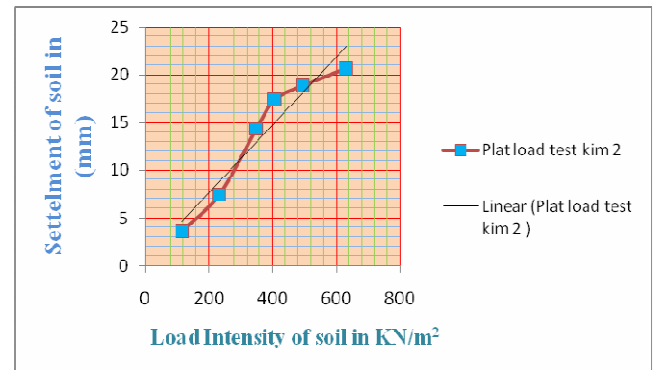
Fig. 9. Typical Load Intensity  $V_s$  Settlement Curve for foundation pad

The site construction control test by 45 cm plate load test on top surface is shown in Fig. 9. The UBC for test with size correction for effective width is more than 600 kPa. The settlement computed based on E = 18000 kPa was less than 20 mm.

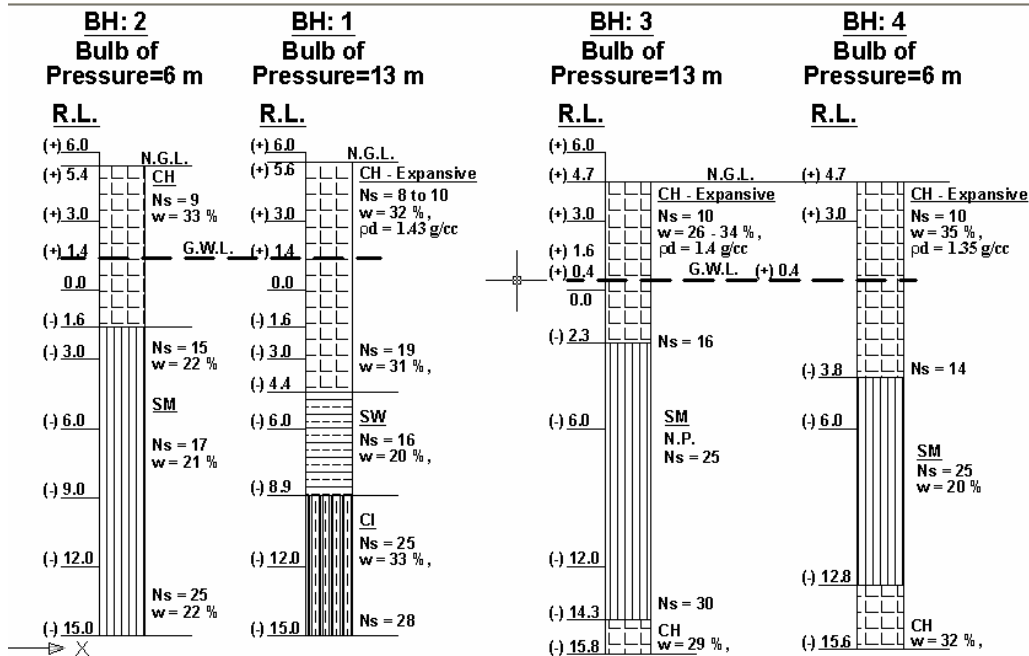
Fig. 11. Typical soil profile for foundation of RE wall.

The typical model soil profile is shown in Fig. 11 incorporating state of clayey subsoil in poor draining, high rainfall areas of expansive sub-soils. The major revision is detail exploration of both RE walls for shallow depths of 6 m. The typical DCPT results and bores will provide soil profile model. Special tests of shear parameters in present and submerged un-drained condition and cracked depth of top clays are investigated.

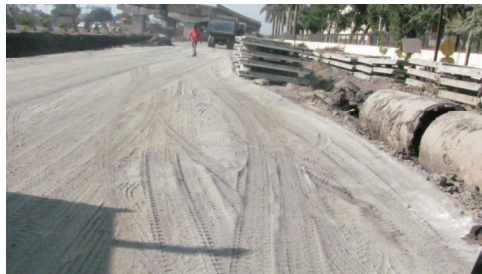
(a) Flyash mixing for soil stabilisation

Fig. 12. Photo plate showing construction of foundation for RE wall at Magadalla crossing in progress.

The backfill of foundation fill of pervious gravel and sand which is pervious is replaced by locally available Flyash with pulverised clay or clay and lime 2 to 3 %. Typical design mix is tested for placement at - 2 % OMC, compacted to 98 % MDD. Mix must satisfy  $\Phi = 30^\circ$  and  $k = 10^{-5}$  cm/sec giving UBC of more than 800 kPa for B = 6 m. The stress in (L - 2e) will be distributed to trench width. A typical section proposed for Magdalla site is shown in Fig. 12.

The fill material in foundation is replaced by local material of Ash Fly and Bottom ash of power plants mixed with 2 % lime and 20 % pulverised black soil. This mix shows OMC = 30 %, MDD = 13.9 kN/m<sup>3</sup> and Cu = 300 kPa,  $\Phi_u = 38^\circ$ . The k value will be  $2 \times 10^{-5}$  cm/sec. This material placed on 1 m reinforced SW - SM layer below is laid to a) control rain water seepage from surface & sides, b) reduce settlement due to shrinkage & swelling of top layer, c) provide high tensile woven geotextile and filters to improve stiffness of fill.

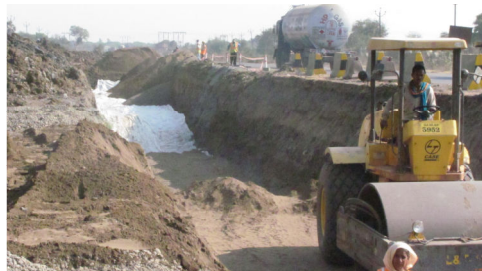
(b) Laying of geotextile
