The Geotechnical Hazard Induced by 8.1 Earthquake in West Pass of Kunlun Mountatin in China in 2001

THE GEOTECHNICAL HAZARD INDUCED BY 8.1 EARTHQUAKE IN WEST PASS OF KUNLUN MOUNTAIN IN CHINA IN 2001

ABSTRACT

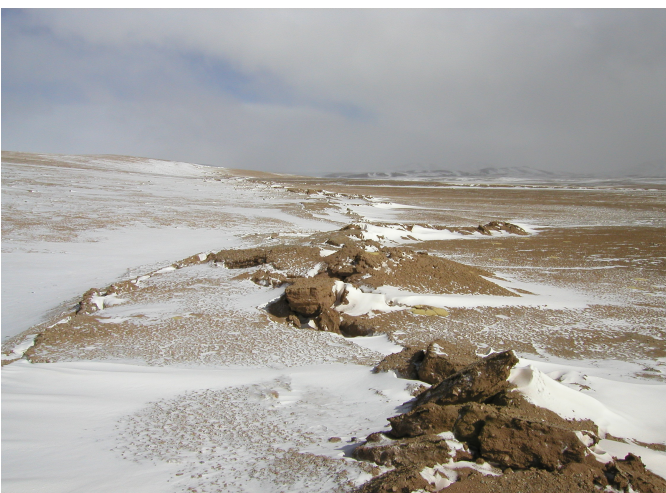
Earthquake fractures. (Fig. 3.) This is the most commonly recognized deformation. It has been found that there are three groups of earthquake fractures. The first group has a strike of $N70^{\circ} \sim 80^{\circ}W$, which has a small difference with the strike of the main rupture of fault. The fractures of this group are relatively straight and smooth. Horizontal scratches can be found on the fracture surface, which indicate the sinistral movement of ground on two sides of the fracture.

Fig. 3. Earthquake fractures

This group of fractures is also big in scale. Sometimes a single large fracture presented alone, which can be well identified. But it can be presented as a group of small fractures, too. This ground of fractures is several meters to over one hundred meters long and scores of centimeters to over three meters wide. They are deep, too. On the cross section, the fractures often become narrower from the surface to underground. The large fracture is very deep while the small one wedge out gradually underneath.

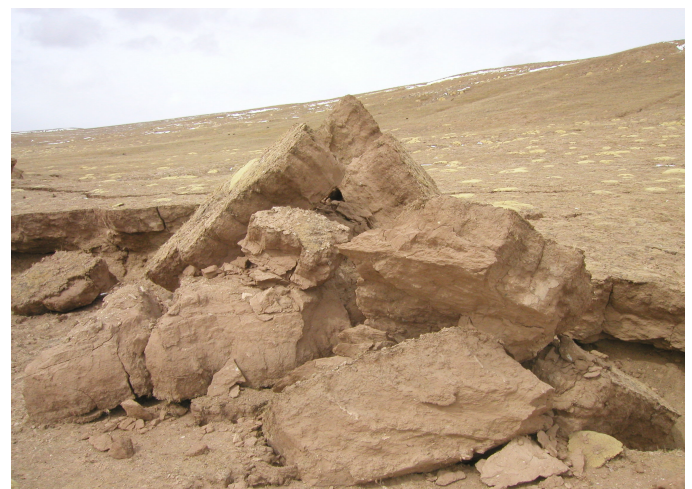
Earthquake mole tracks.(Fig. 5) They often coexist with earthquake fractures along the deformation zone. It is 0.5~3.0 m high, several meters to over ten meters wide and several meters to over one hundred meters long. The length to width ratio ranges from 2:1 to 5:1. Because of the frozen soil, almost all of the mole tracks are results of brittle deformation.

Fig. 5. Mole track caused by the 8.1 great earthquake

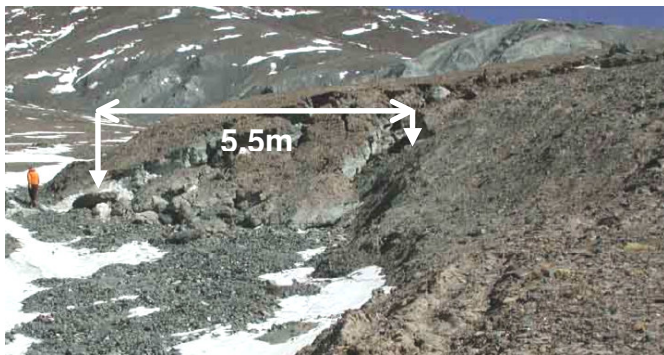
Horizontal displacement. (Fig. 6) As other earthquake caused by the strike-slip fault, horizontal displacement is the most commonly seen phenomenon, which can be well identified from the displacement of linear structures like riverbed, gully, ridge and track. All geological bodies meet the main rupture zone were displaced to some extent and show signs of the sinistral movement. Scratches found on the rupture planes tell us that the movement is predominately horizontal.

Fig.6. Horizontal displacement caused by the 8.1 great earthquake

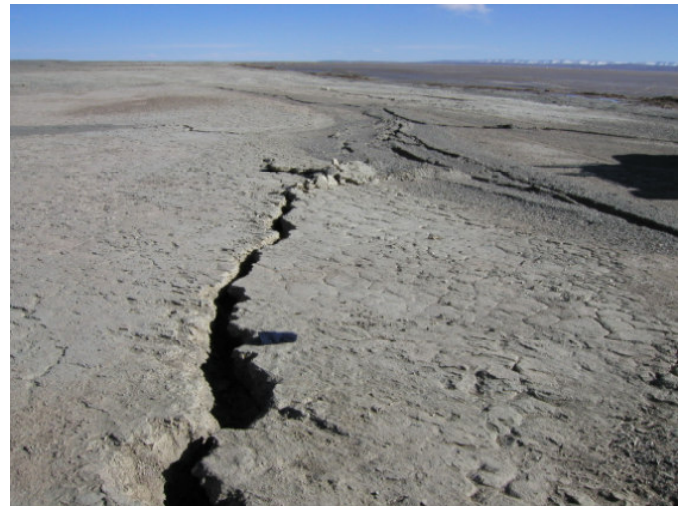
Shaking caused Fissures.(Fig. 8) They are mainly found in the Northeast of Kusai Lake and part of riverbed of the Red River.

Fig.8. Shaking caused fissure

The scale and the direction of extending of these shaking caused fissures varies depending on the where they are. In northeast of Kusai Lake, the fissures are developed in the middle of the diluvial fan and flood plain. They have two dominate directions: NE and NW. The width of these fissures is from 10 to 30cm and their length is from several meters to hundred meters. The walls of these fissures are in shape of gentle wave. There is no relative movement between the two sides of the fissure. When they present in the flood plain of the rivers, they are often wider and cover a relatively large portion of the area. But the shaking caused fissures are relatively narrow and can only be found in a small part of the diluvial fan if there are any. Also, this kind of fissures does not developed nearby the main deformation zone. They often formed in places which are several kilometers away from the main deformation zone. Tests have shown that the failure strength of frozen soil is much higher than that of the thawed soil. In the mainly frozen soil area, there are still thaw soils, which are the cause of the development of the shaking caused fissures. The failure of the thaw soil under the frozen soil make such fissures developed. The areas nearby the main deformation zone are in the high altitude slopes and foothills, where the soil layer is less in thickness than areas further away. Usually, the soil layer is less than 20m in thickness. At the same time, almost the entire soil layer is frozen. To the deeper, the bedrock presents. These facts

explain why even the shaking intensity of the deformation zone is higher, there is yet hardly any shaking caused fissures developed. Away from the main deformation zone, the soil layer is much thicker and underlying the frozen soil, there is thaw soil layer sometimes. When the ground shakes during the earthquake, the thaw soil failures and induces the formation of the shaking caused fissures in the frozen soil above. Also, in places around rivers and lakes, since there are thaw soil in some place and the frozen soil layer is not very thick or even without frozen soil layer, it is easily to develop shaking caused fissures in these places. In the North of Kusai Lake, the development of shaking caused fissures is in a pattern of encircling the lake. The shaking caused fissures also indicate certain vertical movement toward the bottom of the lake, which formed ladderlike stripes on ground. In the riverbed of the Red River, shaking caused fissures are also developed in large number. They are of the similar mechanism of engendering.

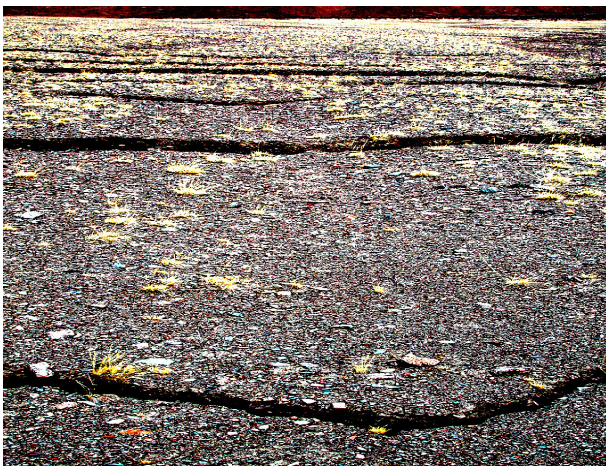
Seismic subsidence and its mechanism. (Fig.9) The seismic subsidence is mainly found at the north of Kusai Lake. It is distributed encircling the lake. The width of the elongated area showing seismic subsidence is about 1~2Km on different section of the area. The maximum vertical fall between fissures can be as larger as 20cm while the accumulating vertical fall reaches 1.5m. The mechanism of the seismic subsidence is: under the 1 to 2 meter thick frozen soil layer there are thaw area which is created by the thermal conduction of the water. So the strong ground motion causes large amount of residual deformation, namely, seismic subsidence in these places. The nearer to the bank of the lake it is, the thinner the frozen would be and the thicker the thaw soil layer will. This is why the seismic subsidence is larger from relatively far away from the bank of the lake to the bank of the lake. The ladderlike stripes caused by the seismic subsidence are also caused by the same reason.

Fig. 9. Seismic subsidence caused ladderlike stripes in the North of the Kusai Lake

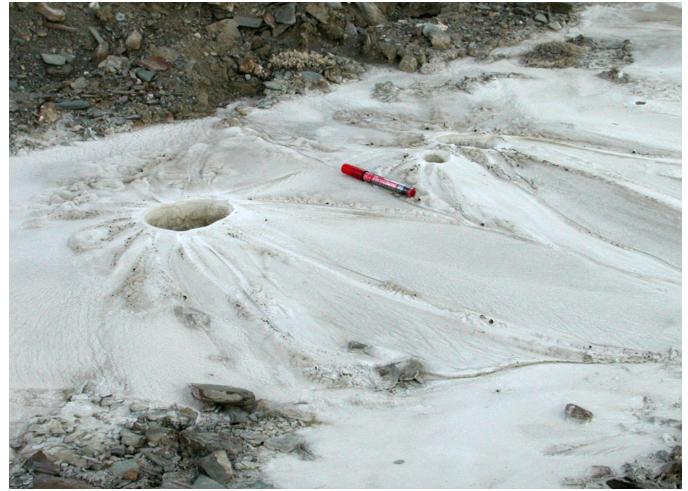
Liquefaction. One of the most worthy to pay attention geotechnical hazard is liquefaction developed in sand (Fig.10). Liquefaction is not very hard to be found in the frozen soil area.

Fig. 10. Sand boiling craters formed by the liquefaction

The places where liquefaction is mostly found are in north of Kusai Lake and in riverbed of Red River. The liquefaction occurs in mainly the deformation zone in riverbed and lakefront. The frozen boiling cones are composed of ice and sand. The sand is mainly of medium and fine sand. It has high sphericity and is well graded. Geological radar exploration shows that the liquefaction layer lies at around 3m underground and sand the water move upward along some of the channels (fissures or pores) (Fig.11). Obviously, the frozen soil layer is thin at the riverbed and the lakefront. The thaw soil layer below has high water content. During the earthquake, the pore water pressure in the thaw soil layer increases and liquefaction develops, which eject the sand out to the surface.

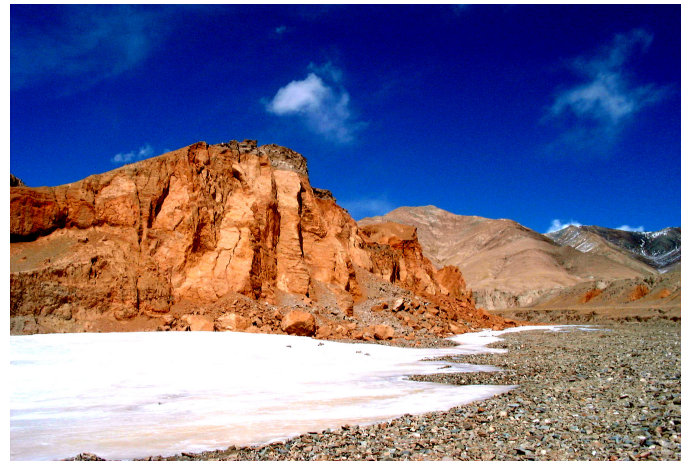
Fig. 14. The rockfall induced by the earthquake

Most of the falls are of small scale. Rockfalls are mainly found in the riverbed of the Hongshui River. The rocks are the brick red sandy mudstone of Tertiary, which often formed steep landform.

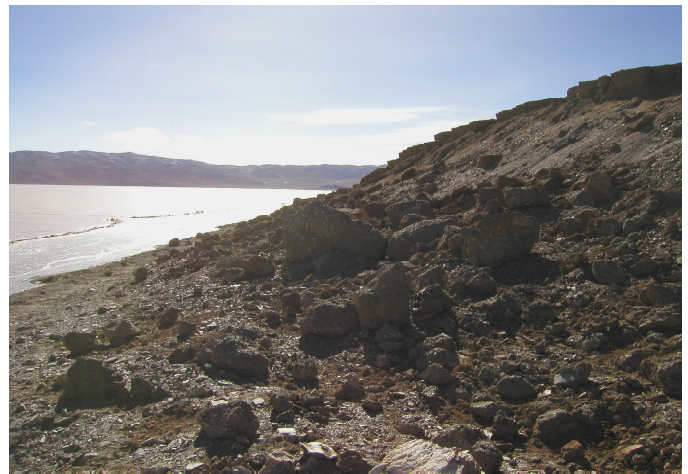
Fig. 15. The earth fall induced by the earthquake

The earthfalls of the frozen soil are mainly found in the North terrace of Kusai Lake, south piedmont of Yuantou Mountain and the terrace of Hongshui River. Most of sites where earthfalls developed are steep. The water content of frozen soil is relatively low and there are also fissures produced by the physical weathering.

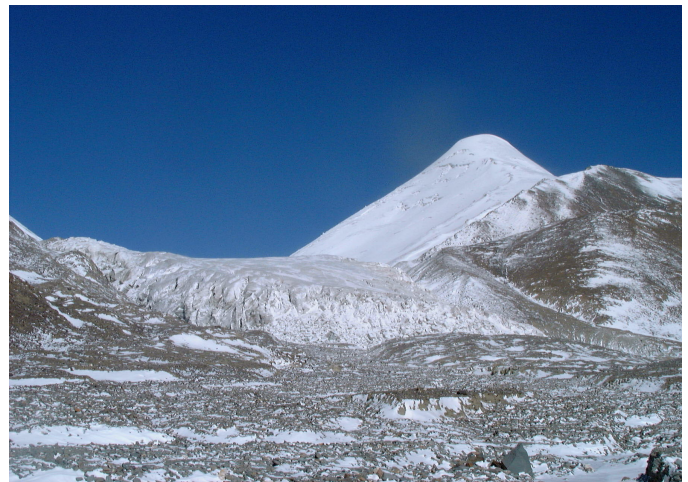
Fig. 16. The avalanche induced by the earthquake

Most of the avalanches induced by the earthquake locates in deformation zone of the south piedmont of Yuzhu Peak and the southeast piedmont of Bukadaban Peak. In south piedmont of Yuzhu Peak, the earthquake deformation zone cuts the Modern glaciers and induced the avalanches and the sliding of glaciers. The similar situation exists in the area near the deformation zone in the southeast piedmont of Bukadaban Peak.
