International Conference on Case Histories in Geotechnical Engineering (2008) - Sixth International Conference on Case Histories in Geotechnical Engineering

## Improvement of Soil and Rock Properties for Foundation Support for Missouri Interchange Project

Expansion and growth in the southwestern region of Missouri necessitated the expansion of State Route 249 and the construction of a new interchange to provide service to the Joplin, Missouri area. The project is located above a former lead and zinc mine in Jasper County, Missouri and includes a five bridge interchange connecting State Route 249 and US Route 171. The variable subsurface conditions, both natural and manmade prompted the design team to use ground improvement via grouting and small diameter micropiles to provide support for several of the bridge foundations on the project.

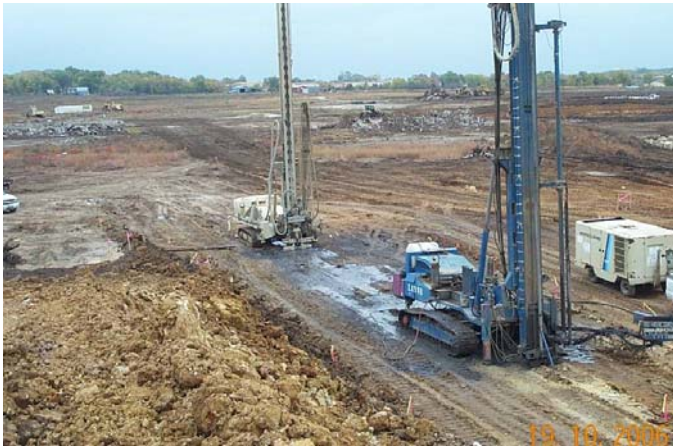
*Fig. 3. Typical Ground Treatment Process – One rig drilling, one grouting*

The main purpose of the ground treatment program was to explore for mine voids and reduce the risk of collapse. The holes normally ranged in depth from 20 to 30 meters. Volume of LMG injected into holes without voids was normally less than a 1 to 2 cubic meters. When mine voids were encountered, injected grout volumes ranged from 5 to 235 cubic meters. In several holes grout was injected in 50 cubic meter increments. Holes were allowed to rest for approximately two hours after each 50 cubic meter increment was placed without achieving refusal criteria in a particular lift. The resting time and grout rate were varied and changes made at the discretion of the rig inspector. In almost all cases, the rest period resulted in achieving the refusal criteria with addition of smaller amounts of LMG.

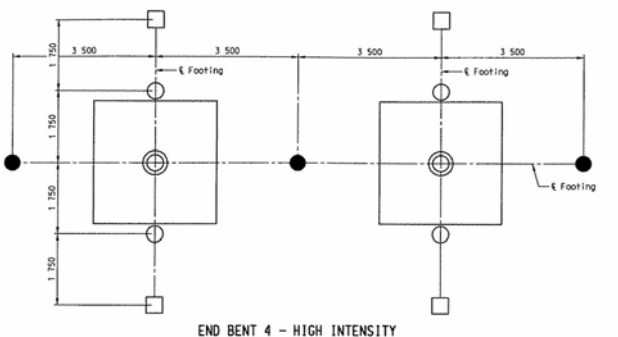
Fig. 4. Typical High Intensity Foundation Treatment Layout

Based on type of ground anticipated, three levels of foundation treatment intensity were specified in the plans as low, medium, and high. The low intensity averaged three primary and two secondary holes for a two footing bent. The medium intensity averaged three primary, two secondary, and four tertiary holes for a two footing bent. The high intensity treatment averaged three primary, two secondary, four tertiary, and four quaternary holes per two footing bent. A typical layout for high intensity treatment can be seen in Fig. 4.

After reviewing the drilling logs, a treatment scheme was chosen based on the character of the rock and the number and size of any voids logged in the drill hole. The purpose of the foundation treatment was three fold, the first to investigate and treat for mine voids and unstable ground beneath the limits of the footing, the second to minimize the potential for runaway grout during the installation of the micropiles and the third to confirm the limits of micropile bond zone. In general, voids larger than 152mm were desired to be treated with low mobility grout while broken and fractured rock was to be treated with high mobility grout.

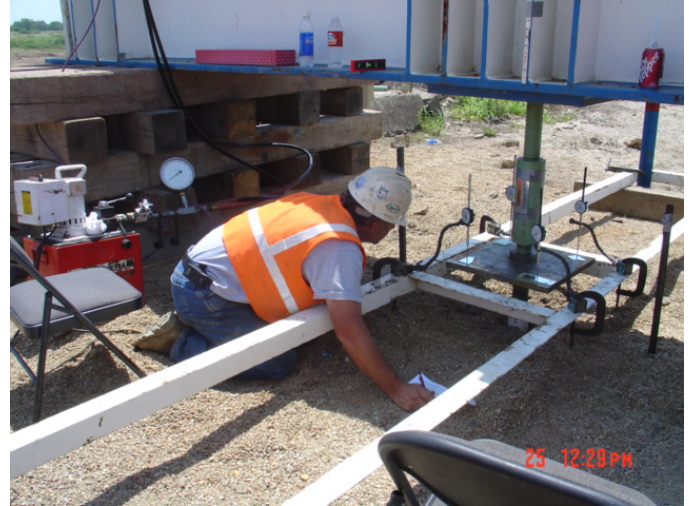
Fig. 5. Micropile Testing

One micropile was selected for proof testing at each bent. Normally, the selection was based on a possible anomaly observed during the installation of the pile. Some of the possible anomalies were; high grout takes, low grout takes, hole instability, or difficulty inserting the bar. Micropile proof testing was conducted both on vertical and battered micropiles. Micropile proof testing acceptance criteria was as follows:

1. Failure does not occur at 1.20 DL.
2. At test load, the apparent debonded length (calculated from the elastic extension) shall not exceed 50% of the bond length.

3. At the end of the 1.20 DL creep test, the creep rate shall not exceed 1 mm per log cycle (1-10 minutes) or 2 mm per log cycle (6-60 minutes). The creep rate shall be liner or decreasing throughout the creep test period.
