A Case History of Raft Foundation Behavior for a Large-Scaled Building Complex

SYNOPSIS This paper describes the field observation of settlement of a raft foundation for a large scale building complex in Nagoya city in Japan. The complex consists of a 28 story hotel, a 15 story office building and a low-storied banquet hall in the middle all of which are supported on a single 80 m square basement on raft foundation. Since the load on the foundation is non-uniform, the differential settlement of the foundation was investigated analytically, taking into consideration the interaction between the ground and the raft. To confirm the validity of the design, measurements were conducted for about 2 years during the building construction. The results of the measurement are discussed below.

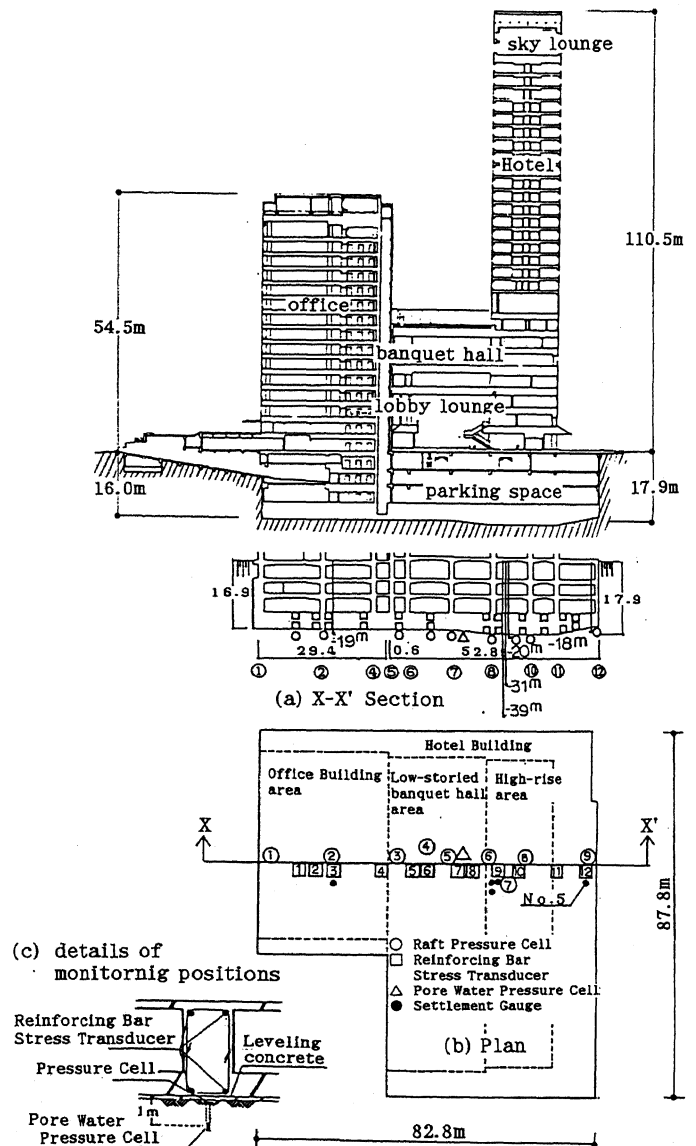
Fig-1 Schematic of building

Fig. 1 shows a schematic of the building complex composed of a 110.5 m tall hotel building with 28 stories, a 64.5 m high office building with 15 stories and a low-storied banquet hall in between the two high-rise buildings. The hotel and office buildings are connected by an expansion joint and they are both supported on a single basement on a raft foundation. The excavation depth for the raft foundation is about 18 m.

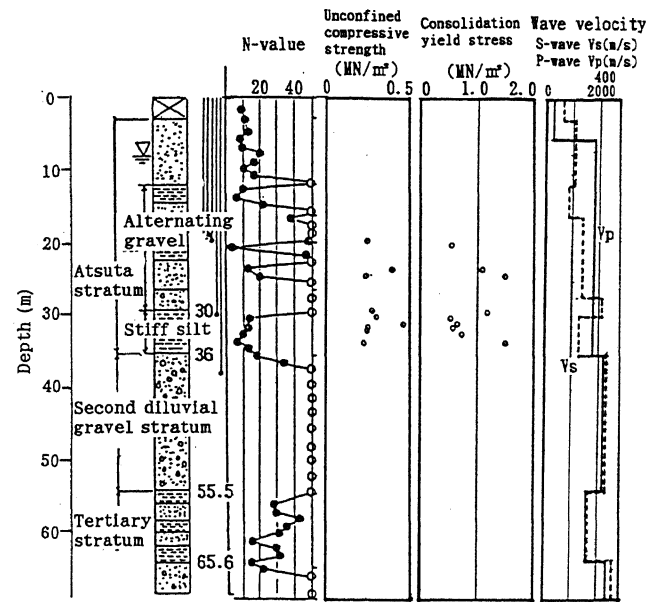
Fig-2 Summary of soil investigation

Fig. 2 summarizes the soil investigation conducted at the construction site. The soil profile up to a depth of 36 m is the first diluvial stratum, the so-called Atsuta stratum, composed of an upper alternating gravel layer to a depth of 30 m and a stiff silt layer below. The second diluvial gravel stratum extends from a depth of 36 m to a depth of 55.5 m. Below this lies the Tertiary stratum. Groundwater was found at a depth of 8 m.

The elastic modulus used in the analysis is taken from the results of PS logging shown in Fig.2, with some modifications based on the measured value of G/G_o' as shown in Fig. 11. As previously mentioned, the measured elastic modulus (E), decreased as the shear strain (γ), increased during the excavation (i.e. unloading), but under loading E remained at about the same value regardless of the strain level. Therefore, in the analysis the value of the elastic modulus of each stratum at the time of completion of excavation was adopted as the elastic modulus under loading.

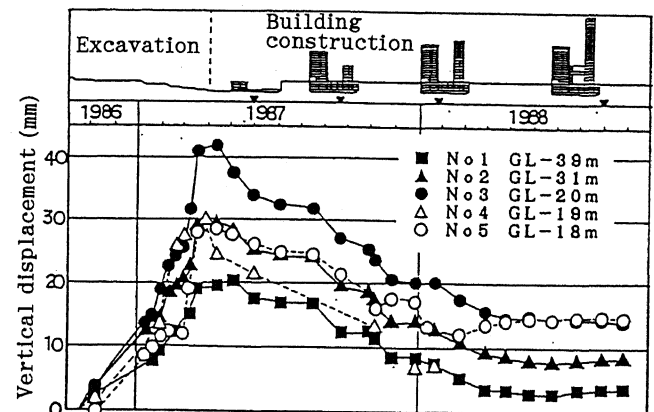
Fig-3 Measured vertical displacement

The measurement results of the differential settlements are shown in Figs. 3 and 4. The control points for the observation were chosen at two places in two buildings away from this construction site. Their levels were checked at each time, it was measured to confirm zero settlement at the control points. At the time of construction the groundwater level in the excavated portion had already fallen below 18 m. Consequently, the settlement associated with the fall of the groundwater level was not included in the measurements. The maximum ground heave after the final excavation was 42.0 mm. Based on the displacement distribution at the time of excavation (Fig. 4(a)) the lower stiff silt layer was found to have a greater inclination and a larger strain than the upper gravel layer. Also the heave at the depth of 39 m is about half that at the depth of 20 m. However, the displacement

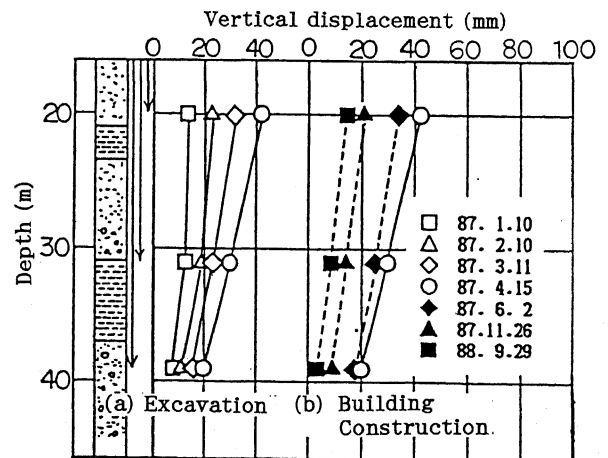
Fig-4 Measured differential displacement of bearing strata

distribution (Fig. 4(b)) of the excavated ground during construction of the building shows that the upper and lower strata have similar inclinations, which were essentially straight lines.

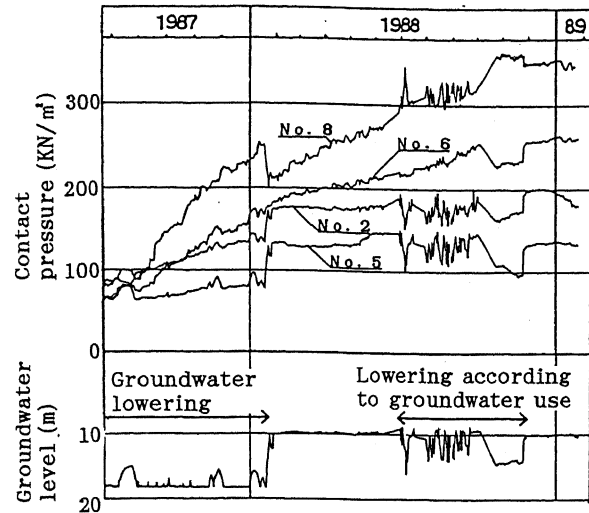
Fig-5 Measured contact pressure and groundwater level

Fig. 5 shows the changes over time in the earth pressure and the pore water pressure. The earth pressure cells were adjusted so that the measured pressure would be equal to the pressure calculated from the time that the foundation beam concrete was placed. The contact pressure gradually increased as the construction progressed and became larger below the office building (No. 2) and the high-rise hotel building (Nos. 6 and 8) than below the banquet hall (No.5). A change in contact pressure induced by buoyancy was, also, observed after the completion of the underground building frame when the groundwater level started to return (January 1988). Generally, the contact pressure increases with the water pressure when it is smaller than the average contact pressure, and decreases when it is larger than the average contact pressure. Such contact pressure fluctuations due to varied groundwater level was also seen from July through November, 1988, when the groundwater level changed as a result of its use.

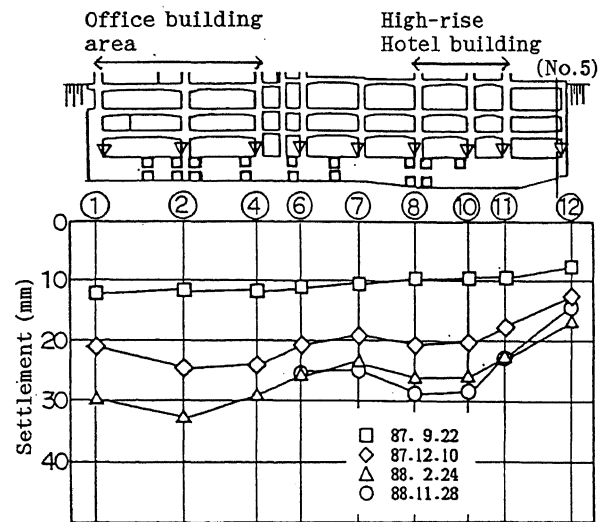
Fig-6 Measured settlement of raft foundation beam

The measurement of the settlement of the foundation beams was initiated on July 21, 1987, after the placement of the foundation beam concrete. Fig. 6 shows the distribution of the foundation beam settlement from the time of the excavation's completion which was derived from the measured differential settlement of displacement gauge No.5. In the early stages of the construction, the area around the office building had a greater settlement than the hotel building since its construction was completed ahead of the hotel structure. At the final stages of the construction, the settlement under the banquet hall, whose load was about 50-60% of that of the high-rise hotel building, was as much as 70-80% of the settlement under the hotel building. This implies that to a certain degree the settlement was distributed uniformly.

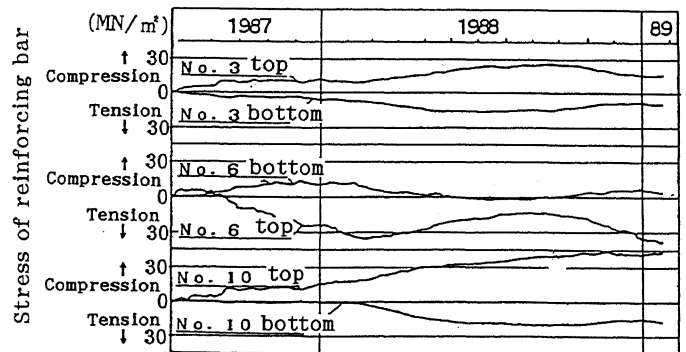
Fig-7 Development of reinforcing bar stress

The measurements of the stress in the reinforcing bars of the foundation beams were begun on July 21, 1987. Fig. 7 shows the changes over time in the stresses in the reinforcing bars of the foundation beams at the office building (No.3), the banquet hall (No.6), and the hotel building (No. 10). The stresses in both the top and bottom reinforcing bars are shifted toward the compressive side at the high-rise hotel and the office buildings, while at the low-storied banquet hall the reinforcing bar stresses shifted toward the tensile side until the ground water level returned (January 1988). However, speaking as a whole, the stress pattern is relatively symmetric and it is judged that the concrete at the tensile side worked effectively throughout the construction period. Fig. 8 shows the changes over time in the bending moment of the foundation beam. The bending moment in the foundation beam was calculated based on the assumption that all the concrete in the tensile side was effective and that the

ratio of Young's modulus of the reinforcing bars to concrete is 15 to 1.

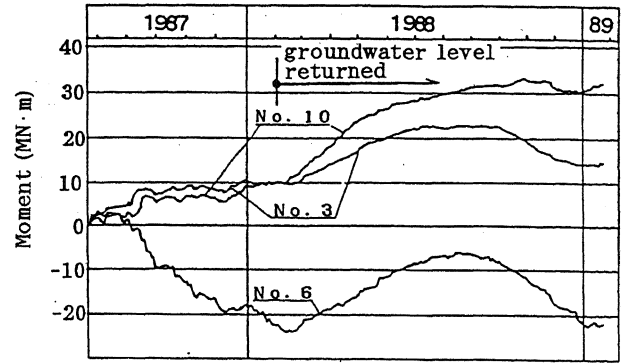
Fig-8 Development of bending moment in foundation beam

The bending moment at the high-rise office and hotel building increased as the construction progressed. On the contrary, at the low-storied banquet hall negative bending moment was observed. Buoyancy associated with the return of the groundwater level, seemed to dampen the rate of increase of the bending moment at the high-rise hotel building. A similar influence was seen in the rate of increase of the negative bending moment at the low-storied banquet hall. These changes in stress are relatively gentle compared to the changes in contact pressure and pore water pressure, shown in Fig. 5. The reason for this is a long term change in the stress level which cause a creep-like behavior. Fig. 9 shows the distribution of the stress in the reinforcing bars at the major stages of the construction. At the high-rise office and hotel buildings compressive stresses of about 20 MN/m² and 40 MN/m², respectively, were produced. At the low-storied banquet hall, a tensile stress of about 40 MN/m² was produced. It is found that the reinforcing bar stress is influenced more by the position in the whole building than by the position in an individual beam.

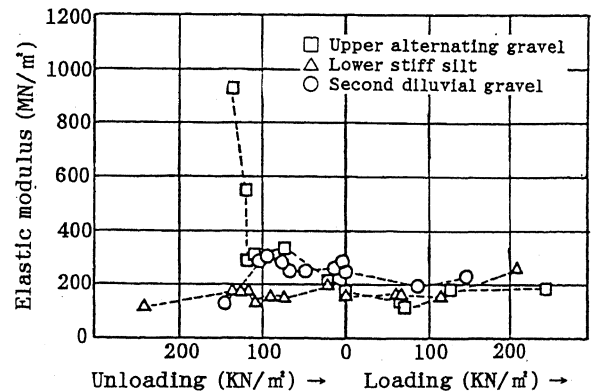
Fig-10 Relationship between increasing load and ground rigidity

Fig. 10 shows the relationship between the elastic modulus of each soil layer, which was re-calculated from the measured ground displacement, and loading and unloading stress calculated at the middle depth of each layer. In calculating the displacement below the second gravel stratum, the displacement at the bottom of the stratum in the Tertiary (at the depth of around 66.0 m) is taken to be zero. The elastic modulus of the upper alternating gravel layer around the bottom of the excavated area rapidly decreased as the unloading stress increased but very little change in the elastic modulus was noted beyond the lower stiff silt layer. Under loading conditions, the elastic modulus was comparatively stable up to the level where it decreased because of the unloading. The elastic modulus of the upper alternating gravel layer was almost equal to that of the lower stiff silt layer under the loading conditions.

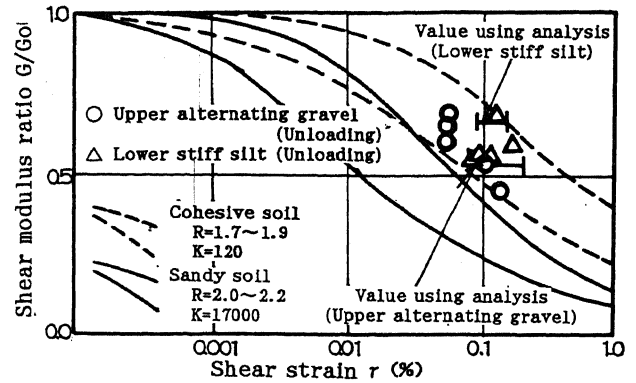
Fig-11 Relationship between shear strain and shear modulus ratio

Fig. 11 shows the relationship between the shear strain (γ), re-calculated from the measured differential displacement and G/G_o' . G_o' is obtained from Eq. (4) using the G_o from the PS logging. Fig. 11 indicates that G/G_o' shows a tendency to decrease as the shear strain (γ), increases. The curve in the figure is drawn based on the Ramberg-Osgood model Eq. (5), using the values of R and K obtained from cyclic tri-axial tests presented by Hatanaka (1982). The values that were used are: $R=1.7$ to 1.9 , $K=120$ for cohesive soil, and $R=2.0$ to 2.2 , $K=17000$ for sandy soil.

The measured shear strain and shear rigidity show a relationship similar to that obtained from the data of the cyclic tri-axial tests.

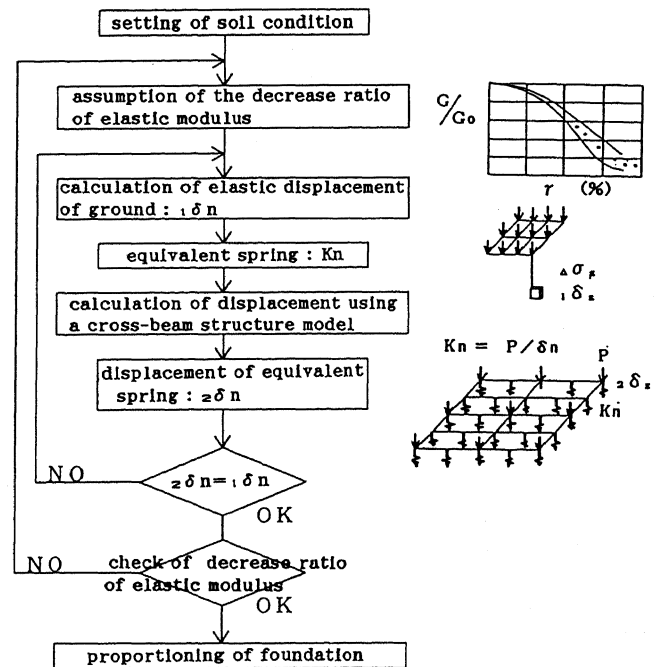
Fig-12 Flowchart of Numerical Calculation

Prior to designing the foundation, an analysis which incorporated ground and foundation beam interaction was carried out to examine the building load distribution. Fig. 12 shows a flowchart of the analytical procedure that was used. The steps in the analysis were as follows:

- (1) The elastic modulus is first evaluated from PS logging data. The actual value used in the analysis is reduced according to a ratio which reflects the strain level.
- (2) The elastic displacement of the ground is calculated based on loads being transmitted by columns and soil below the raft foundation is modeled by equivalent springs based on the theory of elasticity.
- (3) The raft foundation supported on equivalent springs is analyzed and the displacements and reaction forces of the equivalent springs are calculated.
- (4) Steps (2) and (3) are repeated until the displacement of the equivalent springs calculated in (3) converge to the elastic displacement of the ground calculated in step (2).

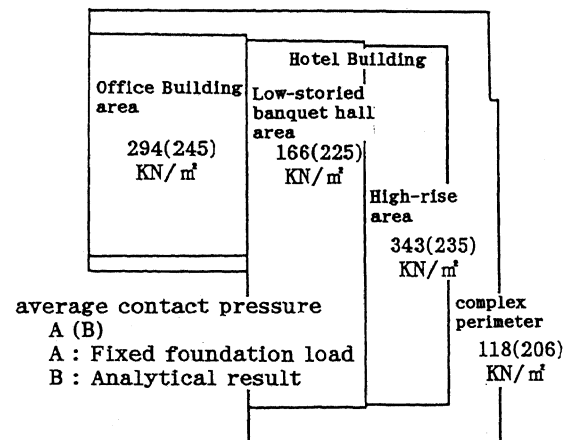
Fig-13 Comparison between Fixed Foundation Load and Analytical Load

Fig. 13 shows the analytical results for the average contact pressure. The average contact pressure is 235 KN/m² at the hotel building and 245 KN/m² at the office building. The analysis (which incorporates the interaction between the soil and the foundation beam) revealed that the localized load of the building is to a large extent distributed uniformly throughout the foundation beams.

The bottom of the raft foundation is at a depth of 16.9 m to 17.9 m on the diluvial gravel stratum. As the building complex has two high-rise buildings, the building load is non-uniform. The design average contact pressure is 343 KN/m² for the hotel building, 166 KN/m² for the banquet hall, 294 KN/m² for the office building and 118 KN/m² for the lower part of the perimeter of the complex. The average contact pressure over the entire area is 230 KN/m² which is approximately equal to the weight of the removed soil, 217 KN/m², or less than the weight of the removed soil when buoyancy is taken into account (see Fig-13).

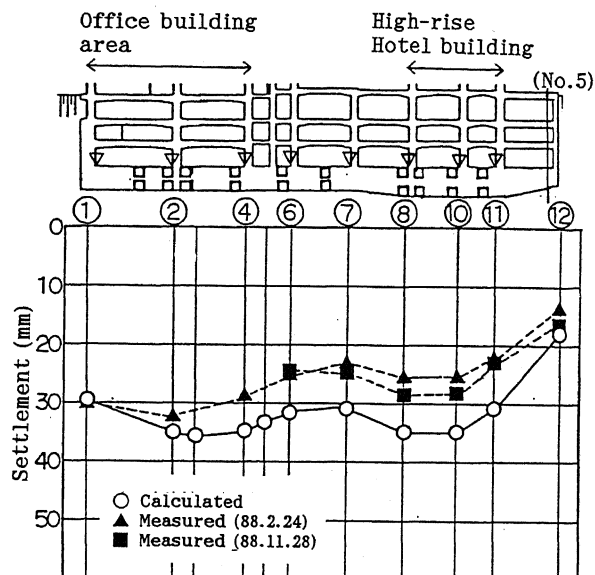
Fig-14 Comparison between calculated and measured settlement

Fig.14 shows a comparison between measured and calculated displacements of the foundation beams after the completion of the building frame. The displacement of the foundation beam was obtained by measurements taken by levels at points on the foundation beams and the readings taken from the differential settlement gauge No. 5 which is the assumed control point. Fig.15 shows a comparison between the measured and calculated bending moment in the foundation beams. The measured bending moment is obtained from the stress calculated from the strain transducers on the reinforcing bar on the assumption that the concrete in the tensile side is effective. The first measured value was on Aug. 31, 1988, when the groundwater level was relatively stable, and the other was on January 23, 1989, at the time of the final measurement, indicated in Fig. 8, show a creep-like behavior resulting from the changes in the groundwater level. The measured moment distribution shown in Fig. 15 exhibited a behavior similar to that of a single beam supporting by itself both the office and hotel buildings. The analytical results agree well with the measured data.
