International Conference on Case Histories in
Geotechnical Engineering

(2013) - Seventh International Conference on
Case Histories in Geotechnical Engineering

Stabilization of Existing Sheet Pile Cell in the Ohio River

STABILIZATION OF EXISTING SHEET PILE CELL IN THE OHIO RIVER

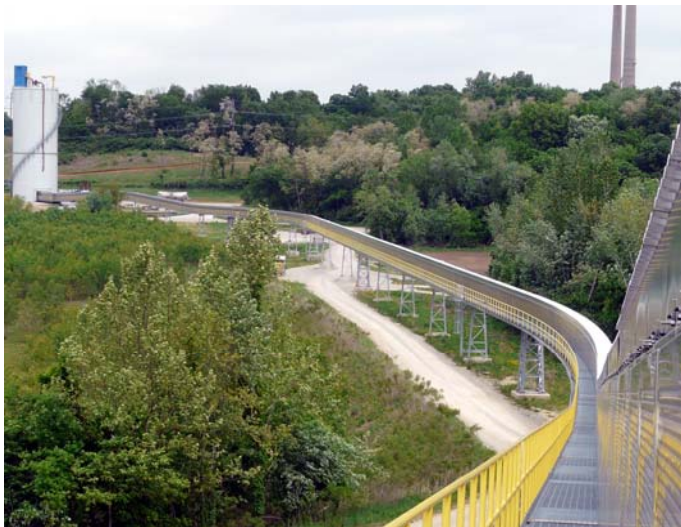
Fig. 3. Storage Silo and Tubular Conveyor.

A regional power company in southwestern Indiana recently completed the installation of a nearly one of a kind dry fly ash tubular conveying system (this installation is the second of this type constructed in the US) with a construction cost of approximately \$14M. The dry fly ash is transported by pipeline from the generating facility to a storage silo located about 2,000 feet from a barge fly ash loading facility on the Ohio River in West Franklin, Indiana, just down-stream from Evansville, Indiana. In addition to the storage silo, the dry fly ash conveying system includes a 2,000 foot long elevated tubular conveyer and the fly ash loading platform. Figures 1 and 2 illustrate the existing cell, loading platform and stabilizing measures. The conveyor (see Fig. 3 and 4) discharges at the fly ash loading platform (see Fig. 5) which is located atop the existing 40 foot diameter cell that was constructed in the Ohio River.

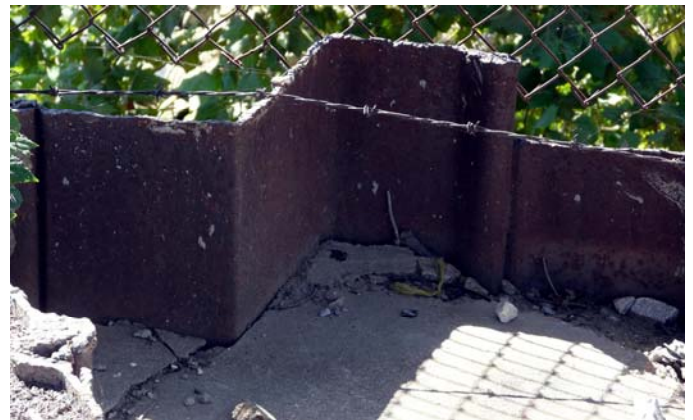
Fig. 6. Settlement of existing access roadway cap.

Although the cell was constructed, it was never put into service for coal barge unloading. In the years since the cell was constructed, the fill within the cell and between the cross-tied access roadway sheet piles had settled almost a foot (see Fig. 6) and the cell had leaned out riverward several inches from the access road to the cell.

A static stability analysis of the cell revealed a lower than normal factor of safety against overturning without any additional loads, thus confirming the reason for the tilting of the cell. Construction of the dry fly ash loading platform on the inadequately stable cell could result in an over-turning failure of the cell under certain loading conditions, which would result in major damage to the new conveyor system and would remove the loading platform from service for an extended time.

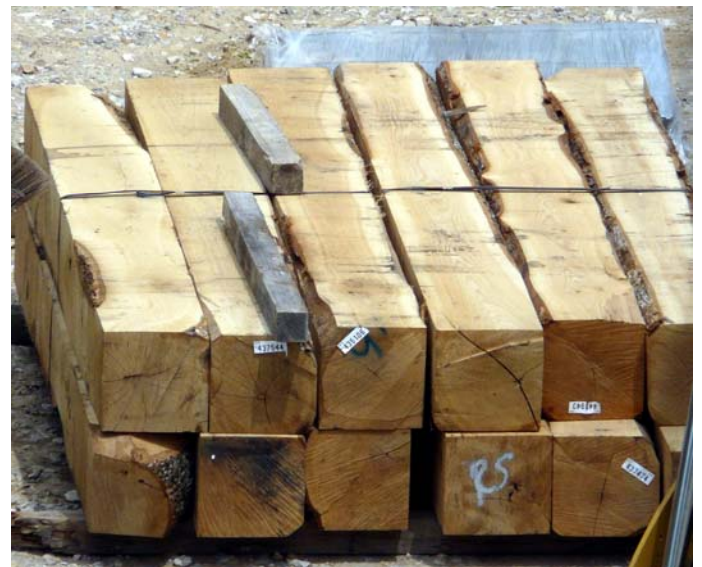
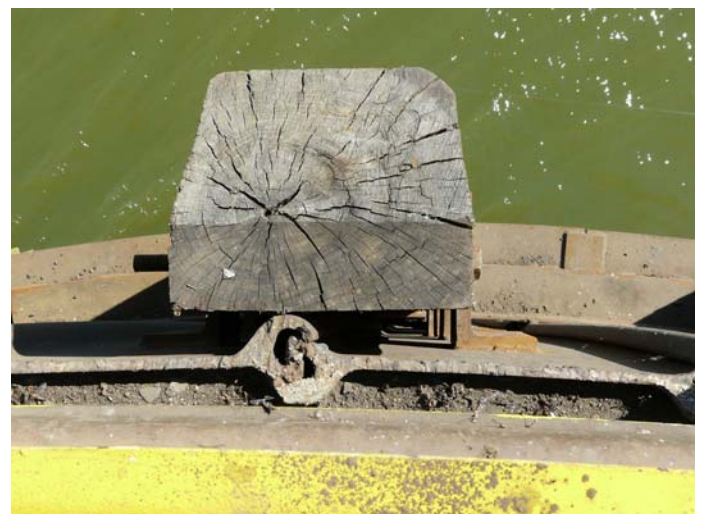
Fig. 11. Timber fenders.

Fig. 12. Installed timber fender.

The weekly barge traffic at the cell is kept off the channel and protective wide flange with 12 inch square oak timbers that

are attached to the cell with clip angles and through bolts (see Fig. 11 and 12).

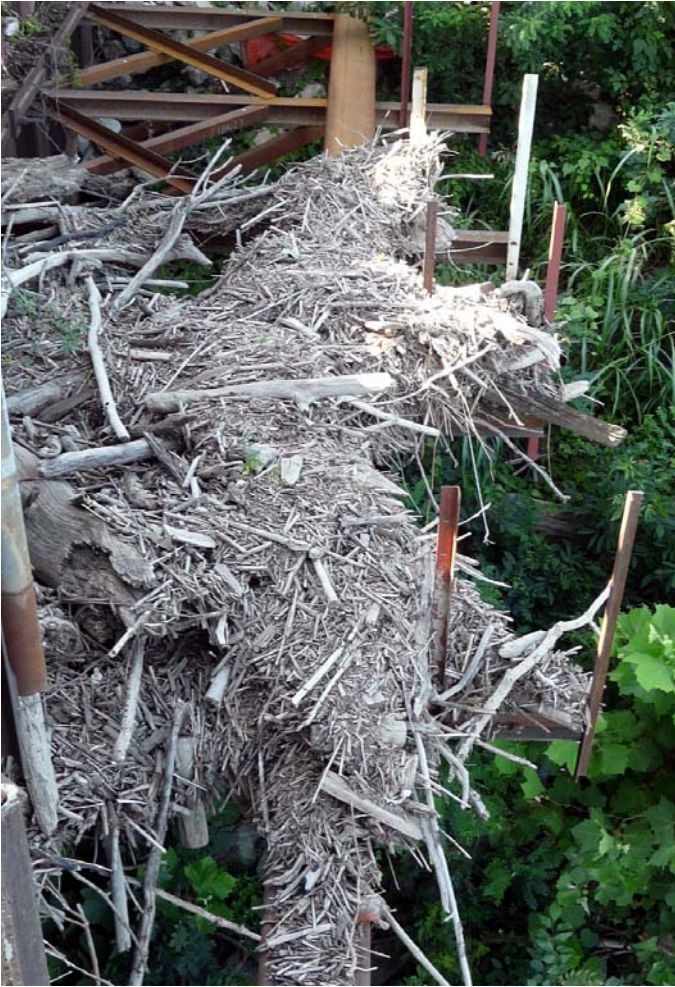
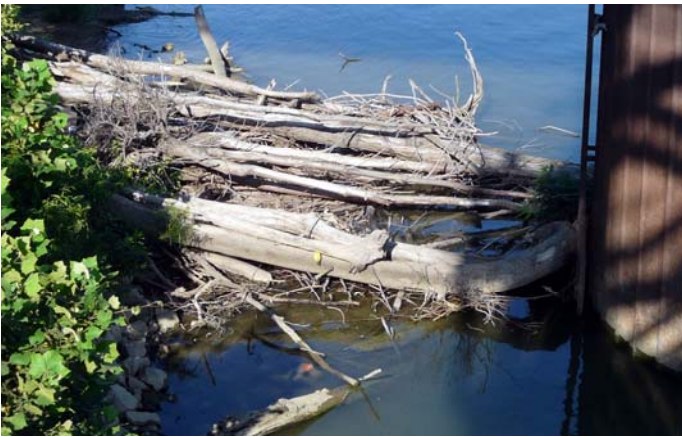
The tension rods, where exposed riverward of the existing river bank, are subject to damage from debris floating downstream in the river (see Fig. 13 and 14). The highly stressed tension bars were protected from floating debris damage by being placed within a TS6x14 structural tube (see Fig. 15). After stressing of the system was completed, the annular space between the bars and the structural tube was filled with cement grout for further protection from impact damage and for corrosion protection purposes. The tension belt channel to tension bar transition connection was also encased within a protective structural tube and the annular space filled with waterproof grease for corrosion protection (see Fig. 16).

Fig. 13. Debris on tension bar protective structural tube.

Fig. 14. Debris at mooring cell upstream of load platform cell.
