Soil Nailing: The MoDOT Experience

SOIL NAILING: THE MoDOT EXPERIENCE

Paper No. 5.10

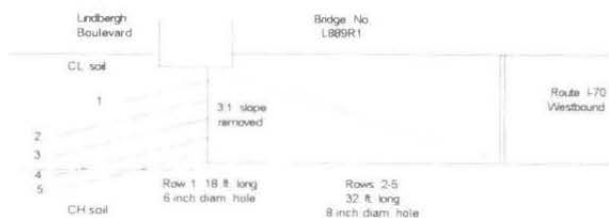
Fig. 1 Profile of Temporary Wall at Lindbergh Boulevard

The planned temporary shoring wall A5316 consisted of 150 nails with a minimum embedment length of eighteen feet installed at a 15 degree angle to the horizontal. The nail locations were spaced at maximum of four feet horizontally and vertically. This covered an excavation of approximately 20 feet in height and 150 feet in width. The nails were 1 1/4 inches in diameter with a planned minimum grouted hole diameter of 6 inches.

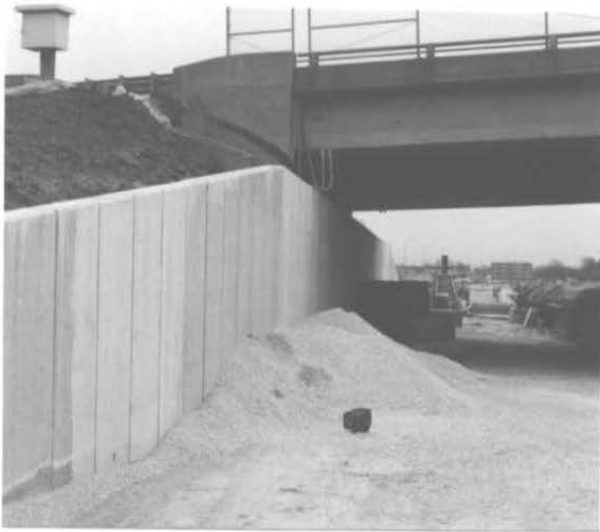
Fig. 4 Completion of Wall A5316 at Lindbergh Boulevard

The temporary wall at Lindbergh was completed in November, 1994. The cast in place L wall A5316 was completed in February, 1994.

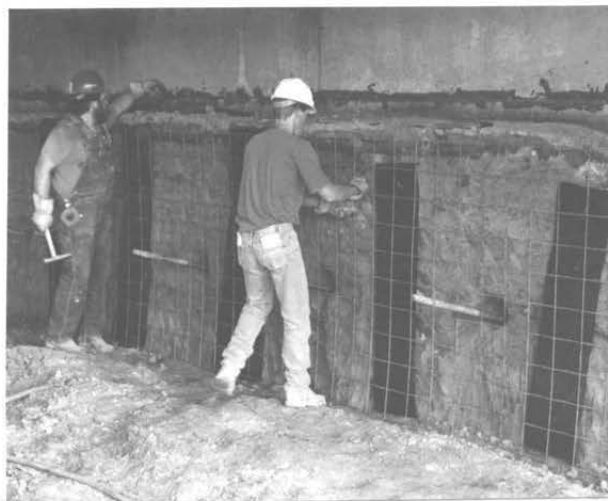
Fig. 3 Construction of Temporary Wall at Lindbergh Boulevard

Construction continued without problem until the installation of the bottom row of nails. The westerly half of the last lift was excavated on November 16, 1994. This last lift consisted of a fissured clayey loess. During the excavation, sloughing and back breaks occurred. The contractor drilled and grouted the nails in the excavation lift but did not shotcrete the face and attach the bearing plates and nuts. The face was left open overnight.

Early the next day a large tension crack was noticed on the west side of the wall running vertically behind the bridge abutment. Sloughing and overbreaks had increased and grew larger overnight. Discussion between FHWA, MoDOT, Subsurface Constructors, Kozeny Wagner, and Reitz and Jens personnel was immediately held and, upon the FHWA's recommendations, an excavator was used to unload approximately 4 feet of soil surcharge from behind the top of the wall. The placement of drain strip and welded wire mesh and application of shotcrete was done at the fastest possible pace. Survey monitoring was established to determine direction and amount of movement. The surveying program initiated in the morning of 11/17/94 revealed from presurveyed points that the wall had outward movement of 0.10 feet. Survey readings in the early afternoon revealed 0.02 feet of

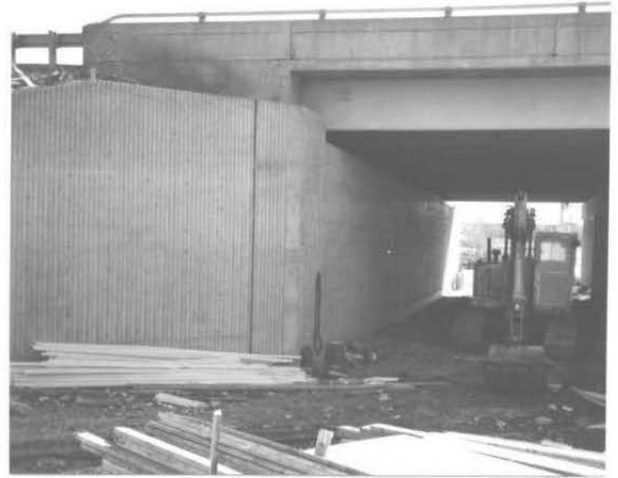
Fig. 7 Completed Retaining Wall at Truman Drive

The installation of shotcrete, drainage strips, nails and testing of designated production nails was completed in early January, 1996, with the cast in place portion being completed in February, 1996.
