Long Term Failure in Compacted Clay Slopes

SYNOPSIS The results of field, laboratory, and analytical investigations of recurring slope failures along the Mississippi River Levee are presented. Observations from slide trenching operations are described. Laboratory measured shear strengths are compared to effective strengths at failure "back-calculated" for two slides. Factors influencing the long term behavior of the levee materials and the mechanism of failure are discussed.

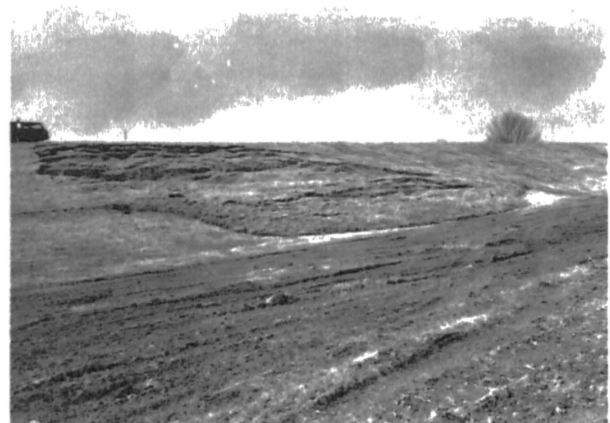
The highly plastic clay on the levee slope is highly overconsolidated by dessication. During dry periods, surface cracking is widespread and repeated cycles of wetting and drying produce a blocky slickensided structure to a depth of 5 to 7 feet. The slides occur in this weathered zone 20 to 40 years after construction and appear to be triggered by heavy rainfall. The maximum depth of the slides varies from 4 to 7 feet. They occur primarily in the riverside slope between the crown and a point midway down the slope and range in length from 100 to 300 feet. A typical slide is shown in Figure 1.

Fig. 1. Typical Levee Slough Slide.

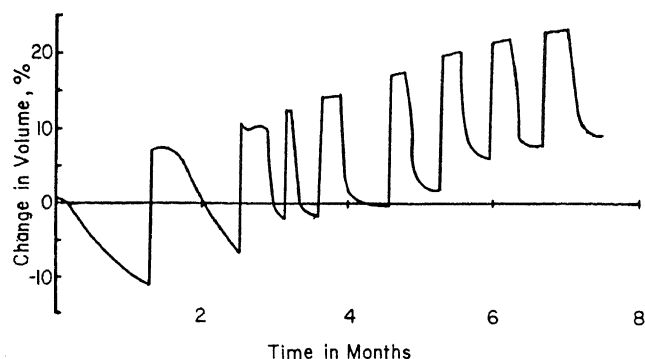
Fig. 4. Results of Cyclic Shrink-Swell Test.

It can be seen that as the number of wet-dry cycles increases there is a corresponding increase in swell volume and that a relative equilibrium where shrinking and swelling occur between constant limits had not been reached even after 9 cycles. Popesco (1980) attributes this phenomenon to progressive slaking which augments the swelling-shrinking ability of the soil. Tests presented by Popesco show that an equilibrium is eventually reached although it might take a number of years to reach this point of stabilization in the field.

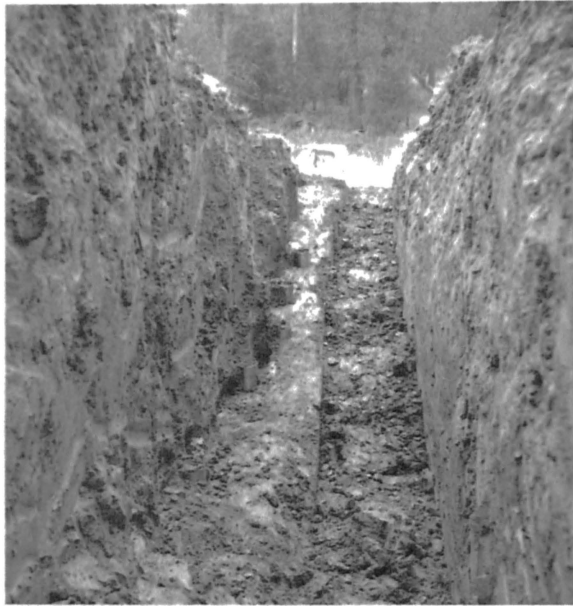
The primary differences in the fully developed slides and slides in the initial stages of development were in characteristics of the slide planes. The typical soil profile encountered in fully developed slides consisted of 1 to 4 inches of soil with a buckshot structure at the surface. Underlying this was soil with either a cubic or platey structure, occasionally combinations of both types, down to the slide plane. The cubic or platey structure was also noted below the slide plane in some of the slides but the structure was not nearly so well developed as above the slide plane. The material immediately above the slide plane, 1 to 3 inches, was usually very soft and wet and appeared to be highly remolded. The degree of difficulty in locating a distinct slide plane depended on the softness and thickness of the remolded zone surrounding the slide plane. If the remolded zone was relatively thin and only slightly soft, a distinct slide plane could be located easily. As the thickness and softness increased, the difficulty of locating a distinct slide plane increased. Immediately below the slide plane the material was generally stiff and showed no evidence of disturbance. The slide plane itself was generally shiny and smooth as shown in Figure 5.

Fig. 5. Downslope View of Trenched Slide Showing Exposed Slide Plane.
