An "Unexpected" Rock Failure in a Limestone Open Pit Mine

AN “UNEXPECTED” ROCK FAILURE IN A LIMESTONE OPEN PIT MINE

On 28th October 2004 a rock failure occurred in a limestone open pit quarry in Tuscany (Italy). The phenomenon evolved slowly with the collapse of about 1000 cubic meters. The complex failure mechanism mainly involved plane sliding along stratifications with rotation and block toppling. The phenomenon continued to evolve slowly and on 3rd November failure extended to the neighbouring portion of rock with a total collapse of about 5000 cubic meters of rock. Failure analysis took advantage of an accurate characterization of geology, geometry and mechanical properties of the collapsed rock mass. Such analysis led to the conclusion that the failure has been caused by the concurrence of various factors, namely:

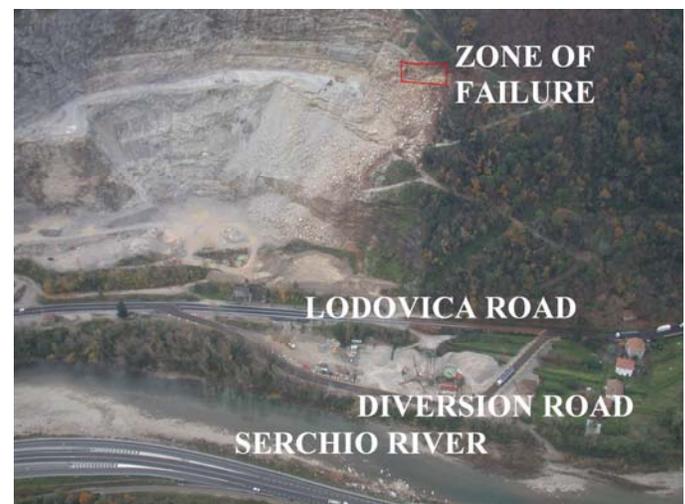
Fig. 1 View of the quarry site

The open pit quarry, under consideration, is located in the Lucca district (Tuscany - Italy). The exploitation of limestone shaped the quarry face as an amphitheatre, with height of about 190 m from the quarry crest to the quarry yard, and roughly developing E-W for a length of about 450 m along the Lodovica district road, which runs along the Serchio river and at the level of the quarry floor (Fig. 1). The rock slope failure occurred in the W sector of the quarry (Fig. 1), where a new access road was under construction, in two separate occasions (October/28/2004 & November/3-4/2004). Both episodes originated at the same elevation (170 m.s.l.m). The phenomenon evolved slowly with the collapse of about 1000 cubic meters on 28th October. The complex failure mechanism mainly involved plane sliding along a 20° dipping stratification with rotation and block fall/toppling. The phenomenon continued to evolve slowly and on 3rd November failure extended to the neighbouring portion of rock with a total collapse of about 5000 cubic meters of rock. The failed rock slid down and spread into two different directions to the quarry yard (elevation 60 m. s.l.m.), covering part of the quarry slope immediately below the failed rock face and obstructing a hairpin bend in the access road. The toe of the failure is located at an elevation of 150 m. s.l.m. in correspondence to the 20° dipping stratification while the crest of the scar is well marked, over a length of about 70 m, by a subvertical tension crack and by the collapse of the access road at 170 m elevation. Figures 2 & 3 show pictures of the same portion of quarry respectively before and after the failure. The characteristic features are identified in both

The rock slope failure had two main consequences: 1) mining exploitation was definitively stopped; and 2) a diversion road (Fig. 1) was constructed and kept in use until the west portion of the quarry was put under safe conditions by means of appropriate works not described in this paper which mainly

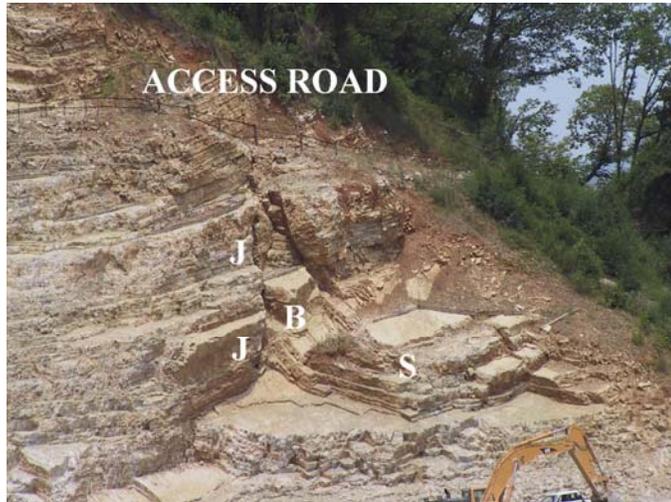
pictures: the same sub - vertical joint indicated as JJ in both pictures, the same block indicated as B and the access road which in Fig. 3 is interrupted.

Fig. 2 Picture taken on 25th June 2003 of the collapsed rock mass before the failure: JJ sub-vertical joint, B Block, S 20° dipping stratification)

In conclusion, the Newmark - analysis results suggest that, more than one single blast, the accumulated effect of repeated blasts should be considered as one possible triggering factor. The rock mass which collapsed in autumn 2004 was apparently stable in June 2003 (Fig. 2). It is also worthwhile to remark that the first signs of rock instability (tension cracks in

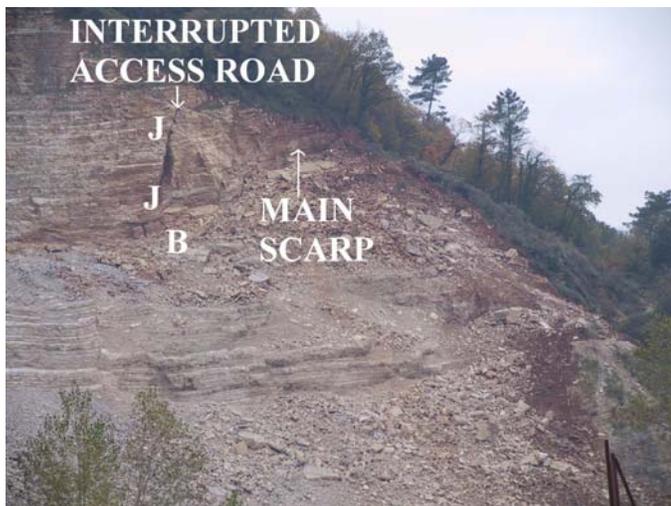
Fig. 3 Picture taken on 22nd November 2004 of the collapsed zone after the failure: JJ sub-vertical joint, B Block

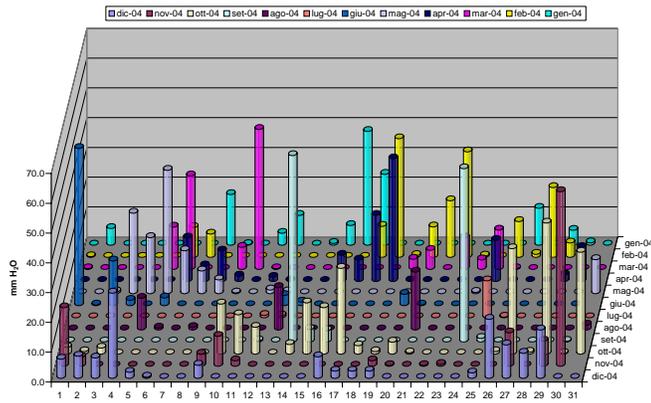
Fig. 4: Rainfall recorded at the Piaggione pluviometer, located near the quarry site (year 2004)

the access road) appeared in the afternoon of 27th October (the day before the first failure) in concomitance with intense rainfall (see Fig. 4).

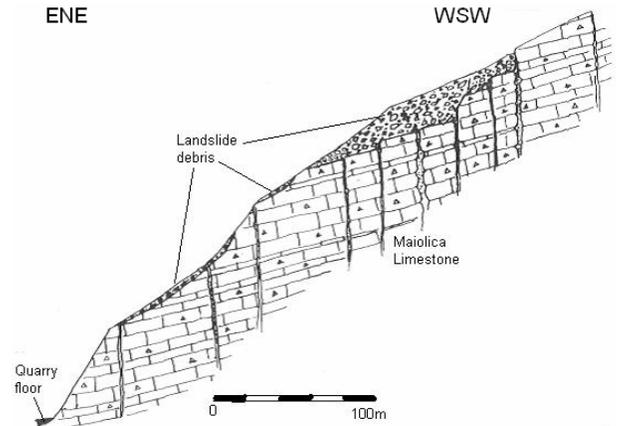
A geological section in sector 3, is shown in Fig. 5. The local rock mass structure is characterized by the bedding joints S_t ($107^\circ/19^\circ$) and three principal joint systems: K_1 ($348^\circ/83^\circ$), K_2 ($45^\circ/82^\circ$), K_3 ($74^\circ/86^\circ$). Bedding joints(those joints developed on bedding surfaces) are highly persistent and represent the lowest angle set while the other three joint sets represent high angle or subvertical joints. All the joints subdivide the rock mass in almost straight dihedral prevailingly formed by the intersection of the K_2 , and K_3 sets as the set S_t which makes up their base. The S_t surfaces appear smooth, slightly weathered and usually tight, sometimes showing silty or sandy infillings. According to the local bed thickness, their spacing is usually $<0.5m$, while the spacing of the other joints is generally $\sim 1m$. The surfaces of the K_2 set, which often shows a less than 1m linear size, are slightly rough and have wide separations. Their intersection with S_t makes the edge of the wedges align with the quarry slope. K_1 , and K_3 sets are also non - persistent and show wide separations, however their surfaces appear oxidized and very weathered and karstic features can be seen. All these disjunctive features could have had an important role on the structural control of the rock mass and on shaping the scar of the rock slope failure.

Fig. 5: Geological section in the sector 3, subject to the failure (Puccinelli, 2005)

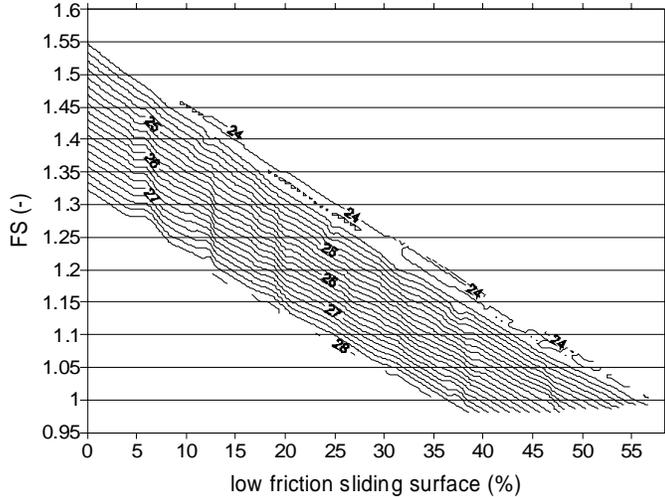
Fig. 6 Trend of FS versus percentage of the sliding surface having low ϕ_i for different α_{ST} .

All the above mentioned types of analyses led to the conclusion that the rock failure becomes justified only assuming a degradation of the joint strength. It is especially instructive to see the safety factor FS obtained from LEM analyses as a function of bedding plane inclination (α_{ST}) and percentage of the bedding plane having low strength (Fig. 6). It is possible to notice that the safety factor becomes less than

1.0 when such a percentage is greater than 40 -55 % for $\alpha_{ST} = 24 - 28^\circ$

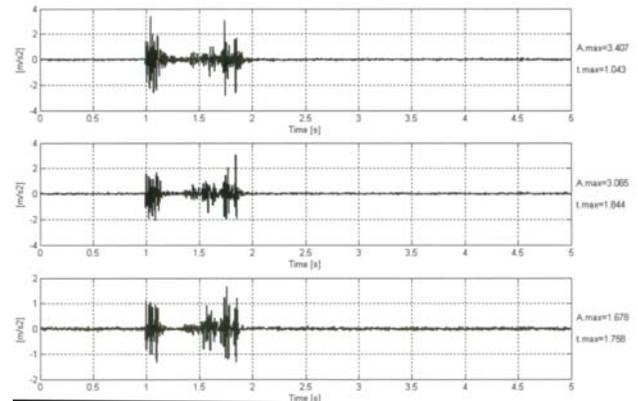
Three 3D SETAC (SEquoia Triaxial Acceleration Computer) accelerometers, located at different distances from the blast area have been used to measure acceleration time histories during the activities for the rock slope re- profiling. The X axis was oriented along the bedding plane. The maximum peak accelerations were recorded in the X direction (Table 1). Probably, the maximum amplitude is associated to surface waves. Figure 7 shows the time histories in the three different directions recorded by SETAC 1. Similar time histories have been observed for SETAC 2 and SETAC 3. The effective duration of time histories is in between 0.7-0.9 s, which appear white reasonable. Two well separated wave trains are observed in each wave trace. In some cases the second train contains the maximum amplitude. Frequency content of both trains is in the same band.

Fig. 7 Time histories (X, Y, Z) recorded by SETAC 1

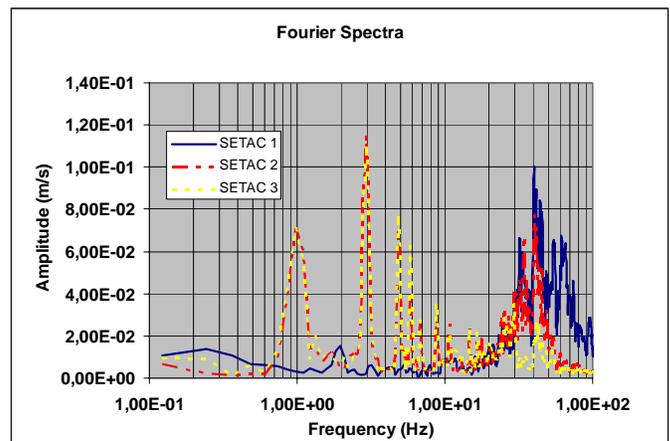
Fig. 8 Fourier Spectra X component of acceleration time histories recorded by SETAC 1, SETAC 2, SETAC 3.

Figure 8 shows the Fourier spectra of the X components, recorded at three different distances. It is possible to notice that for the accelerometer closest to the blast area (SETAC 1) the peak amplitude of Fourier spectrum is observed at around 50 Hz while such a peak moves towards lower frequencies for the other two accelerometers. The same result is obtained if the two wave trains, observed in the acceleration time histories, are analysed separately.
