## Managing Sinkholes at Project Site, A Saudi Arabian Case History

Syed Faiz Ahmad, M. ASCE  
Saudi Oger Ltd  
Riyadh, Saudi Arabia

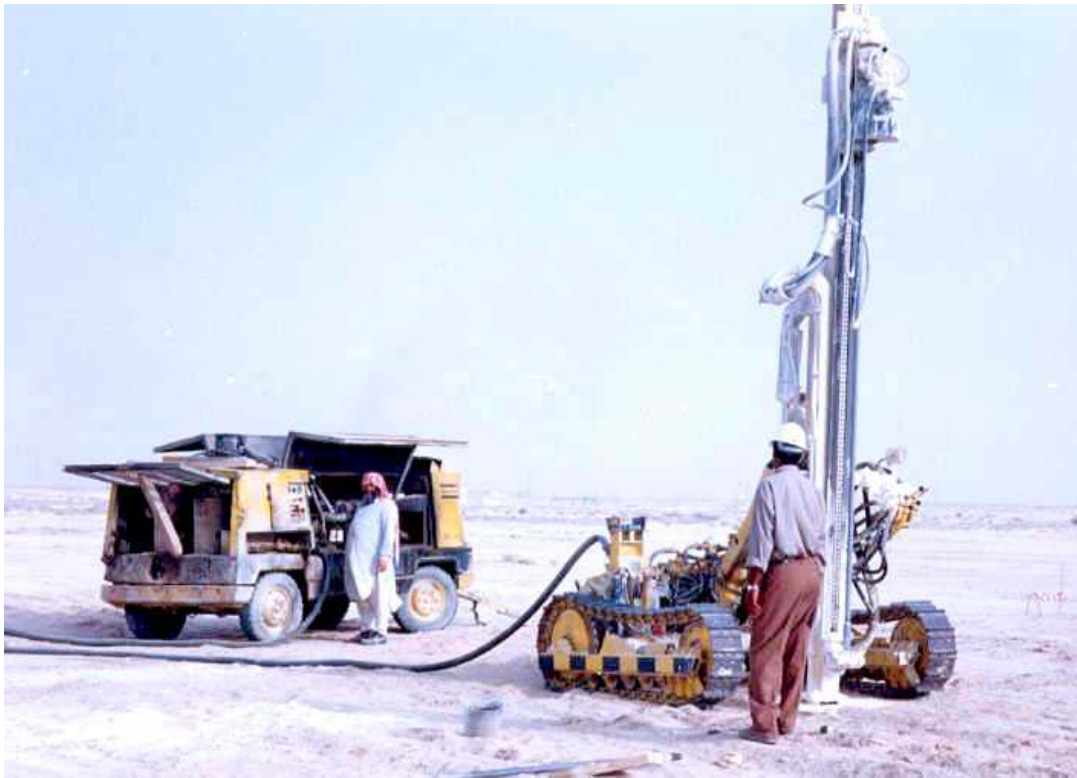
Plate: 1 Cavity Probing in progress at the Site

or absence of the cavities, before going ahead with pouring of foundations. A total of 5,610 nos. of Probe holes (in 166 facilities in 06 zones) were performed. This included an additional 219 nos. around the problem areas in 18 nos. of facilities. The Cavity search program was very detailed & extensive. The Probing was carried out by means of pneumatic driving of a rock probe into the rock using a Wagon Drill. Compressed air was used to clean the hole as advanced. The time of penetration of probe through each consecutive depth of 20 cm was carefully recorded which indicated the resistance of rock to penetration. In case of occurrence of cavity/loose zones in underlying strata, the time for penetration records will be comparatively small. A duration of less than 10 seconds for 20 cm penetration is considered the presence of loose zones, while in case of cavity, there will be no resistance to rock penetration and it occurs all of a sudden.

- Time taken for 20 cm penetration
- Air escape in the finished boreholes
- Sudden fall of drill rod
- Boreholes, where time was 10 seconds or less

When the last three observations were noted in any bore, the probing was repeated around them until either presence of cavity was detected or some reasonable explanations were found for the same. In case of cavities, the same was back filled with grout. Excavations were also done, around these problem probe holes, to expose the Sinkholes or Cavities.

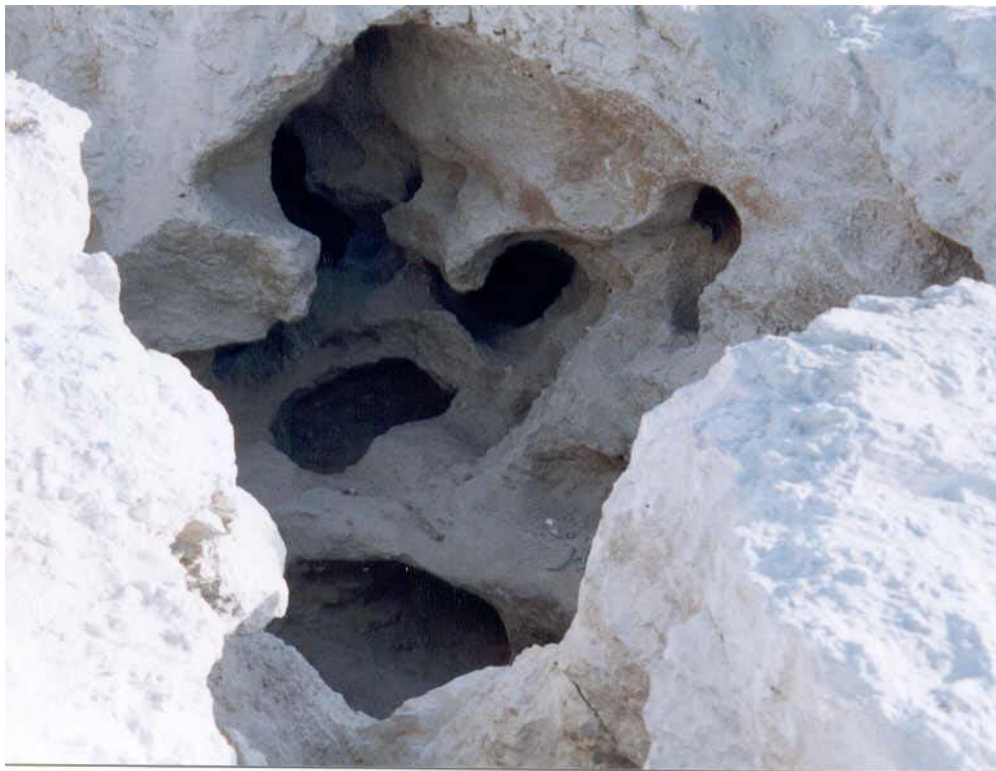
Plate: 2 A Typical Sinkhole at the Site

At the Project Site, Sinkholes identified ranged from “small dropouts” or simply trenches to large sized (about 2-m wide) irregular depressions. At some places, luckily outside the buildings, some cave like holes were found which had multi-lateral solution channels like features. Some of the pictures of these Sinkholes, discovered at the Project Site, are attached.

Foundation Construction: The Sinkholes and Cavities were mostly found outside the footprints of the facilities, except for some including 7E-010-1, 1F-030-1 & 5A-200-1. In these, large open-mouthed Sinkholes (about 5m x 4m x 3m deep) were found right inside the footprint. These were over excavated to expose the extent of the cavities and later were treated by means of Compaction Grouting. This new technique was developed in the USA and is defined as, “the Grout injected with a slump less than 25 mm”. In this, normally a soil-cement with sufficient silt sizes, to provide plasticity, is used which develops internal friction. The grout generally does not enter soil pores but remains in a homogenous mass that gives controlled displacement. Normal Grout was also used to fix the problem in this particular facility. Some were also rock backfilled using bridging technique.

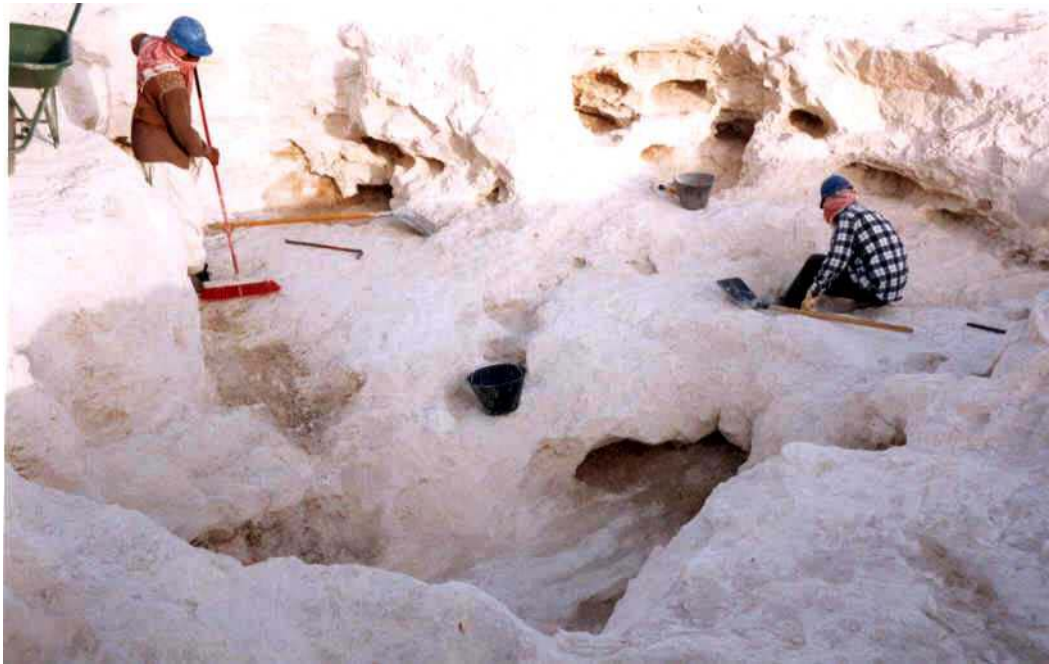
Plate: 3 Preparation being made for Treatment of Sinkhole at the Site

themselves. If the “throat” of a Sinkhole is located, a commonly used treatment involves excavating the overburden soils to expose the opening in the rock surface.

The throat is then plugged or covered with an inverted filter, and the excavation backfilled. If the throat cannot be located, or the depth to rock makes exposing the rock surface impractical, a less effective treatment is normally used.

dividend and at some places pockets of dropouts were exposed & detected. These weak points were treated by various methods, including grouting and Bridging. Bridging included making use of rock pads & rock backfill together with use of geo-fabrics, etc. Efforts were also made during rough grading works not to push debris or soil into depressions that might mask evidence of Sinkhole activity. Large pan scrappers were used to move the soil and heavy traffic loading were monitored to reveal soft areas or dropouts. At some locations, multiple passes of this heavy equipment did result in dropouts, revealing voids or incipient Sinkholes. These were then treated by excavating and backfilling with grouts.
