(2013) - Seventh International Conference on
Case Histories in Geotechnical Engineering

GEOTECHNICAL LESSONS LEARNED FROM EARTHQUAKES

ABSTRACT

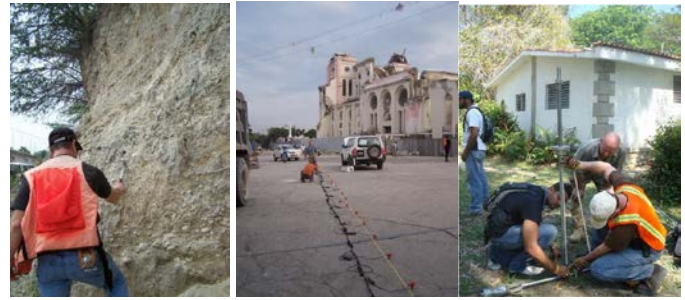
Fig. 1. Field activities in Haiti: geologic and damage mapping, MASW testing, and DCPT testing.

The 2010 M_w 7.0 Haiti earthquake represents one of the most devastating earthquakes in history from a human impact perspective, with an estimated 200,000 or more deaths and millions left homeless. NSF supported a GEER team to investigate the influence of geotechnical conditions on the devastation in Haiti (Rathje et al. 2010). The team was able to take advantage of various remote sensing data sources during its reconnaissance, including high-resolution aerial photography and LIDAR acquired by the World Bank. They performed geologic and damage mapping, shear wave velocity profiling using the multi-channel analysis of surface waves (MASW) technique, and dynamic cone penetration tests (DCPT) at liquefaction sites.

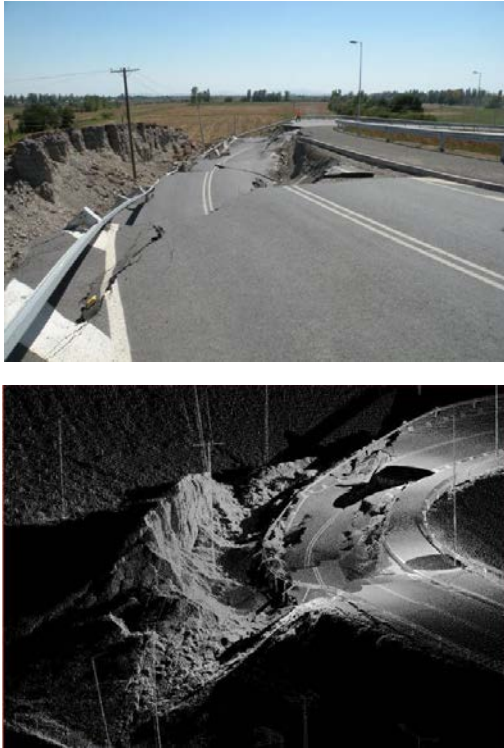
Fig. 3. Ground-based optical and LIDAR images of a failed overpass embankment on Ruta 5 as a result of the 2010 Chile Earthquake (courtesy of Kayen/GEER).

Besides photographic documentation that records images of damaged and undamaged facilities and systems, advanced techniques, such as LIDAR, can be used to help document more completely ground deformation across wide areas (Kayen and Collins 2012). Ground-based LIDAR has been used successfully to document ground failure in several earthquakes as well as after other extreme events. For example, aerial photography and ground-based LIDAR were used to document the Shiroiwa (White Rock) landslide that resulted from the shaking of the 2004 Niigata-ken Chuetsu, Japan earthquake (see Fig. 2). This large landslide adversely impacted a major road and adjacent bridge (Rathje et al. 2006). Another example is the detailed depiction of a failed highway overpass embankment in Chile, as shown in Fig. 3.

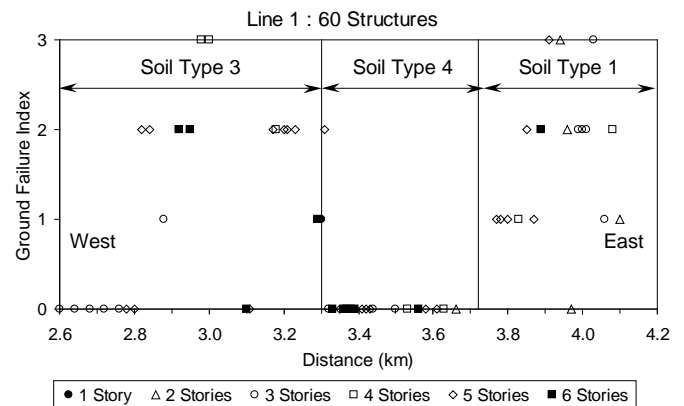
Fig. 6. Correlation of Ground Failure and Soil Type on Line 1 in Adapazari, Turkey. Soil Types 1 and 3 contain liquefiable silt deposits, but Soil Type 4 does not (Sancio et al. 2002).

Existing techniques can also be better utilized in a coordinated manner to obtain quantitative data on ground failure and building performance after an earthquake. For example, using a modified version of the Coburn and Spence (1992) rapid survey of structural damage and the ground failure index presented in Bray and Stewart (2000), reliable damage data were obtained in the city of Adapazari after the 1999 Kocaeli, Turkey earthquake before damaged buildings were razed or repaired. These data (an example is shown in Fig. 5) proved to be invaluable for focusing later in-depth studies. These data allowed investigators, such as described in Sancio et al. (2002), to correlate the occurrence of ground failure with particular ground conditions, as illustrated in Figure 6.

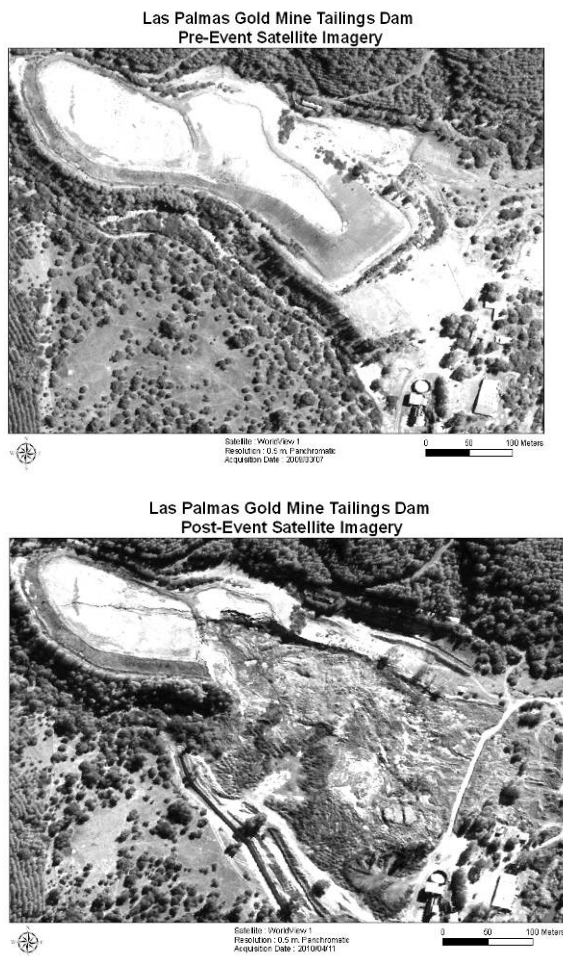
Fig. 8. Pre and post satellite images of failed tailings impoundment.

Most earth retention systems, such as retaining walls and basement walls, proved to be inherently robust. Landslides and other large earth movements were not pervasive, which appears to have resulted from native slopes that are generally composed of competent earth materials and the relatively low groundwater levels present at the end of the dry season. Most dams, levees, and mine tailings dams also performed well. Several key earth structures experienced some distress, and in one case a liquefaction-induced tailings dam failure produced a flow slide that killed four. Pre- and post-event satellite imagery of the tailings impoundment is shown in Fig. 8.
