International Conference on Case Histories in
Geotechnical Engineering

THE CASE OF THE NEW TAGUS RIVER LEZIRIA BRIDGE

A brief description of the New Tagus River Leziria Bridge composed by 1695 m North Viaduct, by 970 m Main Bridge and by South Viaduct with a length of 9200 m is presented.

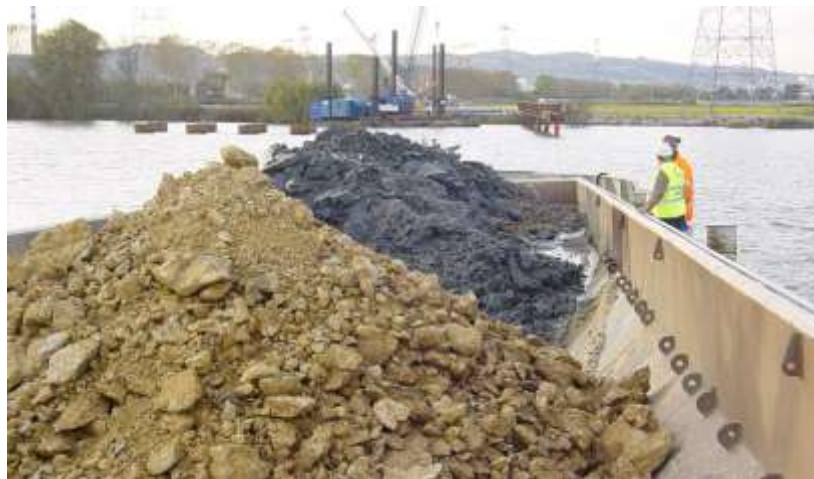
Fig. 5. Visual aspect of the materials

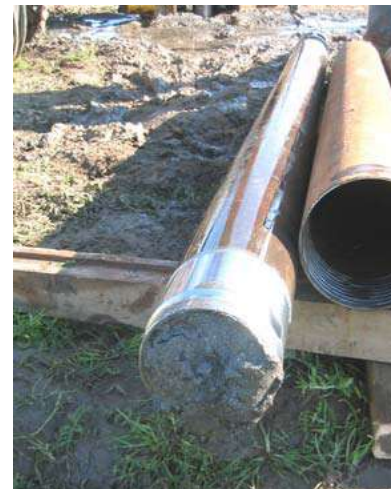
Fig. 7. Geobor S sampler

In three boreholes continuous undisturbed sampling with a triple sampler Geogor S was performed.

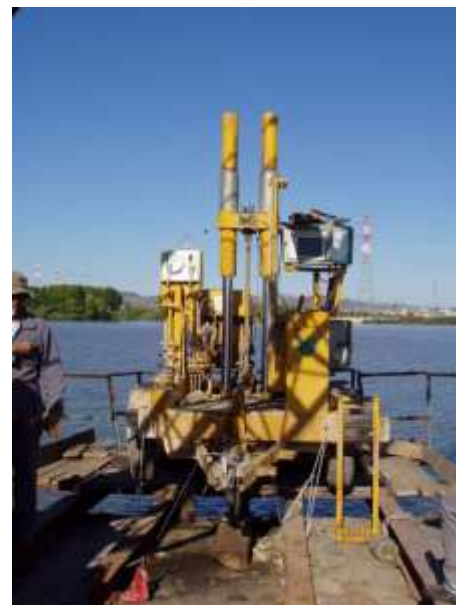
Fig. 8 CPTu equipment

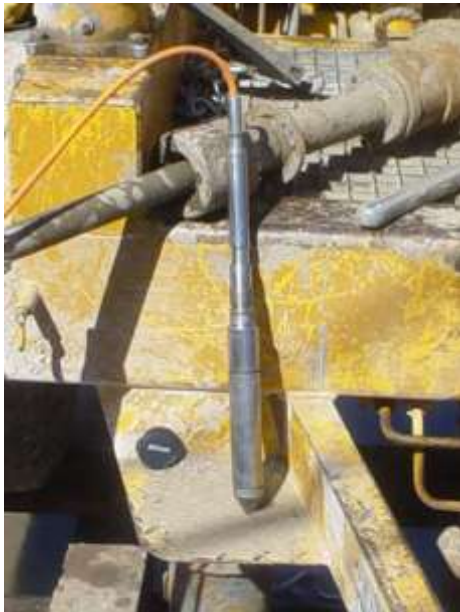
Fig 9. CPTu tip

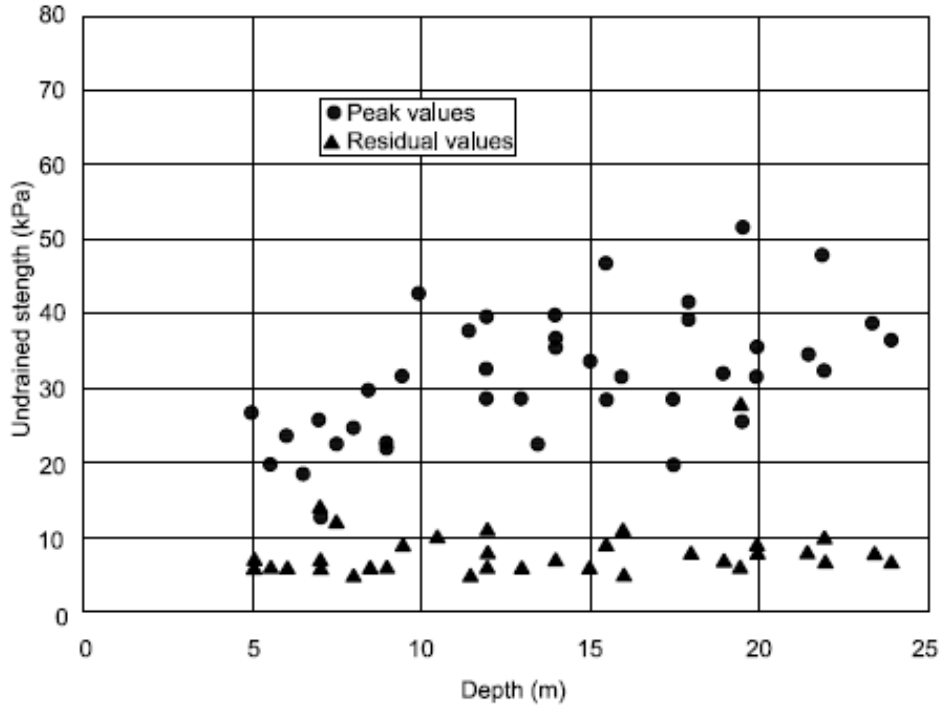
Fig 11. Variation of undrained strengths with depth

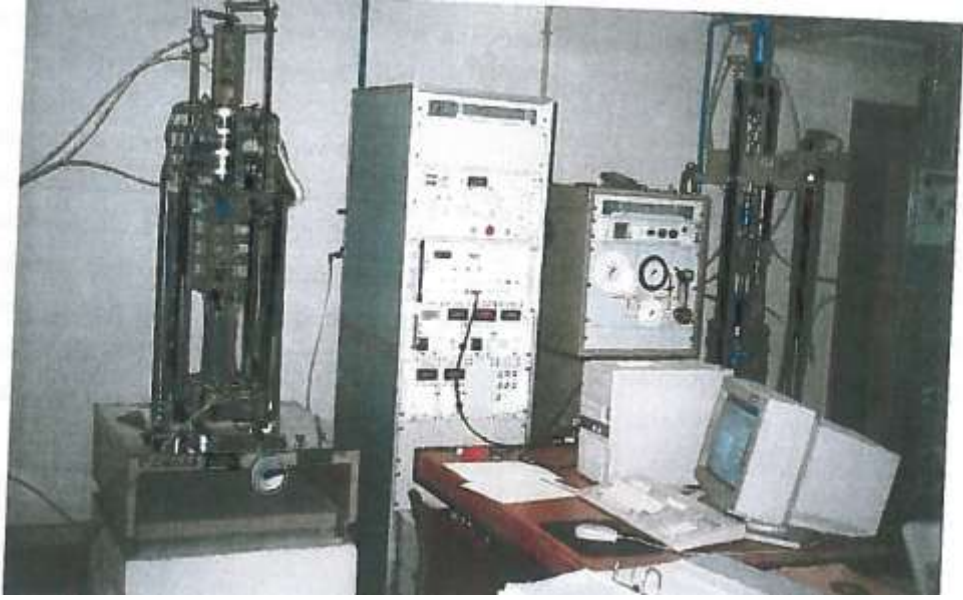
Fig. 13. View of cyclic torsional shear apparatus (after IST, 2005)

A view of cyclic torsional simple shear apparatus is presented in Fig. 13.

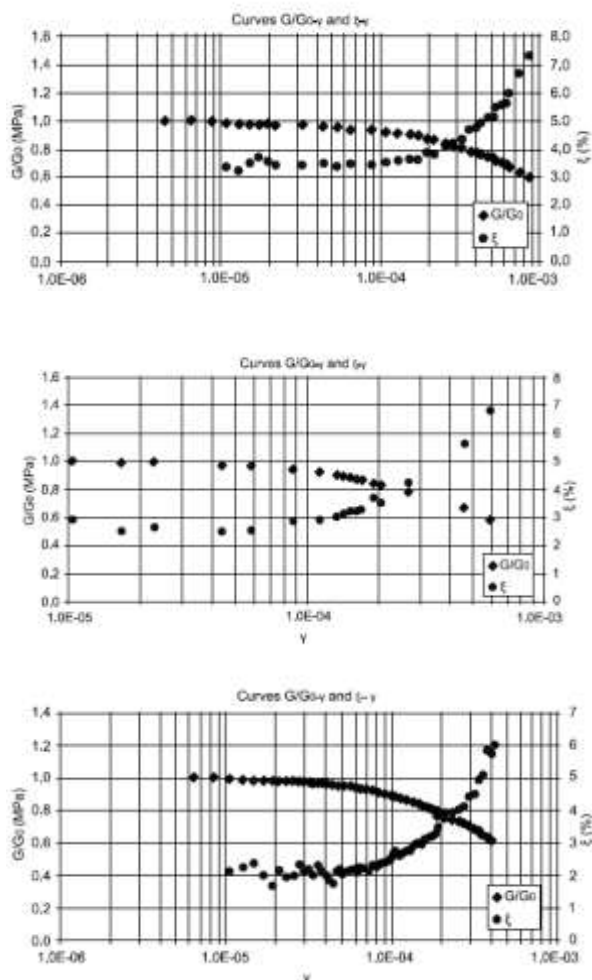
Fig. 14. Curves shear modulus and damping ratio versus shear strain (after IST, 2005)

The results of cyclic torsional tests are shown in Fig. 14 (IST, 2004b, 2005).

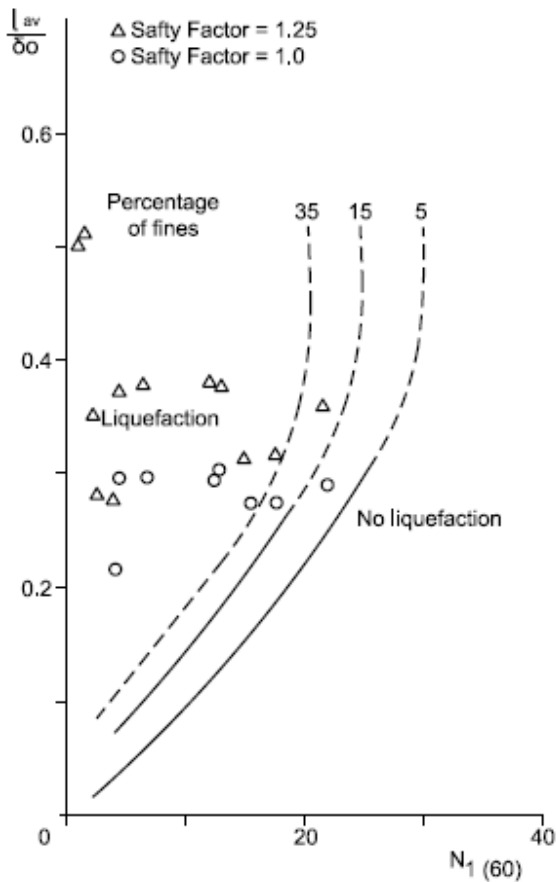
Fig. 29. Liquefaction potential evaluation by SPT tests

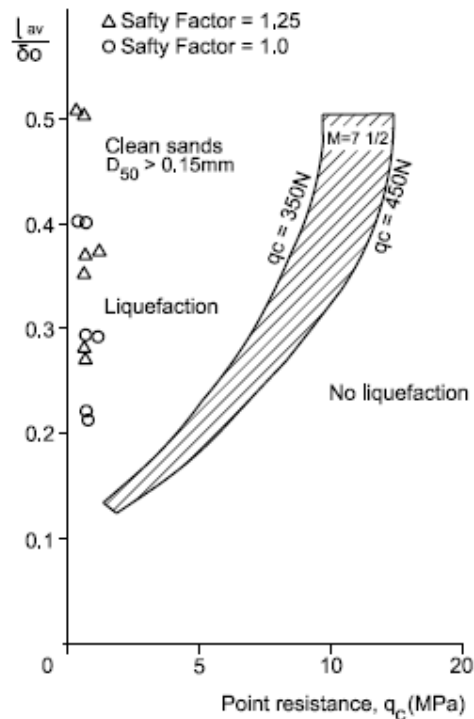
Fig. 30. Liquefaction potential evaluation from CPT tests

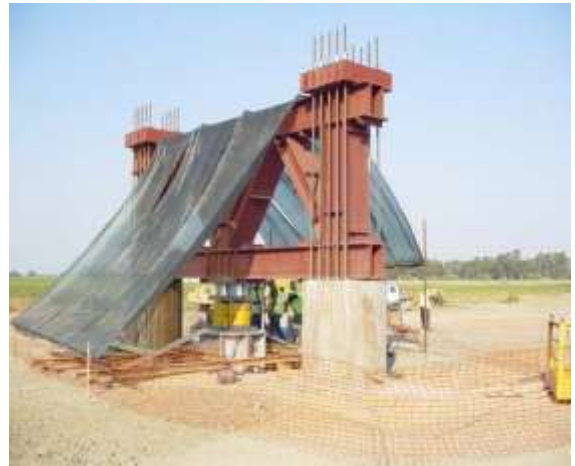
Fig. 33. General view for vertical pile load tests (after Ferreira et al, 2008)

A general view for vertical pile load tests is presented in Fig. 33.

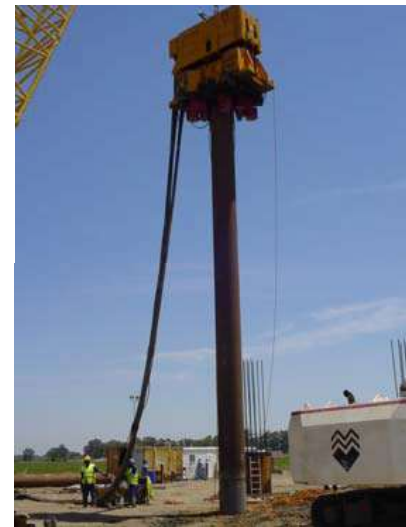
Fig. 44. Placement of pile casing (after Ferreira et al, 2008)

A view of South Viaduct construction is shown in Fig. 43. The placement of pile casing is shown in Fig. 44.

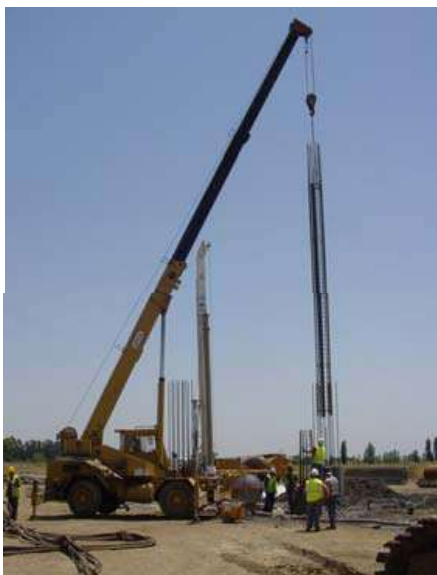
Fig. 45. Placement of pile reinforcement (after Ferreira et al, 2008)

The placement of pile reinforcement and tremi pipes are shown in Figs. 45 and 46.

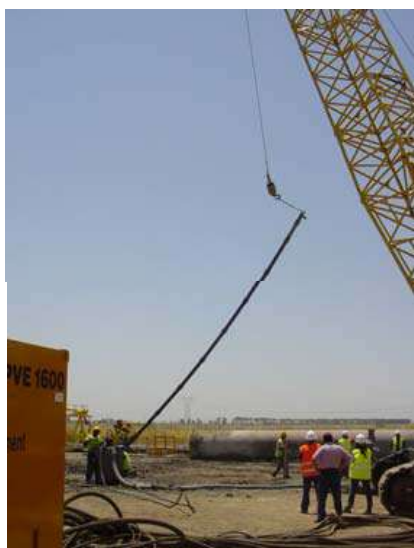
Fig. 46. Placement of tremie pipes (after Ferreira et al, 2008)

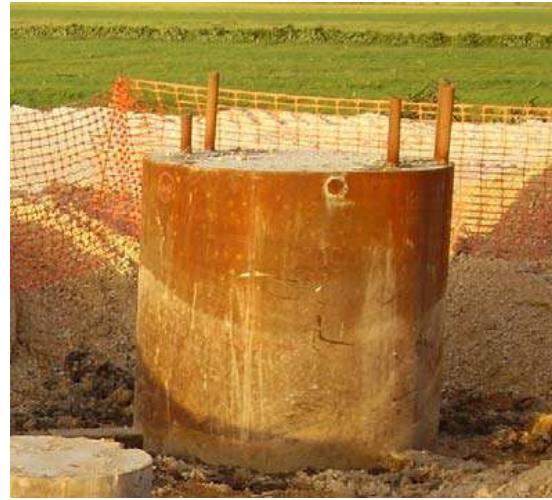
Fig. 50. 4 tubes for crosshole tests in a 1.5m diameter pile (after Ferreira et al, 2008)

Fig. 50 shows a pile view with 4 tubes.

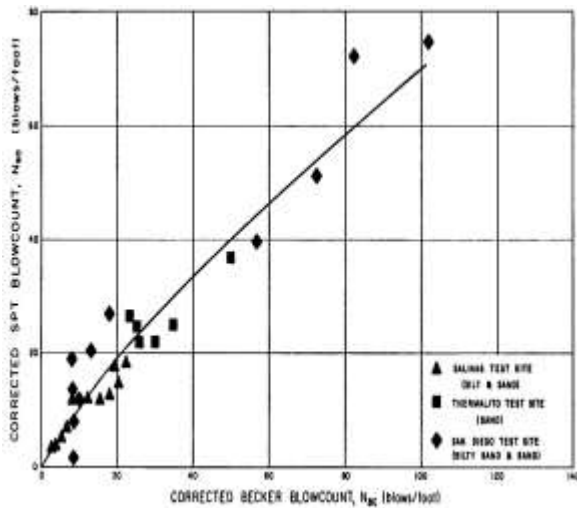
Fig. 52. Correlations between BPT and SPT modified values (after Harder and Seed, 1986)
