Underpinning a Residential Structure on Uncontrolled Fill With Helical Screw-Piles

UNDERPINNING A RESIDENTIAL STRUCTURE ON UNCONTROLLED FILL WITH HELICAL SCREW-PILES

ABSTRACT

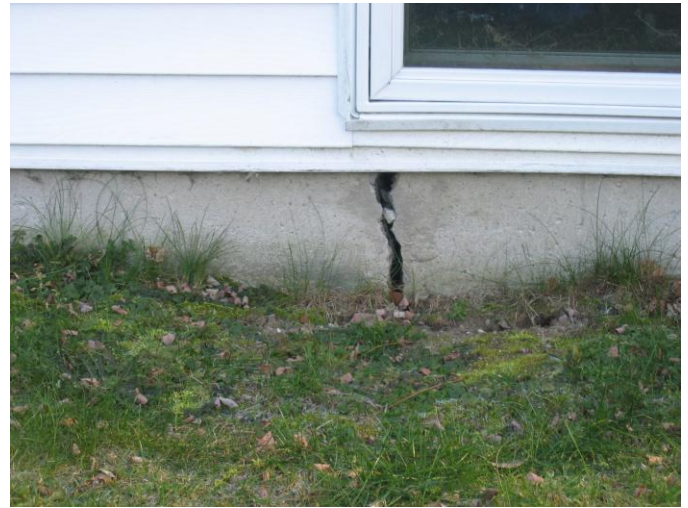
Fig. 1. Basement Wall Crack on South Side.

An initial site visit performed by the author in November of 2007 included a walk over the site and the surrounding area, including adjacent properties, a preliminary surface survey of the topography, and an inspection of the outside and inside of the structure, especially the basement. At that time, several large open cracks were identified in the exposed concrete basement walls on the south side and west side of the house, as shown in Figures 1 and 2. The opening on both cracks was about 1 in. at the top and they appeared to extend downward for a considerable distance. It wasn't until the inside walls of the basement were examined that it became clear that the cracks extended the full height of the walls and were connected by a crack extending across the concrete floor slab.

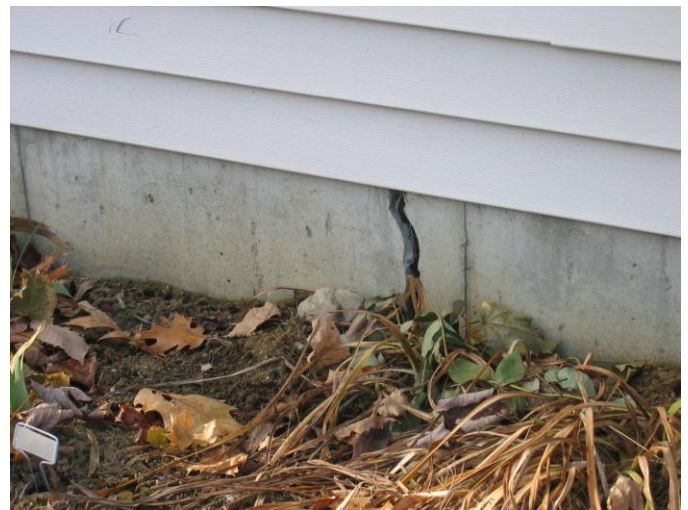
Fig. 2. Basement Wall Crack on North Side.

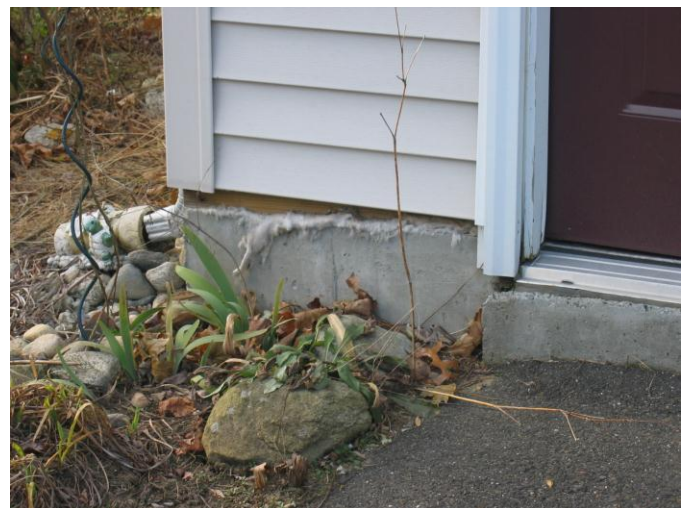
Fig 3. Separation of Garage from House.

At the same time, signs of settlement of the concrete floor slab in the attached garage were noted and separation between the slab and concrete perimeter walls was noted, as shown for example in Figure 3. The author attempted to perform several hand auger borings near the structure and in the yard but was met with refusal on gravel at about 2 ft. in all locations.

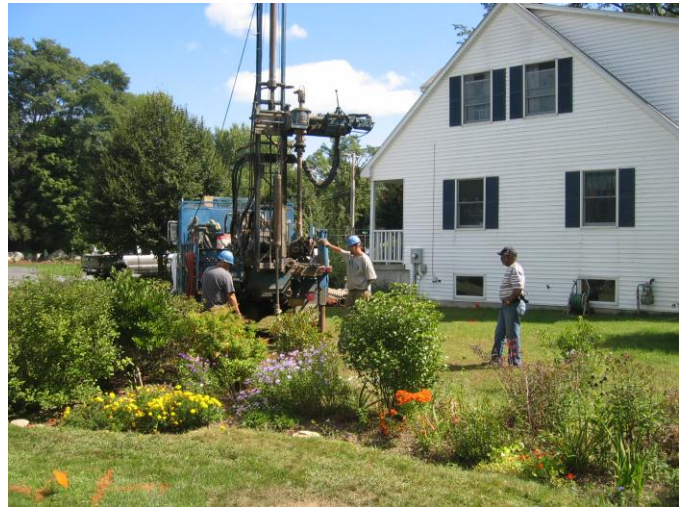
Fig.5. Test Drilling Between Adjacent Houses.

In September of 2008 a site investigation consisting of 8 test borings drilled to depths of 23 ft. using a truck mounted Mobile Drill Rig was performed at the site, Figures 4 and 5. Borings were placed as close as possible to the house and at several locations in the yard where depressions had been identified as well as in areas where no depressions were present. All of the borings were conducted on the same day and consisted of soil sampling and Standard Penetration Tests as well as ground water observations in each boring; very routine site investigation practice.

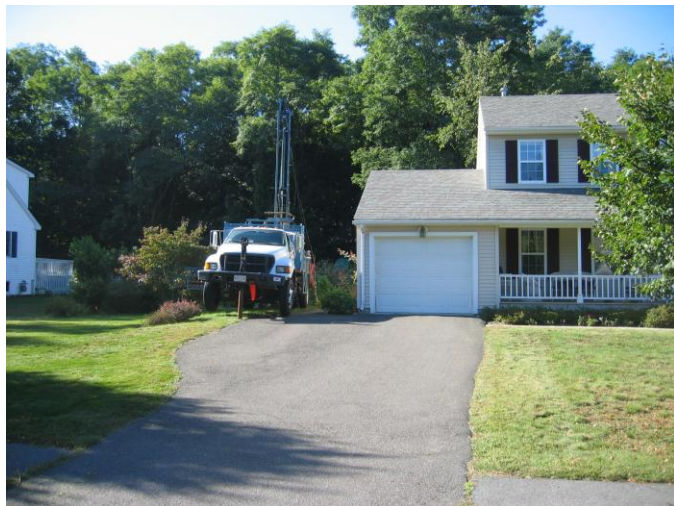
Fig.4. Test Drilling Adjacent to House.

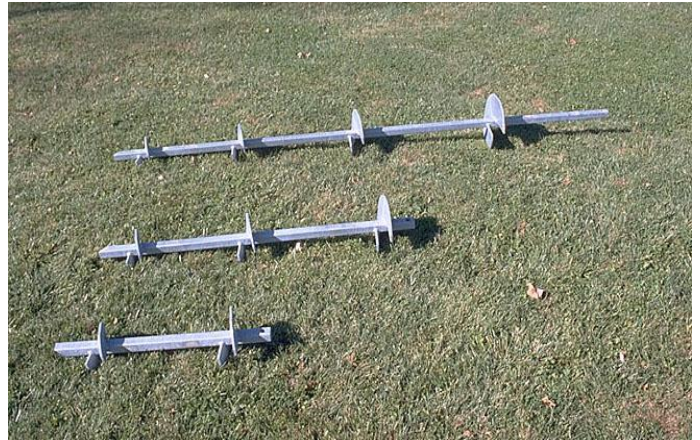
Fig. 7. Typical Square-Shaft Screw-Pile Lead Sections.

In many cases, depending on the site conditions and site access, Screw-Piles are considered an economic and attractive alternative to the more traditional forms of underpinning, such as open-hole micropiles or jacked/driven minipiles. A Screw-Pile consists of a central steel shaft that may be either circular or square in cross section and one or more helical plates welded to the tip. Most screw-piles currently being manufactured and used in the Civil Construction industry have either a central hollow pipe section or square shaft steel bar as shown in Figure 7.

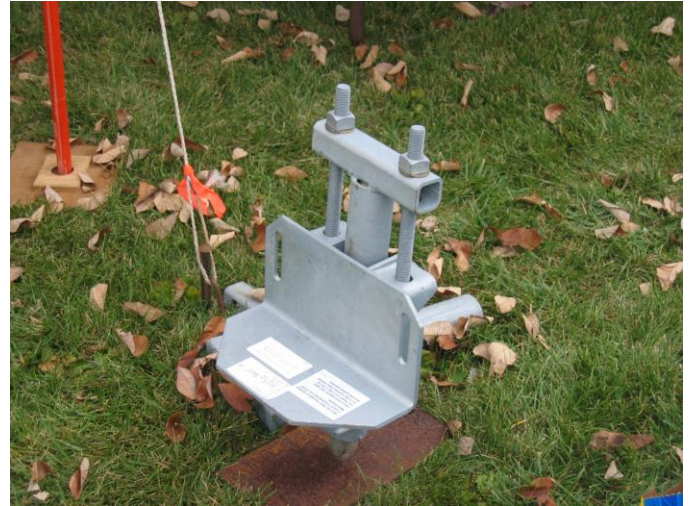
Fig. 9. Typical L-Style Foundation Bracket

hot-dipped galvanized. Figure 9 shows a typical L-style foundation bracket.

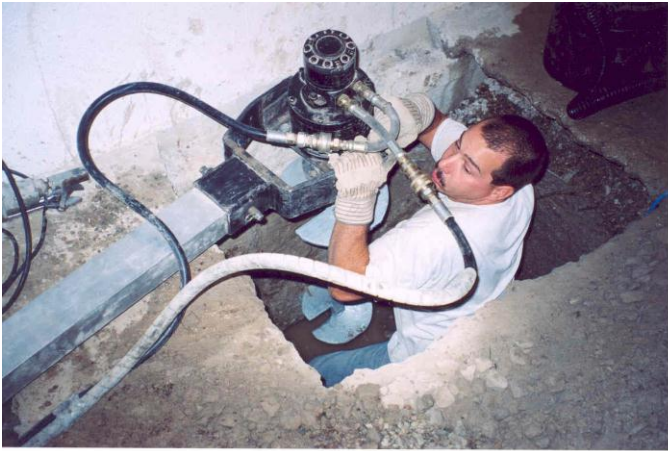
Fig. 10. Installation of a Screw-Pile Through a Cutout in a Basement Floor.

hydraulic torque motor was provided by the existing concrete wall using a lightweight torque arm. Figure 10 shows a worker installing a screw-pile through a floor access in a basement of an existing structure using light-duty hand-held portable hydraulic equipment.

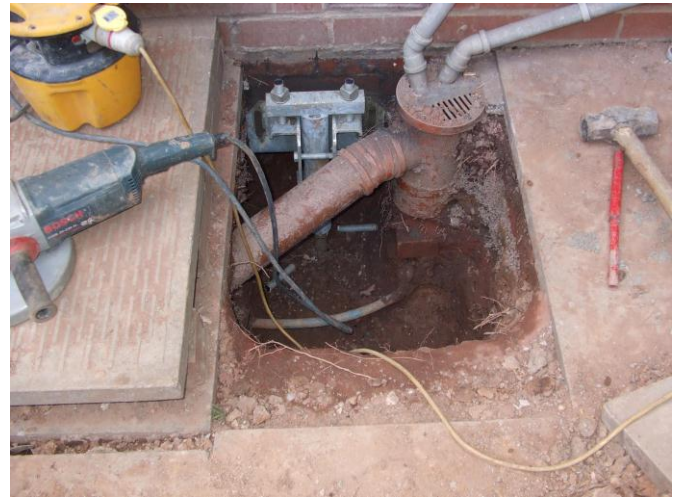
Fig. 11. Installation of a Screw-Pile Adjacent to Existing Drain Line.

The installation of Screw-Piles produces minimal disruption to existing utilities since the actual structural member is relatively small and produces minimal ground disturbance. Figure 11 shows the successful installation of a Screw-Pile adjacent to an existing drain line.

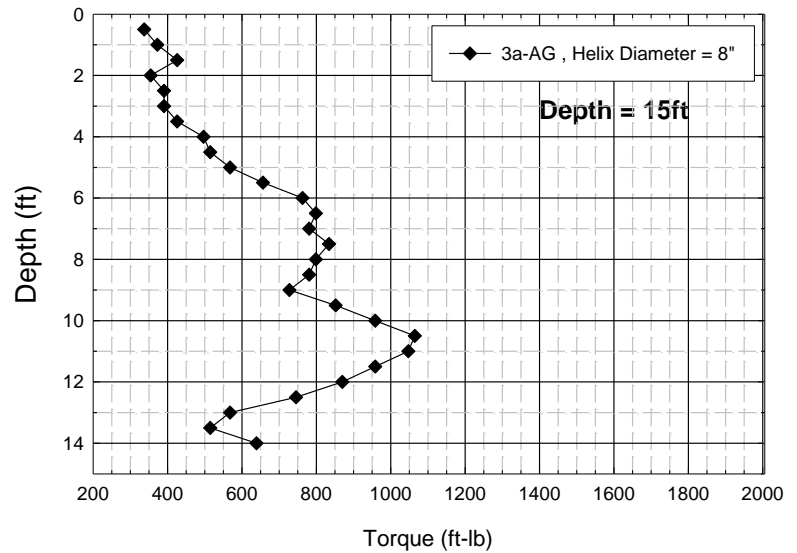
Fig. 12. Typical Screw-Pile Torque Installation Record.

During installation of screw-piles the hydraulic torque can be monitored to provide a continuous record of the installation torque. This attribute of Screw-Piles allows for field verification of the soil conditions at each pile location and for verification of load capacity. In effect, measurement of the installation torque means that load capacity of each Screw-Pile can be validated during installation; much like using a Pile Driving Analyzer during the installation of driven piles. This is particularly important when installing Screw-Piles for an existing structure where the soil conditions under the structure are often unknown and difficult to determine at ever pile location ahead of time, especially at interior locations. The installation torque record of every Screw-Pile provides an excellent quality control tool and should be included as a part of every project. The engineer can also use available empirical correlations to estimate capacity based on installation torque. Figure 12 shows a typical Screw-Pile installation torque profile.

In addition, field quality control can also include the number of rotations and time for each foot of advance. This will assist the engineer to evaluate if proper installation has occurred. The combination of these field measurements can also allow for rapid field modifications of the geometry of Screw-Piles to insure that the required load capacity will be achieved.
