## Improving the Structural Performance of Heritage Buildings. A Comprehensive Romanian Experience.

## **IMPROVING THE STRUCTURAL PERFORMANCE OF HERITAGE BUILDINGS. A COMPREHENSIVE ROMANIAN EXPERIENCE.**

The paper is devoted to the building that houses the “National History and Archeology Museum”, located in Constanța, a seaside city in Romania.

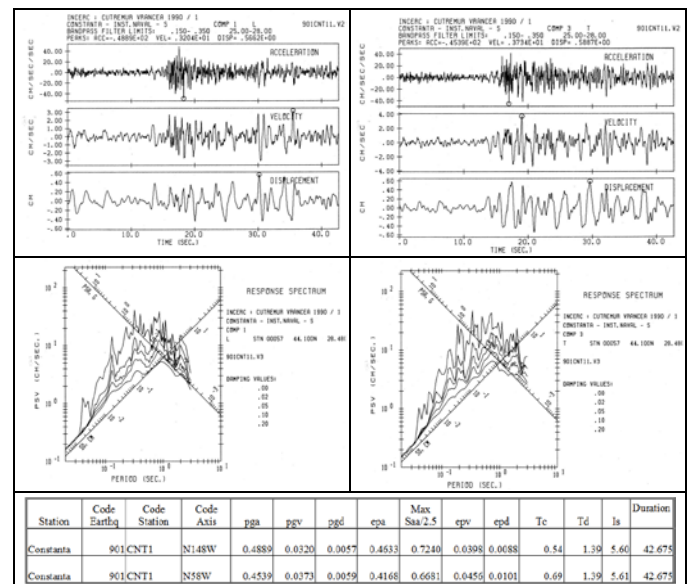
Fig. 4. May 30, 1990 earthquake recordings. Horizontal accelerations and corresponding response spectra (INCERC, 1990).

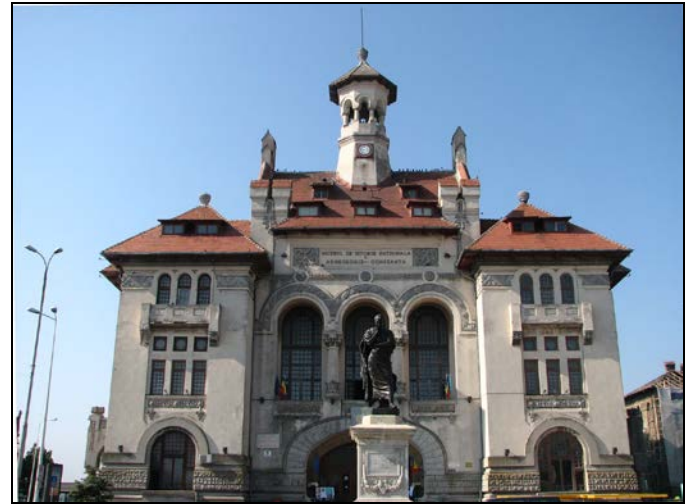
Fig. 5. General view of the main façade of the building.

For the entire old construction assembly in Constanța, this building represents the most important exponent of the Neo-Romanian architecture realized at the beginning of XX century. It is a massive monumental construction, which dominates the entire square, with expressive façades, conceived by architect Victor Ștefănescu, one of the students of the architecture school founded by the great Romanian architect Ion Mincu (Fig. 5).

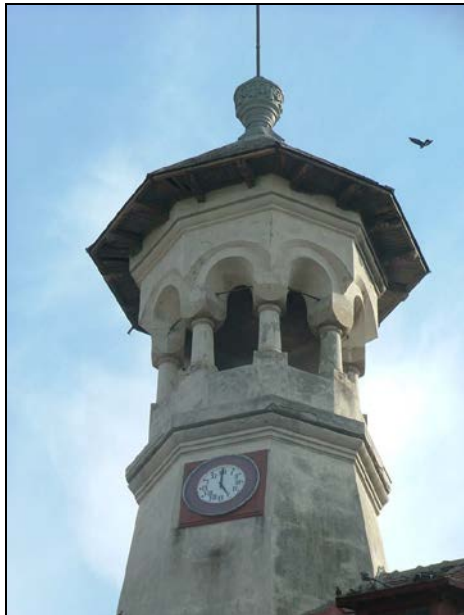
Fig. 6. Detail of the reinforced concrete turret.

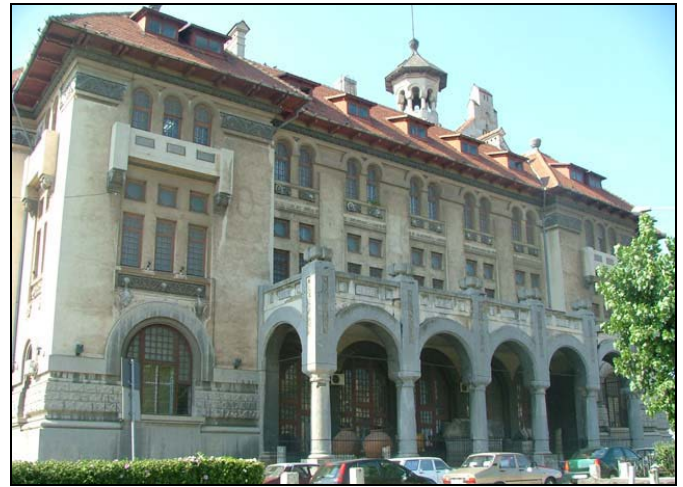
Fig. 7. View of the lateral façade.

Elements of Romanian traditional architecture are visible on all façades in the framing areas of all openings (especially of those for the windows) and at the marking of the cornice. On the lateral façades the traditional architecture is present in the area of the terraces, where seven arched vaults sustained by brick masonry pillars can be seen (Fig. 7).

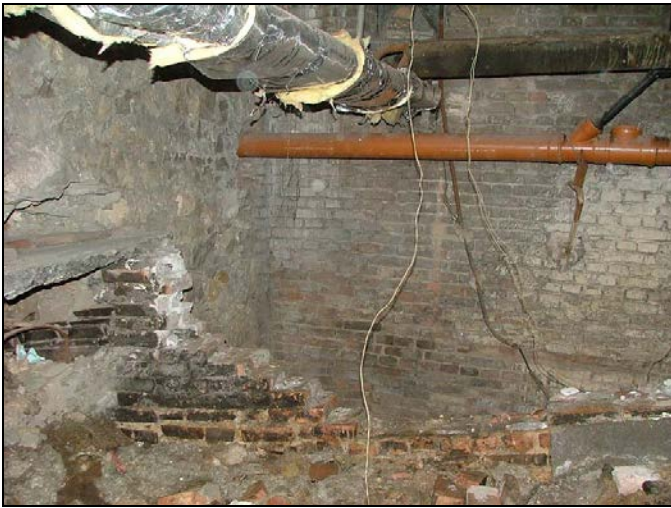
Fig. 10. View of the basement of MINA building.

The substructure of the building is 6 to 8 m high and consists of stone masonry walls, constituting the general basement (Fig. 10).

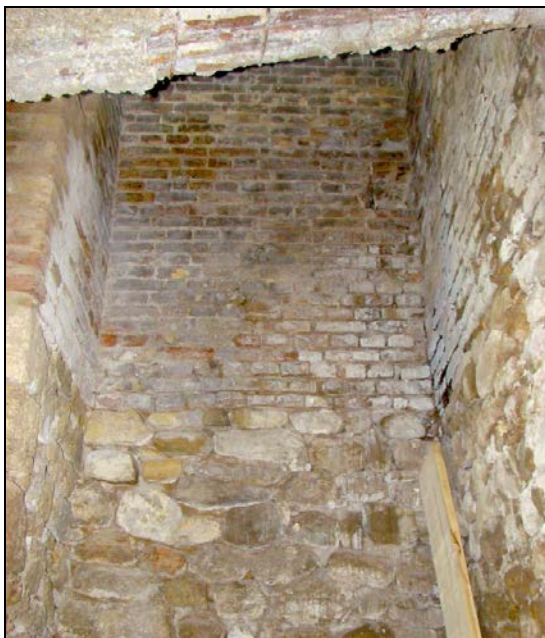
Fig. 11. MINA building: structure of foundation.

The structure of the foundation consists of continuous stone cyclopean concrete walls type of approximately 10m height, beneath all the substructure walls. This information was taken from the National Archive documents of Constanța and from the press at that time, and was confirmed in 2008 by performing a geotechnical study (Fig. 11).

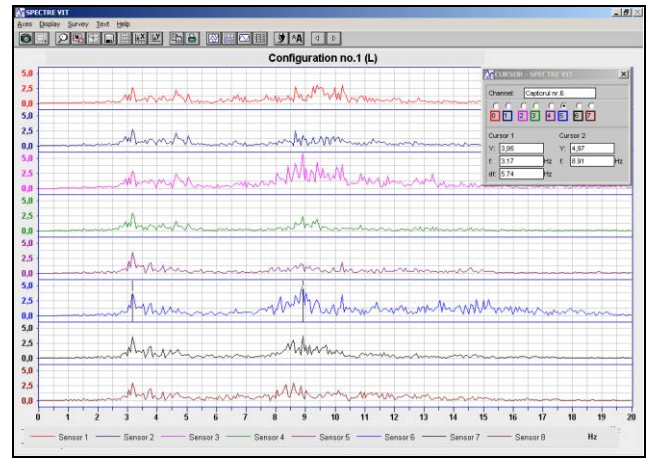
Fig. 13. Ambient vibration testing; longitudinal direction; velocities ( $\mu\text{m/s}$ ). Time domain (a) and Fourier amplitude spectra representations (b).

Fig. 13÷16 present time domains, amplitude Fourier spectra, and auto-correlation functions representations, both for longitudinal and transversal directions.

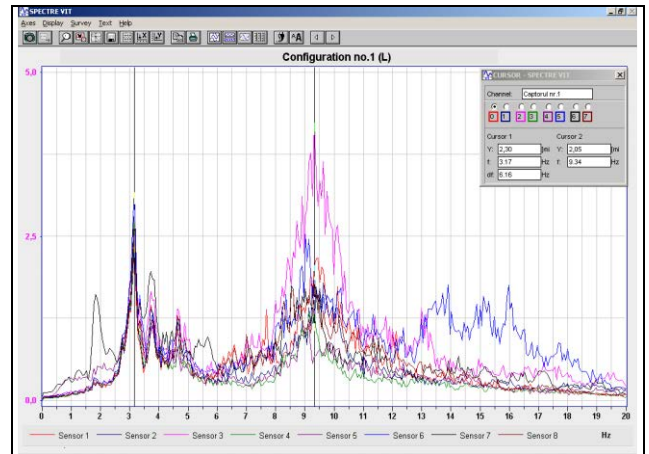
Fig. 14. Ambient vibration testing; longitudinal direction; velocities ( $\mu\text{m/s}$ ). Average Fourier amplitude spectra representations.

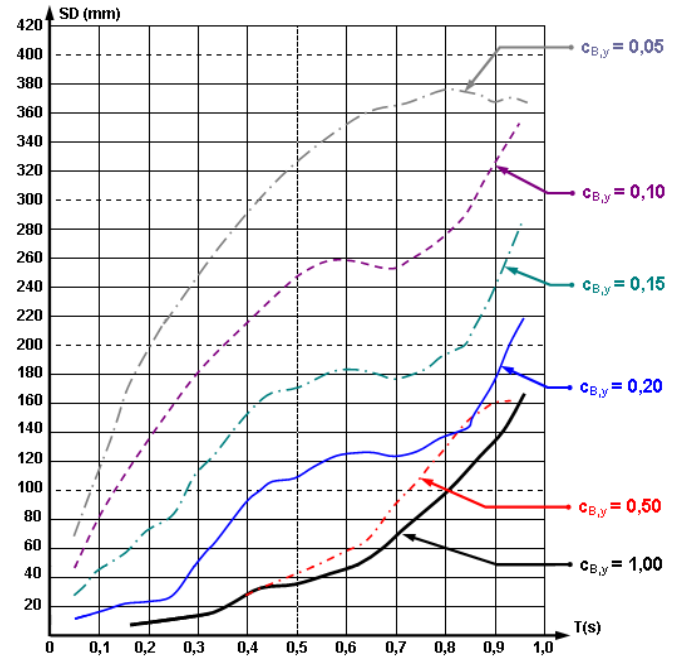
Fig. 17. Inelastic displacement response spectrum.

One can notice that the pairs of values “ $T_{n,1}$ ” and “ $c_{B,y}$ ” placed the structural system of the building in unfavorable spectral positions of the inelastic response spectra. In Fig. 17 (Țițaru and Crăițăleanu, 2009), for a period of vibration  $T_{n,1}=0.4$ s and for the two values of  $c_{B,y}$  (0.20 and 0.13), large values of the displacement can be observed. These unfavorable “spectral positions”, on both directions, led to exaggerated values for the required ductility factors.

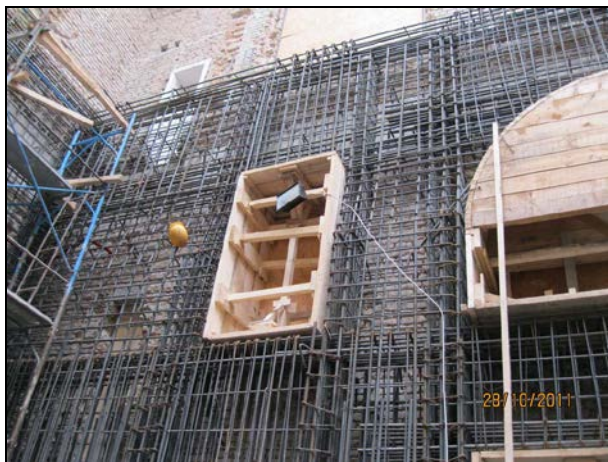
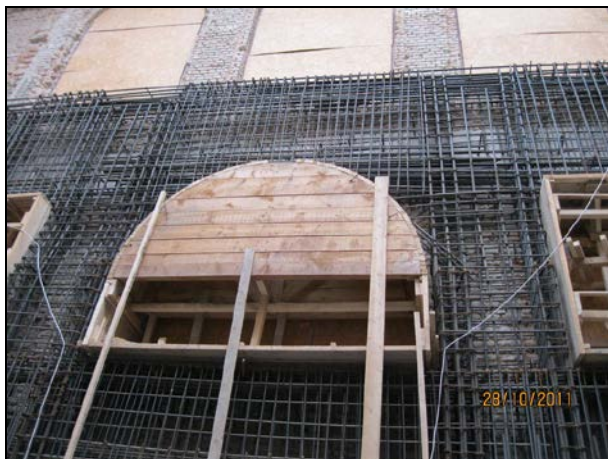
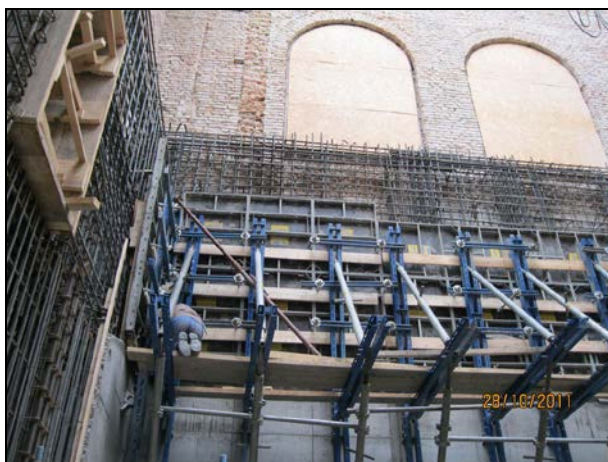
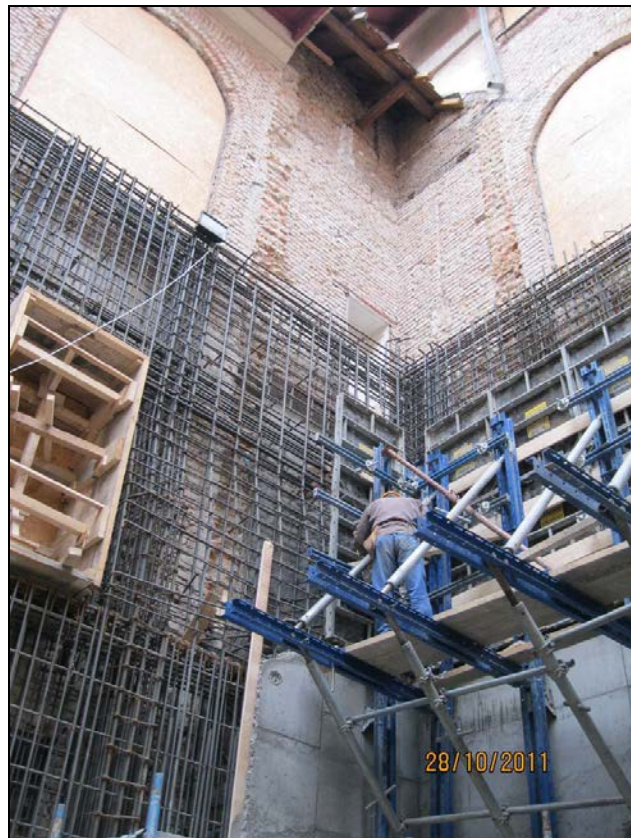
7. The strengthening of a monumental old unreinforced masonry building is engineering in its purest form. The relationships and responsibilities of the engineer with regard to other participants in the strengthening and rehabilitation process are unique.
8. In the followings, some photos taken during the strengthening works are presented.
