## A Field Test Study on Instrumented Soil Nail Installed in Cut Slope

## A FIELD TEST STUDY ON INSTRUMENTED SOIL NAIL INSTALLED IN CUT SLOPE

Soil nailing is a technique routinely used in Hong Kong whereby closely spaced steel bars are installed into a slope so that its stability conditions can be improved. A full-scale field test has been carried out by The Department of Civil Engineering of The University of Hong Kong to study the development of passive load along the full length of soil nails when subjected to induced rise in groundwater table. The cut slope was formed to a very steep angle of  $55^\circ$  and 10 m high in completely decomposed volcanic material. Grouted curtain was also formed behind, at the bottom and on both ends of the slope in order to form an impermeable barrier that would allow groundwater table to increase artificially by injecting water into slotted PVC pipes. Nine number of soil nails (in regular 2 m c/c spacing of 3 rows and 3 columns) of 6 m long high yield steel bar were installed at  $15^\circ$  from horizontal into the formed cut slope. Instrumentation included strain gauges along the nails, inclinometers, piezometers, and settlement prisms. Thi

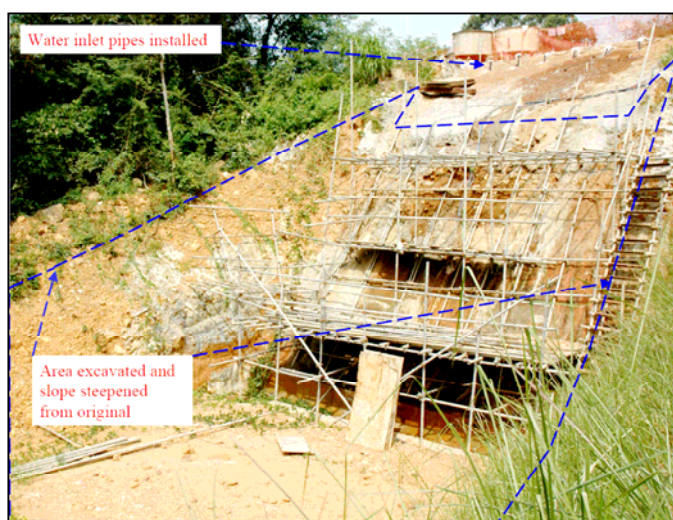
Figure 3. Overall view of slope after excavation.

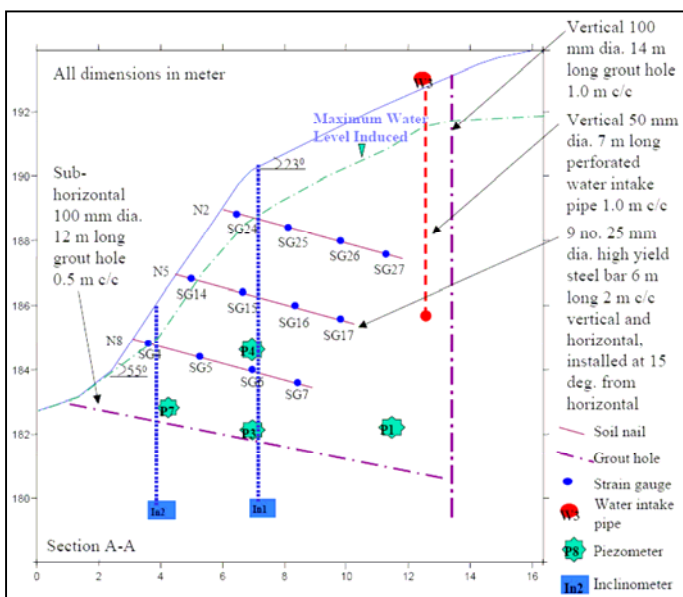
Figure 6. Sectional view of instruments installed.

Figures 5 and 6 show the location of the instrumentations in plan view and sectional view respectively.

Piezometric head shown in Figure 6.

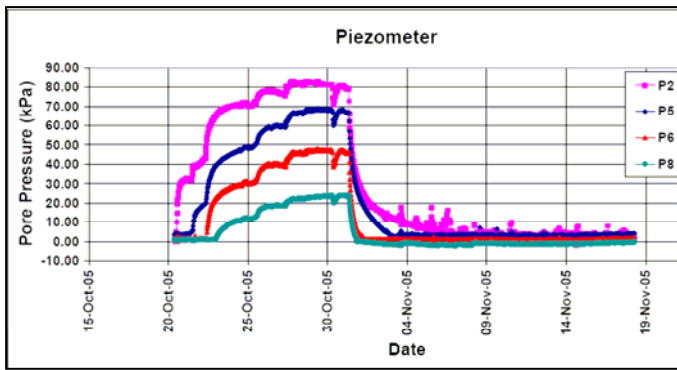
Figure 8. Pore pressure recorded during induced rise in groundwater table.

Figure 8 shows the maximum pore water pressure recorded in the piezometers (P2, P5, P5 and P8 location refers to Figure 5) and Figure 9 shows a typical plot of the maximum load developed in the nails (N9 location refers to Figure 10) between 20 Oct. and 31 Oct. 2005.

and the load developed in the nails were spontaneous and synchronized, as reflected by the gradient of the curves in Figures 8 and 9.

Based on the elevations of the piezometers tip and the measured pore water pressures, piezometric elevation reached a maximum level equivalent to the base of the fill layer between the morning of 29 October 2005 and the evening of 30 October 2005. Water was observed seeping out at the toe and at the mid level of the slope on around 28 October 2005. When the water level reached the base of the fill layer on 30 October 2005, water was observed seeping out through the entire slope face and at the interface layer between the fill and the residual soil. The test was stopped on 31 October 2005 because any further injection of water into the slope would only cause water to seep out through the base of the fill layer, and would not cause any further increase in the piezometric elevation. After water was shut down on 31 October 2005, the water level was allowed to gradually reduce to its original level, which was below the base of the slope.

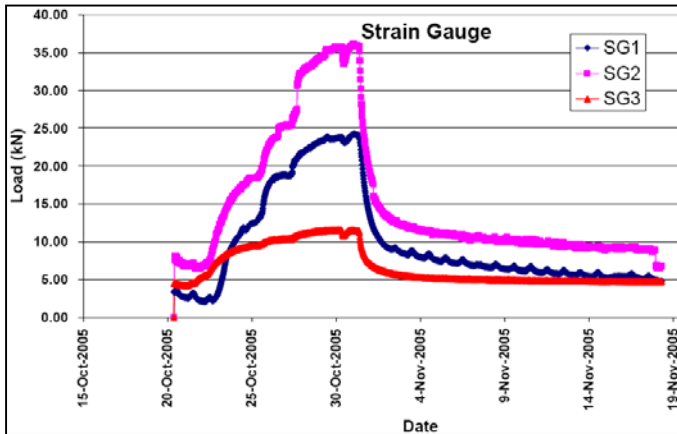
Figure 9. Load recorded in soil nails during induced rise in groundwater table.

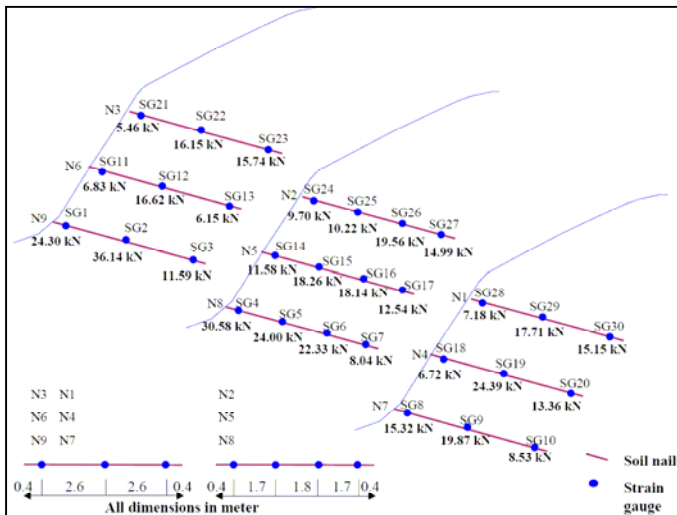
Figure 10. Load recorded in soil nails during induced rise in groundwater table.

The maximum developed force at each strain gauge location is shown in Figure 10.

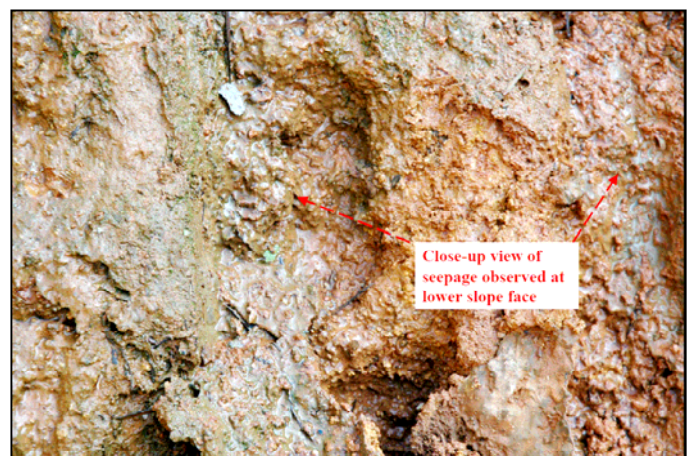
Figure 12. Close-up view of observed seepage at the face of the slope.

Figure 11 shows the entire slope surface was wet on 29 October 2005. A close-up view of the water seeping out at the slope face is shown in Figure 12.

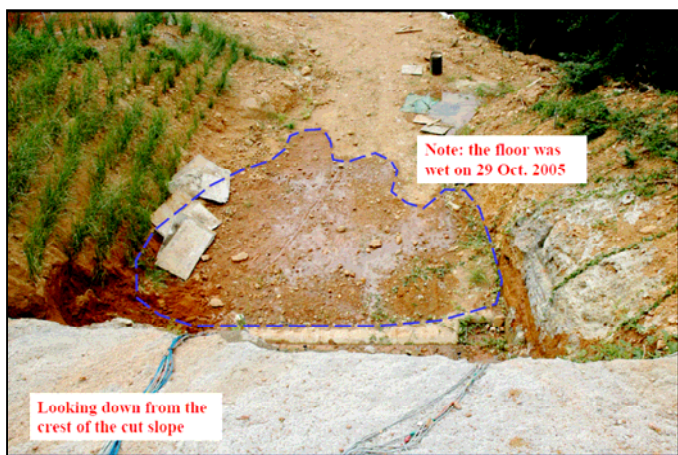
Figure 13. The floor of the slope was wet on 29 October 2005.

The purpose of the grout curtain was to retain the injected water within the soil masses and to induce a rise in piezometric elevation. Its construction was successful as demonstrated by the piezometer readings described and the seepage observed. With a very close spacing of 0.5 m c/c at the base of the slope, the grouted holes have formed a relatively impermeable layer and allowed the water level to rise. As noted earlier, a U-channel was constructed at the toe of the slope to receive the surface runoff and to divert it away from the toe of the slope. It was very interesting to note that the floor was wet on the morning of 29 October 2005 (see Figure 13). Water could not have come from the slope surface because they were intercepted by the U-channel. The water was in fact came from below the base of the slope, as demonstrated by the water path indicated by the arrows in Figure 14. When the water level was very high on 29 October 2005, there was significant water pressure built up within the soil masses. Water eventually passed through the spaces between the bottom grouted holes, entered below the bottom of the slope and exit to the floor.

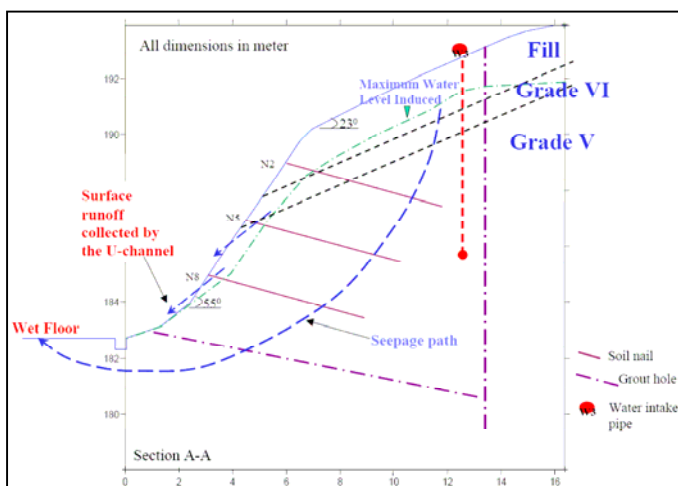
Figure 14. Flow path breaking through the bottom rows of grouted holes.
