Self Hardening Slurry Wall Installation by Hydromill at The Herbert Hoover Dike – An Innovative Solution

SELF HARDENING SLURRY WALL INSTALLATION BY HYDROMILL AT THE HERBERT HOOVER DIKE – AN INNOVATIVE SOLUTION

In 2007 the US Army Corps of Engineers classified the Herbert Hoover Dike in Florida as a DSAC 1 dam, and started the implementation of one of the largest dam rehabilitation projects in the nation. The construction of the cutoff wall is a key feature of this rehabilitation work to upgrade the dike to current dam safety criteria. The cutoff wall installation is currently being completed on Reach 1, which extends from Port Mayaca to Belle Glade, under a Multiple Task Order Contract based on performance specifications and stringent verification criteria.

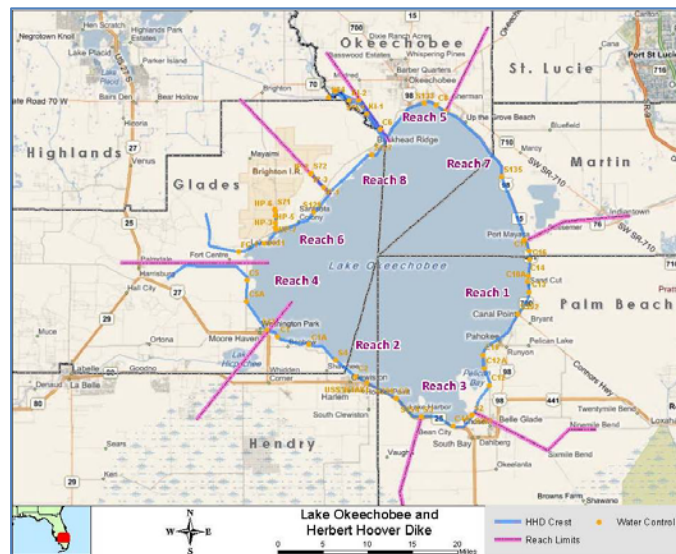
Fig. 2. HHD Rehabilitation Reaches

In 2007, the USACE placed HHD on the Top 6 list of dams in the nation needing repair and has prioritized and budgeted more funding for HHD than any other dam safety construction project in the nation. Rehabilitation of the levee system at high risk, "Reach 1" (Port Mayaca to Belle Glade) was further prioritized (Figure 2).

Reach 1 was subsequently divided into four sub-reaches, Sub-Reach 1A through 1D and further divided into nine Task Order contracts, Task Orders 1 (A) through 9 (I), which have

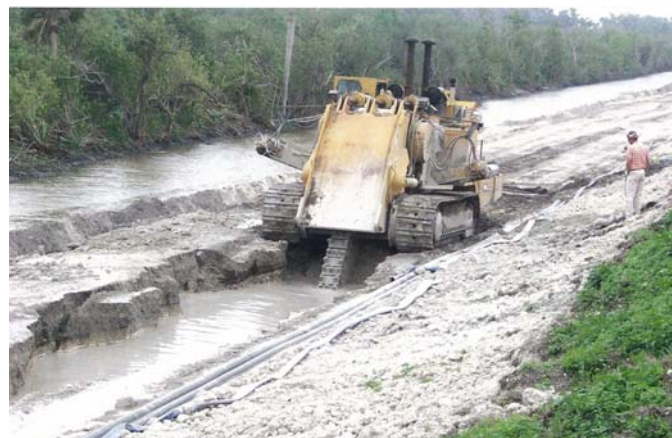
Fig. 3. Long Reach Excavator (by Others)

Early attempts of cutoff wall construction were performed by others. Excavation was performed using long reach excavators and bentonite slurry as stabilizing fluid (Figure 3).

The method was disregarded due to the occurrence of walls cave-ins and collapses.

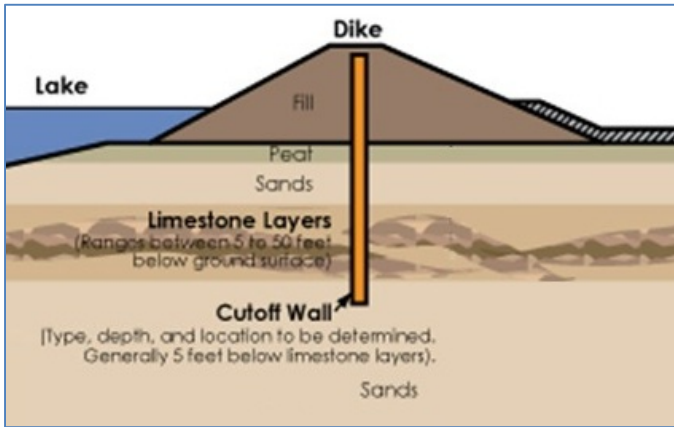
Fig. 4. HHD Rehabilitation Concept

One of the main components of the HHD Rehabilitation Project is the construction of a cutoff wall within the levee that will eliminate the existing seepage through the levee

foundation and limestone layers below (Figure 4).

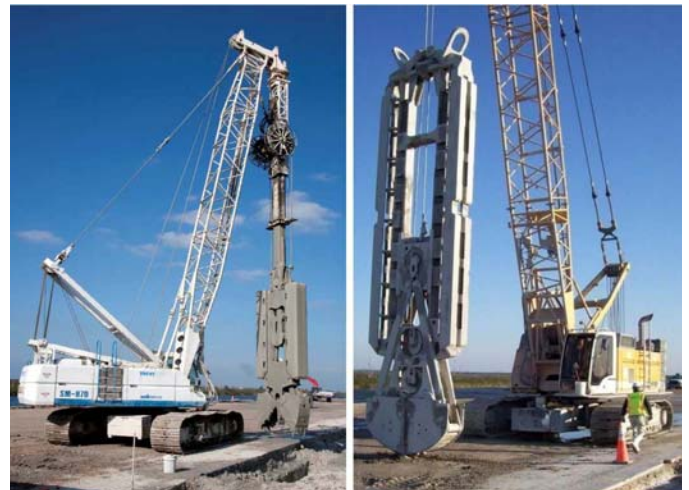
Fig. 5. Hydraulic & Mechanical Clamshells

Excavation with the clamshell, either hydraulic or mechanical (Figure 5), was performed through the embankment fill and soil down to the top of the limestone layer. Soil material that was excavated with the clamshell was dumped directly into off road dump trucks and stockpiled on site for drying and then later disposed off site.

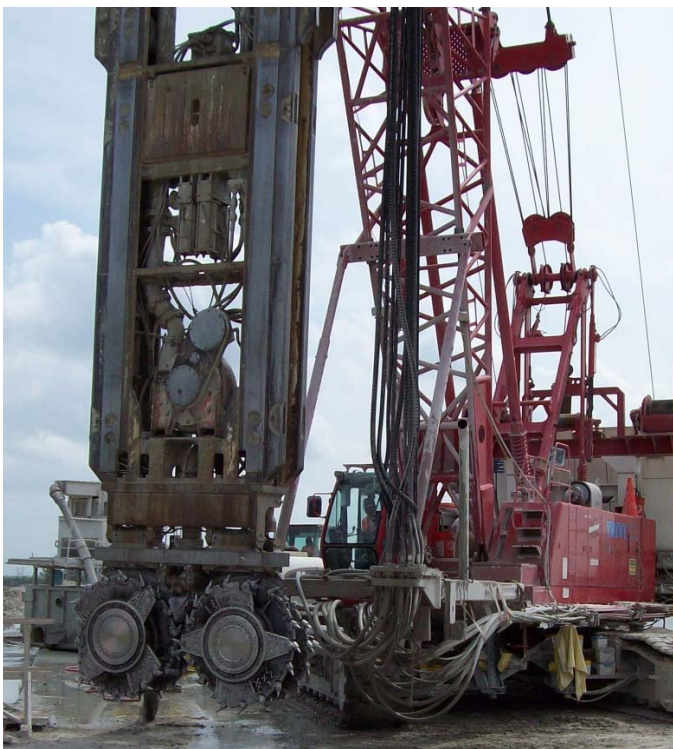
Fig. 6. Hydromill Equipment

The Hydromill equipment system is made up of a crawler crane, milling unit and desanding plant. The milling unit is comprised of a heavy steel frame on which are mounted two counter-rotating and independent cutting wheels with carbide tipped teeth (Figure 6). A powerful submerged mud pump, located directly above the cutting wheels, creates a reverse circulation of the self-hardening slurry, which acts as a transport medium to evacuate the limestone and sand cuttings, and delivers the cuttings-laden slurry to a desanding plant.

As the self-hardening slurry is circulated through the desanding plant, a screen removes the rock particles in excess of ¼ inch. After passing through the desanding unit, the self-hardening slurry sets and becomes the wall backfill material.

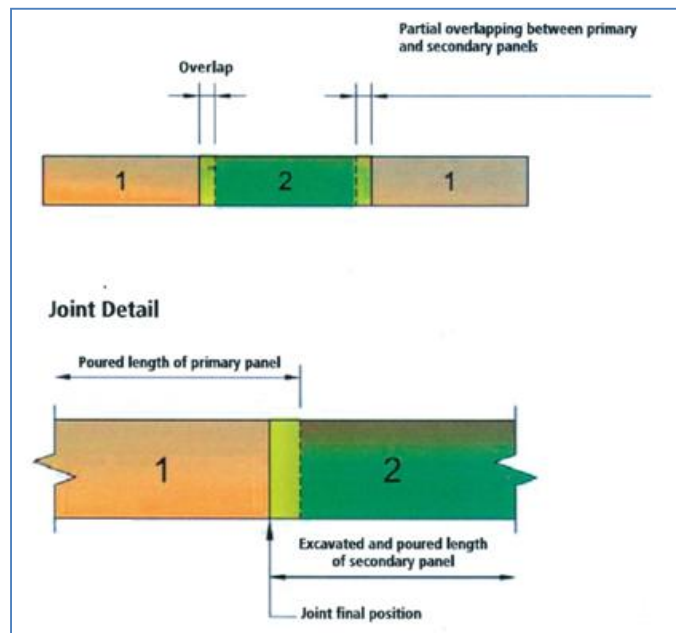
Fig. 7. Panel Joint/Layout

The Panel Method was used to create a continuous cutoff wall with overlapping primary and secondary panels (Figure 7).

The primary panels typically ranged from 23 feet to 35 feet long and were made of multiple bites. The secondary panels, which were individual bites, were typically 9 feet long. The secondary panels provided a 1.5 feet of overlap on each side of the adjacent primary panels ensuring good continuity. During the excavation of the secondary panels, the Hydromill cutter creates a rough, clean contact surface on the ends of the primary panels, resulting in a high quality watertight joint.

Panel verticality was controlled through a down-the-hole inclinometer mounted within the body of the Hydromill milling unit, which provides verticality information in real time and allows for corrections for any deviations, if necessary. Longitudinal deviations can be corrected by independently varying the rotation speed of the cutting wheels; transverse deviation correction is made by inclination of a tilt plate, on which the cutting wheels are mounted.

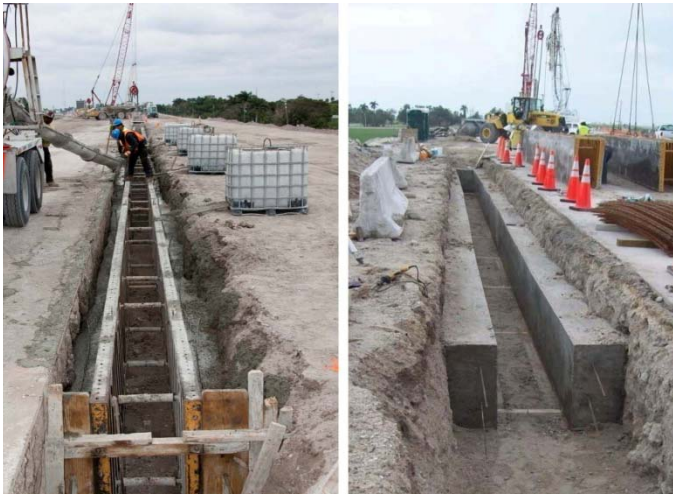
Fig. 8. Guide Wall

In addition, a concrete guide wall (Figure 8) was constructed about 1.5 feet below the existing levee road along the alignment of the cutoff wall. A guide wall is used to control the start of excavation and as a fixed referenced for panel location, depth measurements and verticality measurements as excavation advances.

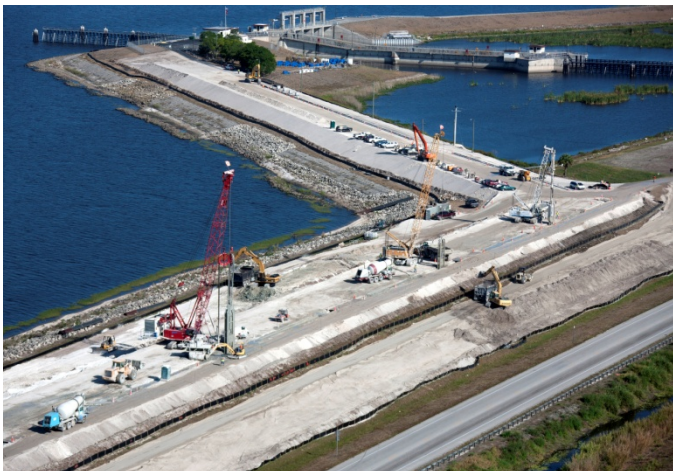
Fig. 9. Site Overview

The whole construction process can be followed in Figure 9, below.

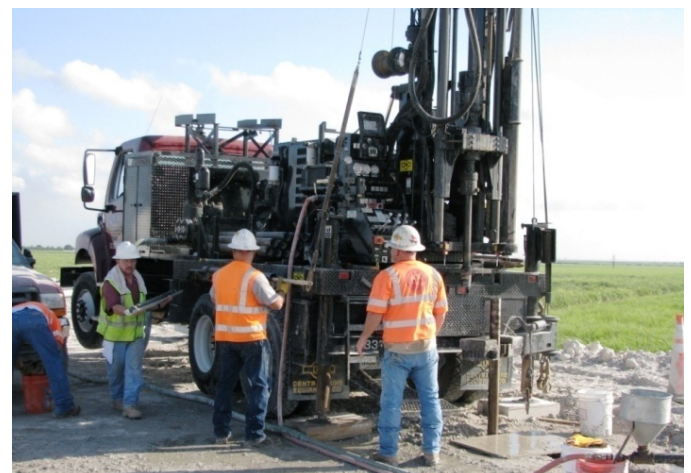
Fig. 10. Verification Boring & Typical Core Sample

The Technical Specifications required at least 95% core recovery for the entire length cored, therefore a rotary core drilling method was selected in order to provide the necessary samples for testing (Figure 10). Coring was performed using a wireline system with a double tube type core barrel. Drilling fluid was typically water with a small amount of polymer added to help lift the drill cuttings out of the borehole.

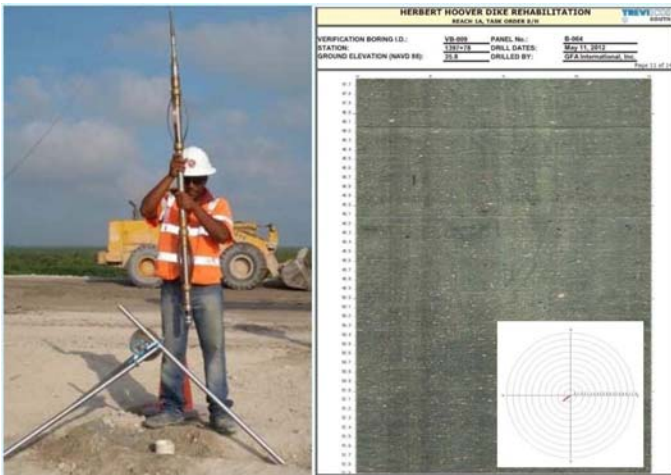
Fig. 11. Video Log Record

Upon completion of the verification boring, the hole was flushed with a light bleach solution and surveyed using an Optical Geologger, manufactured by Robertson Geologging Ltd., which was lowered down the hole. This logger recorded a 360-degree view of the borehole surface and projected the image as a “flat core” with description of depth and orientation (Figure 11). In addition, the Geologger output provided a graphic display of the borehole alignment (verticality), which was measured continuously along the full depth.

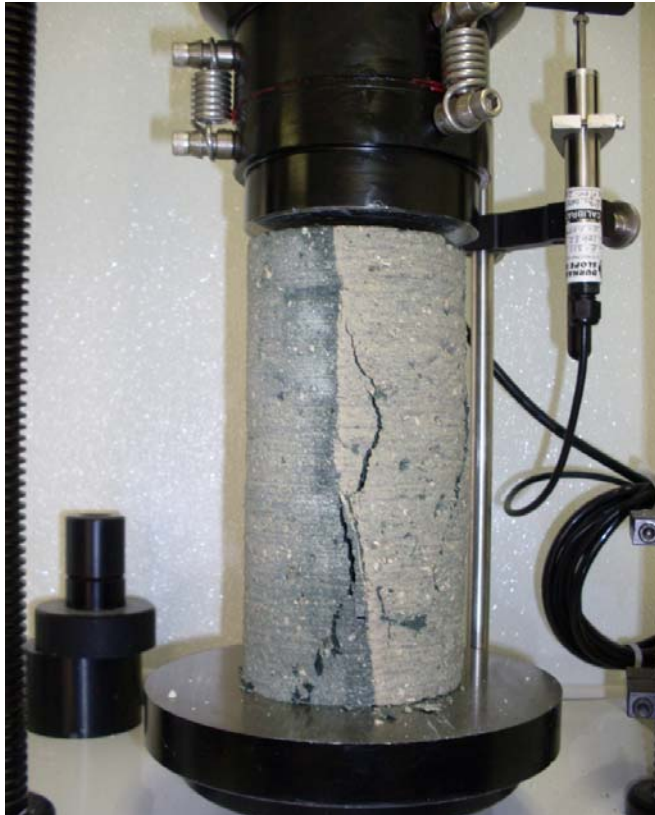
Fig. 12. Core Sample at Joint

The continuity of the cutoff wall was confirmed by the core samples from the verification borings and the borehole televiewer logs. In addition, the use of the successful performance of the Panel Method was proved through verification borings located at the joint between primary and secondary panels. The retrieved core samples showed good bonding and color difference between the different aged self-hardening slurry mixes (Figure 12).

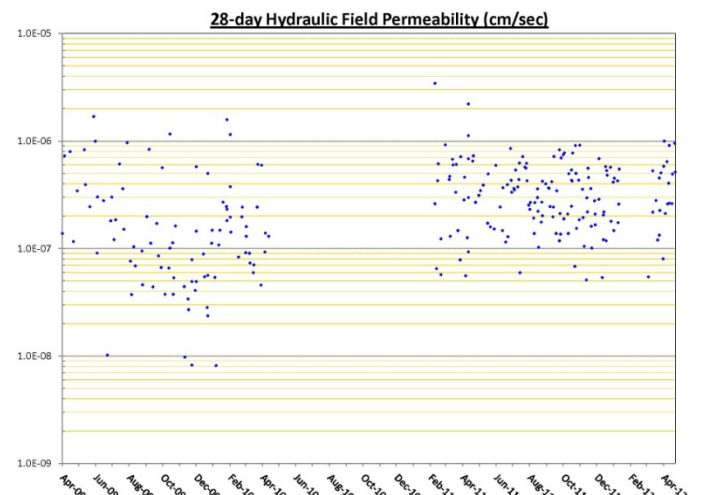
Fig. 13. Summary of Field Permeability Test Results

At 28 days after completing the cutoff wall, an in-situ permeability test was performed in the verification boring by means of a falling head test.

After the boring was filled, the water level drop was recorded over a half hour holding period. The formula used to calculate the permeability was specified by the Technical Specifications using the Hvorslev Method, which is shown in Formula (1), below:

In order to validate the cutoff wall for in-situ permeability, the performance requirement must be less than 1x10⁻⁶ cm/s for the entire length of the verification boring (Figure 13).

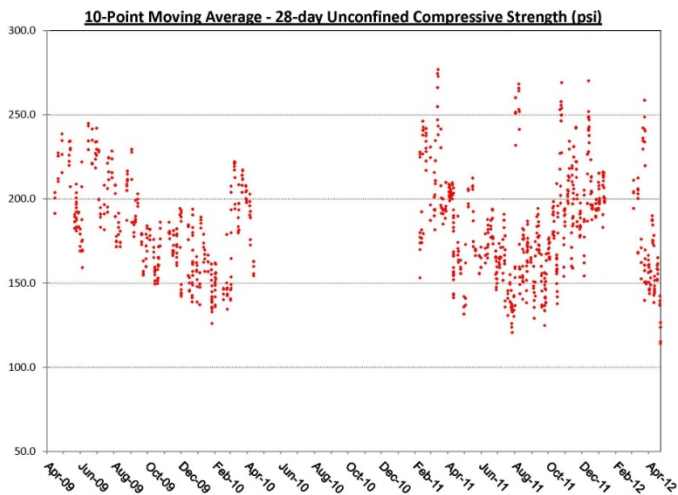
Fig. 14. Summary of UCS Test Results

UCS testing was assessed on core samples from the verification borings. Four samples were selected per each verification boring; two from depth ranges of 10 to 20 feet and two below 30 feet, with one within 10 feet of the bottom.

In order to validate the cutoff wall for strength, the performance requirement ranged from 100 to 500 psi. Strength was evaluated by a 10-point moving average (Figure 14).
