Post-Tensioned Caissons Permit Interstate Construction: A Case History

A. Joseph Nicholson Jr.
National Foundation Company, USA

SYNOPSIS: Due to severe right of way restrictions associated with the relocation and widening of Interstate 85 in Atlanta Georgia, a special post-tensioned caisson retaining wall was constructed within 12 inches of an adjacent parking garage and office building. National Foundation Company's design for the twenty foot high retaining structure was used in lieu of an L-shaped cantilevered concrete retaining wall that required extensive temporary shoring for construction. The caisson wall was instrumented and monitored during and after construction using slope indicators and optical survey.

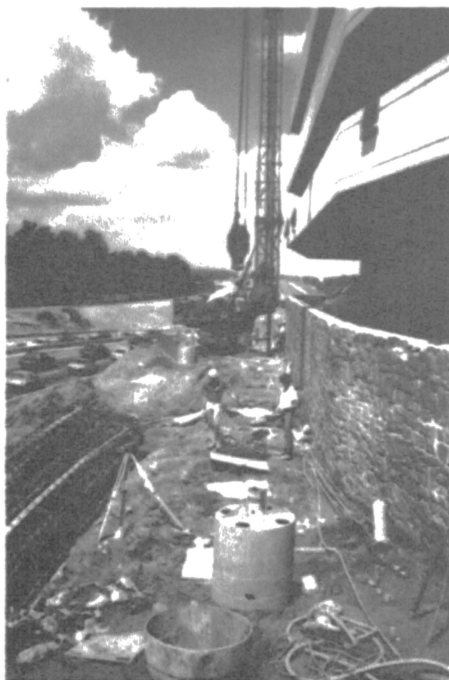
Construction began in July of 1984, and took a total of 8 months. Five months were required to construct the caissons and rock anchor tendons. The remaining time was used to excavate in front of the wall and pour the concrete facing. The first phase of work was to drill the caissons, which averaged 42 feet long from the ground surface to the top of rock. Forty-two inch diameter rock sockets in the hard granite gneiss were cored for 25 of the caissons. The sockets were generally 1 or 2 feet in depth, although three of the caissons had sockets of 4, 4.5, and 6 feet in length where seamy rock was encountered. The reinforcing cages were fabricated in advance with the draped metal post-tensioning ducts tied into the proper position. The cages were lowered into the drill holes, and concrete was pumped from the bottom up, maintaining the void space in the post-tensioning ducts. When the caisson concrete had sufficiently cured, a rotary hydraulic drill rig was positioned over the ducts to drill the rock anchor sockets. The drill tools, consisting of a 6 inch diameter down-the-hole hammer and 3 inch diameter drill rods were first lowered through the draped ducts to the bottom of the caissons. The 25 to 30 foot sockets were then drilled into sound bedrock.

FIGURE 4. CAISSON DRILLING

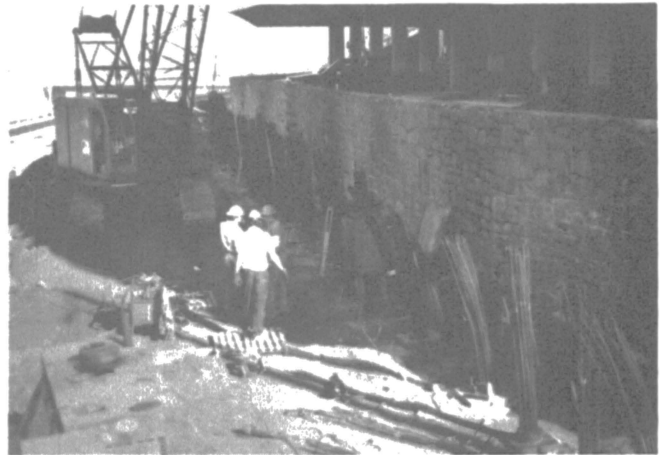
FIGURE 5. ROCK ANCHOR TENDONS

The rock anchor tendons were prefabricated and delivered to the job by truck. The individual strands were "basketed" around centralizers in the bond length to maintain at least 1/2 inch of grout cover over the steel. The tendons were placed with the aid of a crane. Primary grout, consisting of a plain cement-water mix was injected through a plastic tube placed to the bottom of the rock anchor sockets. A predetermined quantity of the mix was injected to fill only the bond length of the anchor. After allowing the primary grout to cure, bearing plates were installed at the top of the

caissons at an angle perpendicular to the drape of the tendons. The rock anchors were tested to 1.5 times the design load (up to 1268 kips) using a large center hole hydraulic jack, which pulled all of the strands simultaneously. Once the anchors were tested and locked off at design load, the strands were cut off and the ducts were filled with secondary grout. The bearing plates and anchor heads were encased in non-shrink grout for corrosion protection.

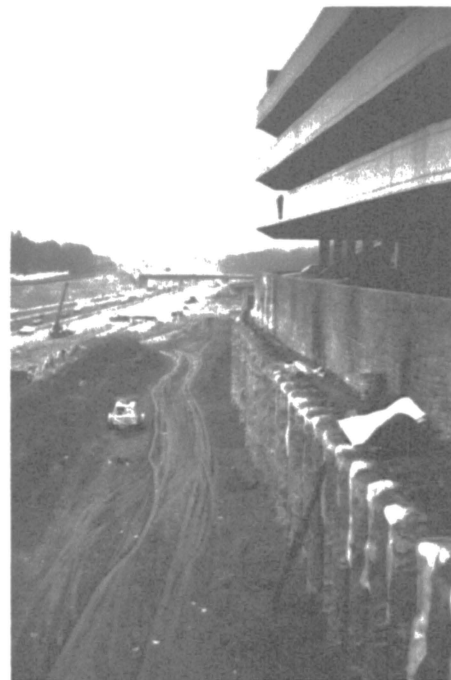
FIGURE 6. EXCAVATION IN FRONT OF WALL

Excavation was performed in three lifts. As soil was removed from the face of the caissons, two separate operations took place. The drainage board or PVC drainage pipes were placed and the steel shear studs were epoxied into holes drilled into the caissons. When the excavation was complete, the reinforcing steel for the fascia was tied and the facing was cast. The weep holes were cast through a New Jersey barrier which was slip-formed along the base of the wall.

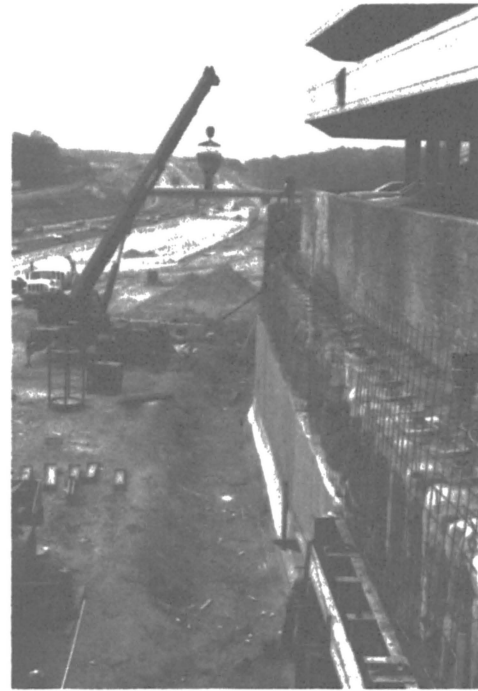
A cast-in-place, 12 inch thick reinforced concrete facing was designed for the wall. The facing consisted of 19 to 32 foot wide segments. These segments were cast around steel shear studs that were drilled and epoxied into the caissons. The facing was provided with a rusticated finish to architecturally match the adjacent conventional retaining walls.

FIGURE 8. CONSTRUCTION OF CONCRETE FACING

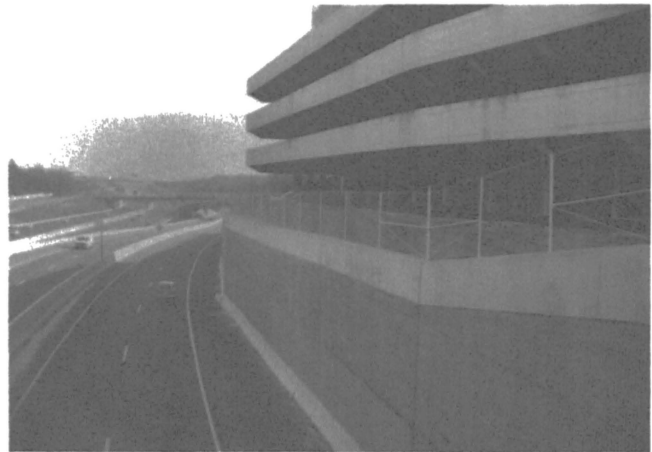
FIGURE 9. COMPLETED RETAINING WALL

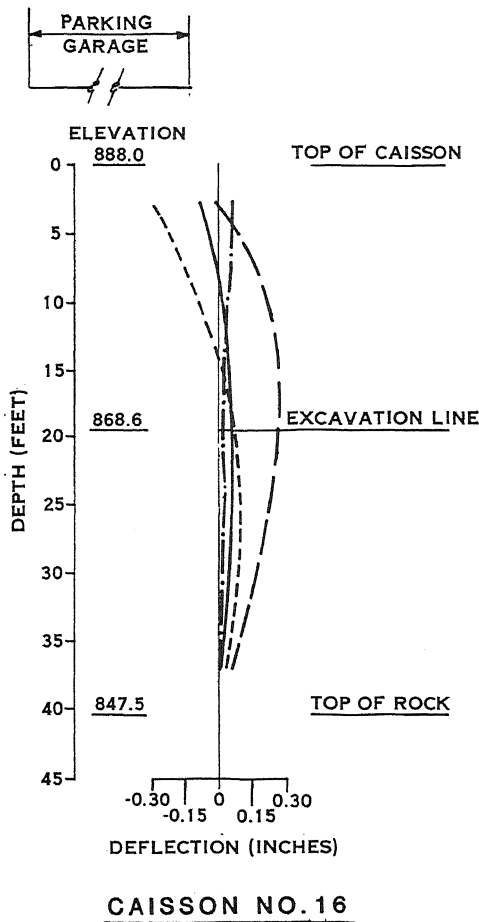
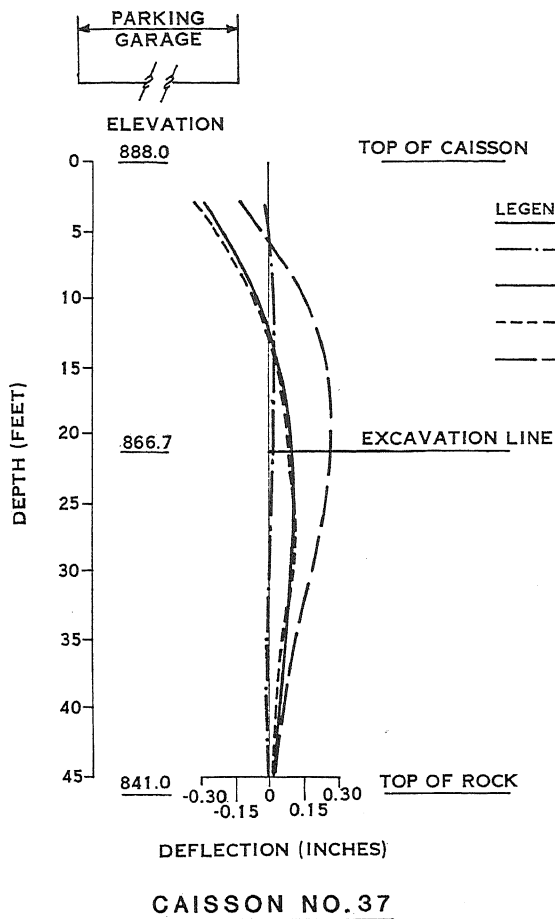
The inclinometer data provided the deflected shapes of the instrumented caissons. Plots of the deflected caissons are shown on Figures 10, 11, 12, and 13. The exaggerated horizontal scale of these figures show the evolution of the deflected profile at important milestones throughout construction and up to the most current readings.

The shafts responded to the post-tensioning by bowing backward towards the parking garage at the top and bulging outward at approximately mid-depth. The resulting shape was a smooth curve which looked like an archery bow. When the 20 foot excavation was performed to road grade in front of the wall, the released confinement allowed the tops of the caissons to bow backwards an additional amount towards the parking garage (especially where the caissons were not tangent.) The caissons then deflected and rotated outward in response to earth pressure after excavation. However, the post-tensioning forces were high enough to maintain the caissons in a permanently bowed configuration. Maximum outward deflections of 0.25 to 0.30 inches were measured approximately at roadway grade. The tops of the caissons are currently located either at their original installed positions or slightly more towards the parking garage than when first installed.

FIGURE 10. SLOPE INDICATOR RESULTS

FIGURE 11. SLOPE INDICATOR RESULTS

FIGURE 12. SLOPE INDICATOR RESULTS

FIGURE 13. SLOPE INDICATOR RESULTS

Approximately 55 to 65 percent of the outward movement of the caissons occurred within 8 weeks after excavation was complete. In general, these movements occurred uniformly, indicating a gradual application of earth pressure to the wall over an extended period of time.

Caisson 28 experienced a shift in the inclinometer casing at a depth of 37 feet, 12 days after stressing. This caisson contained the deepest rock socket (6 feet) on the project. Very seamy rock was encountered during the drilling of this caisson (a very hard zone was drilled immediately above a soft zone.) The inclinometer casing shift apparently followed the caisson's response to the application of the post-tensioning load in these subsurface conditions.

- 2. The wall did not deflect outward at the top as much as anticipated, although the pre-excavation response to post-tensioning was predicted accurately during design. The caissons responded to the post-tensioning by deflecting back towards the parking garage at the top; and by bulging outward at approximately mid-depth. The bowed shape became more pronounced after excavation was performed in front of the wall. The post-tensioning force was apparently large enough to retain the bowed shape throughout the project, even after the application of earth pressure. This locked-in shape was responsible for the reduced outward deflections observed at the tops of the caissons.
